## Appendix E

### PHASE I: SIDEWALK SURVEY

# City of Sullivan Sidewalk Inventory

This inventory was completed in January 2012 by the city of Sullivan, with assistance from the Meramec Regional Planning Commission. Data for the map was gathered through a “windshield” survey and is only intended to be a general representation of sidewalk condition.

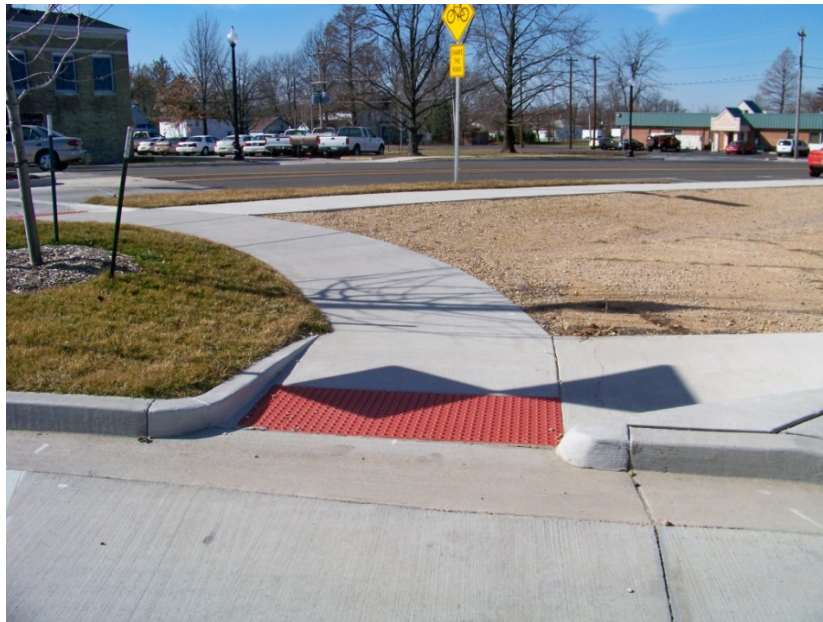
Good Condition: Roundabout at intersection of Taylor and Washington

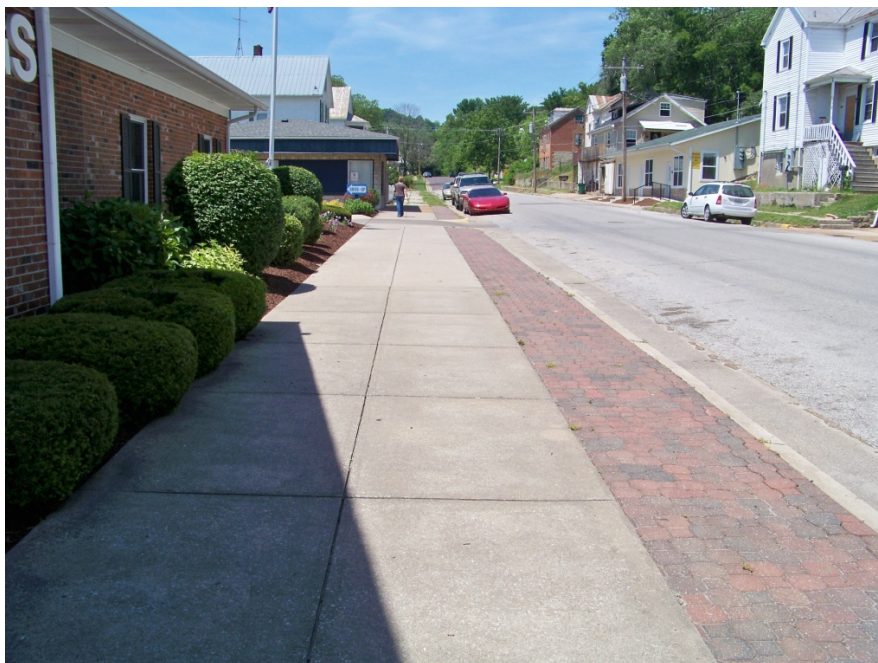
Good Condition: West Fifth Street, south side looking west

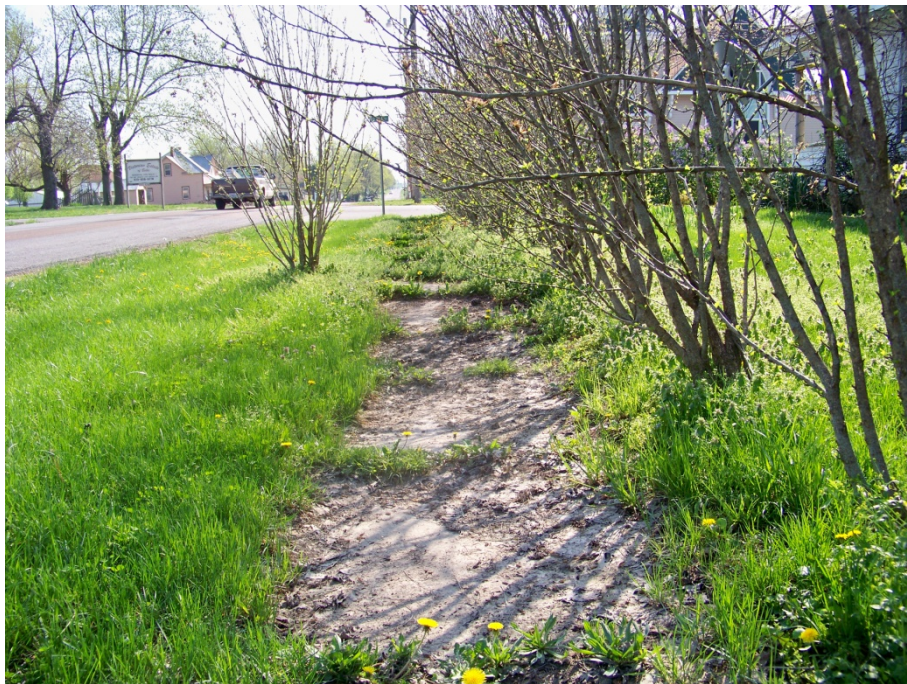
Poor Condition: First Street, south side looking east

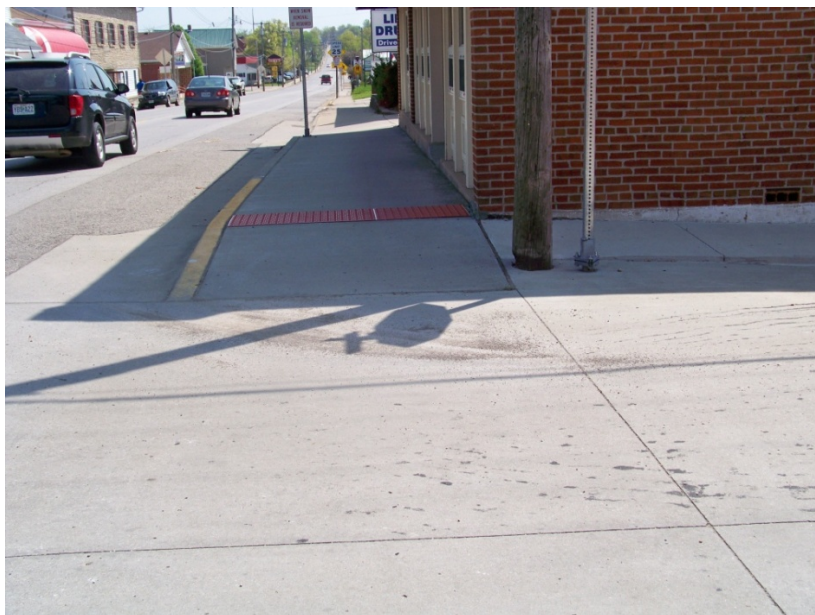
Good Condition: Corner of U.S. Hwy 50 (Main) and Third Street, south side looking east

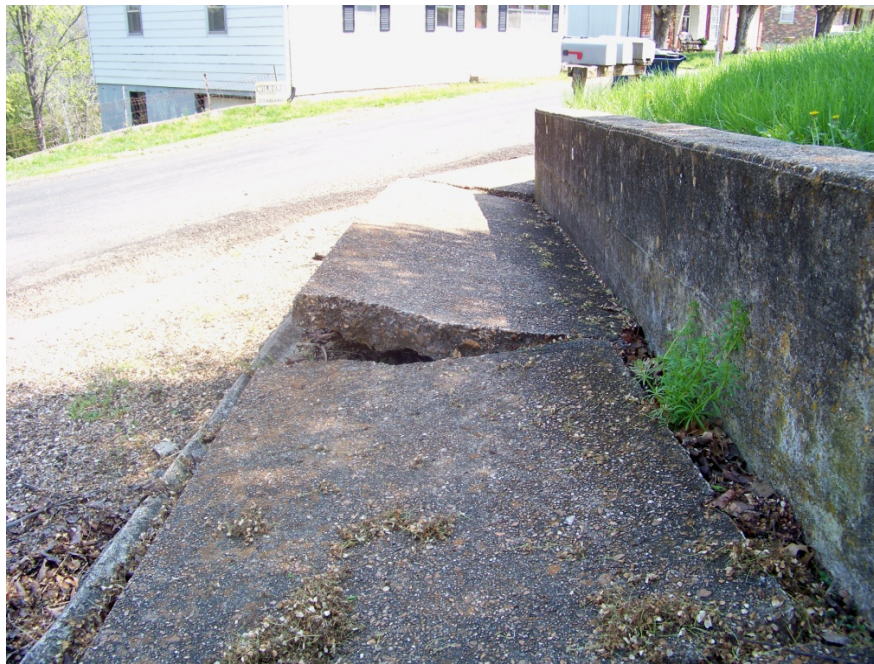
Poor Condition: Corner of Benton Street and Fifth Street, south side

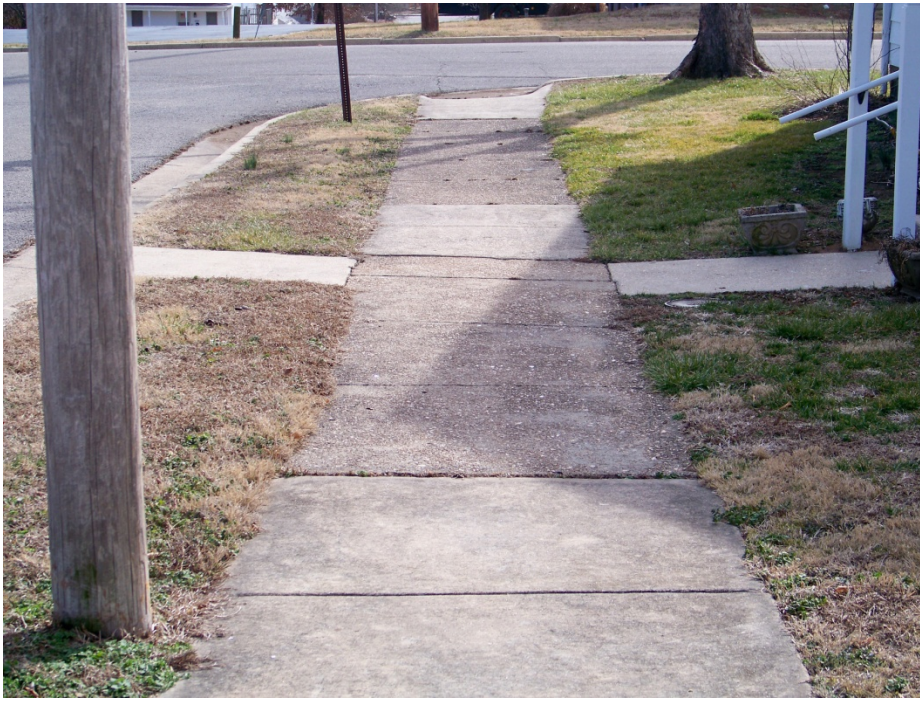
This sidewalk, in fair condition, is located on Cedar Street.

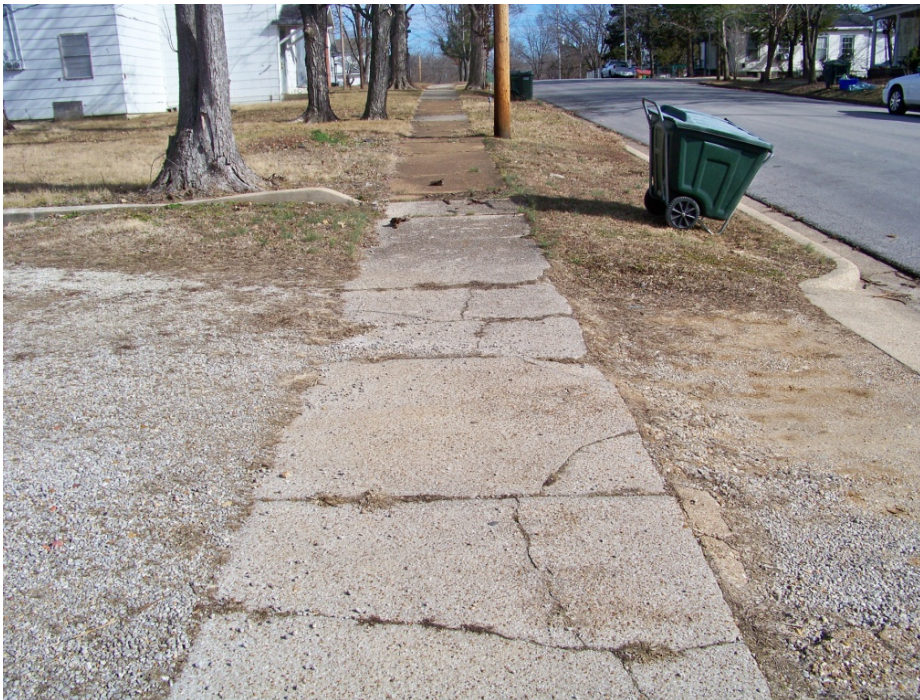
Sidewalks on portions of Olive Street are in poor condition.

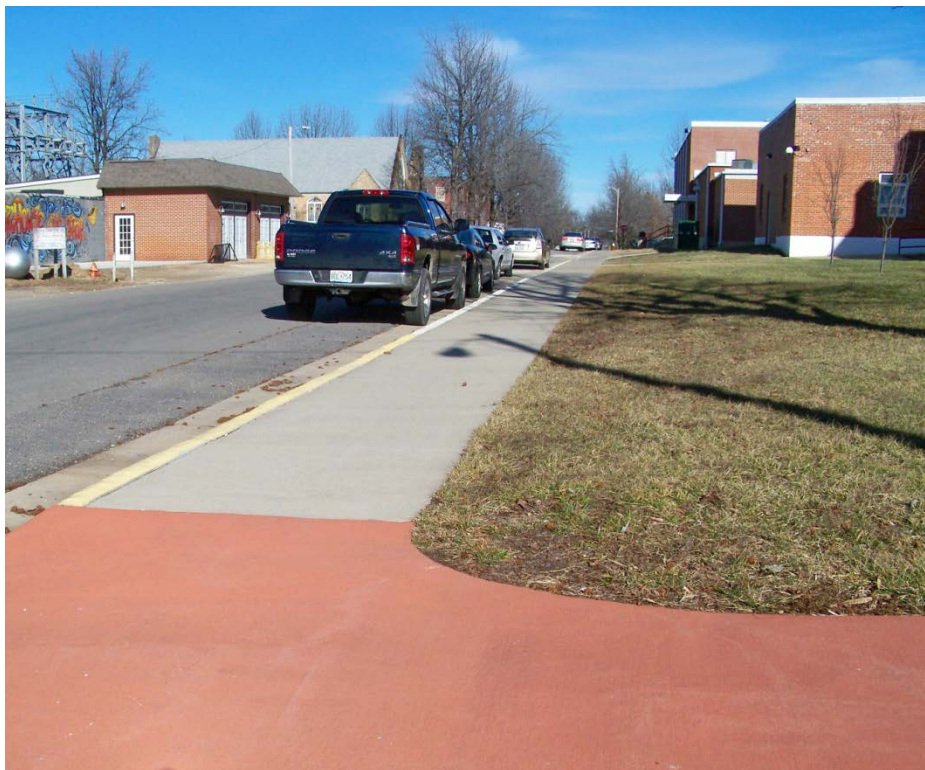
This sidewalk, located on the north side of Washington Street, is in good condition.

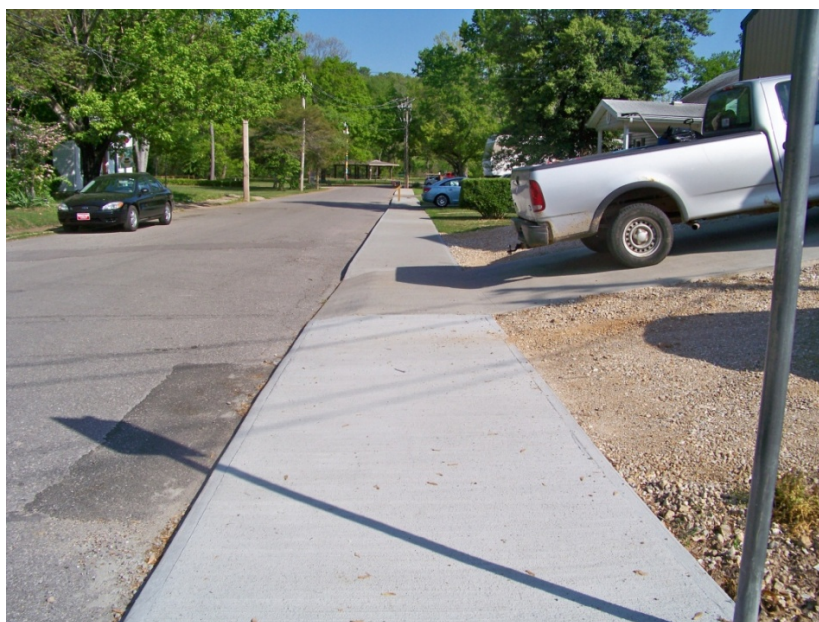
Good Condition: Olive Street, east side looking north

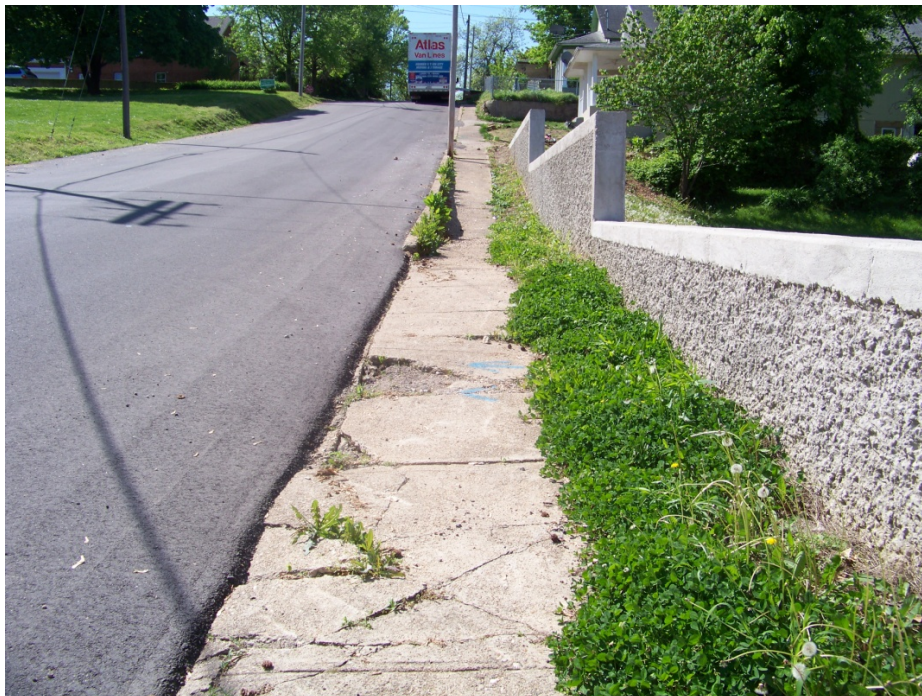
Poor Condition: South Benton Street, west side looking south

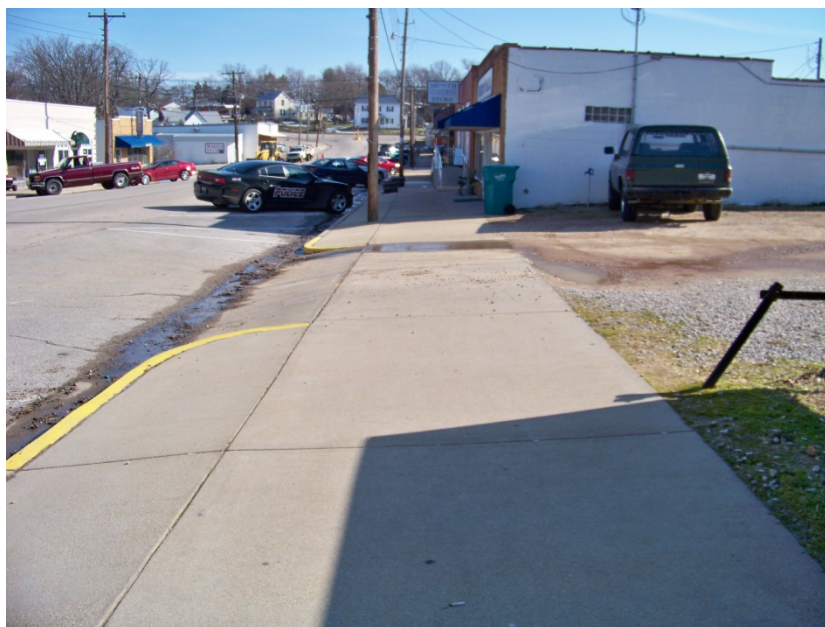
Good Condition: E. Pine Street, south side looking east toward Walnut Street

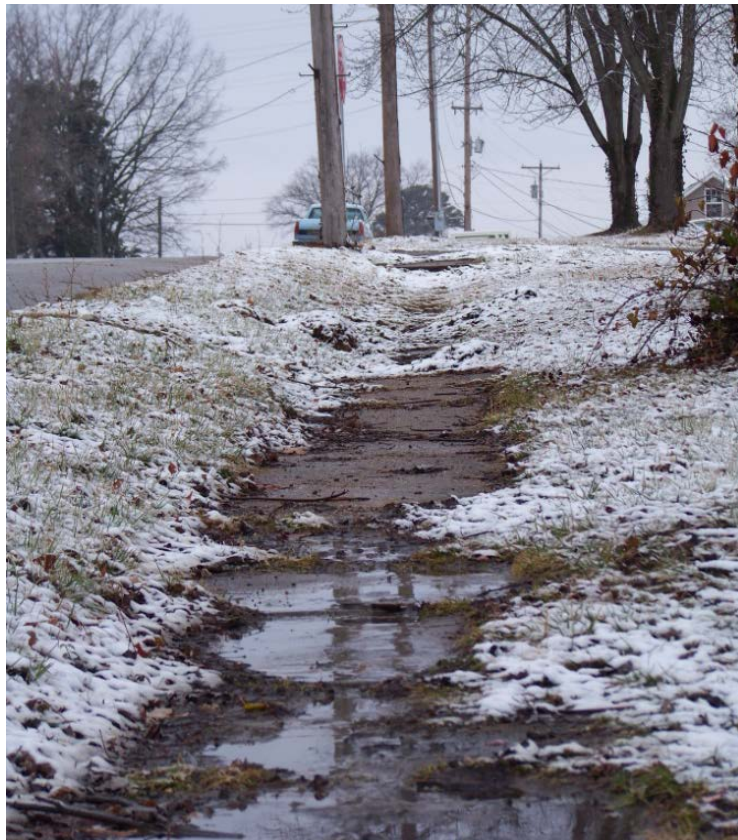
Poor Condition: Washington Blvd, north side looking west

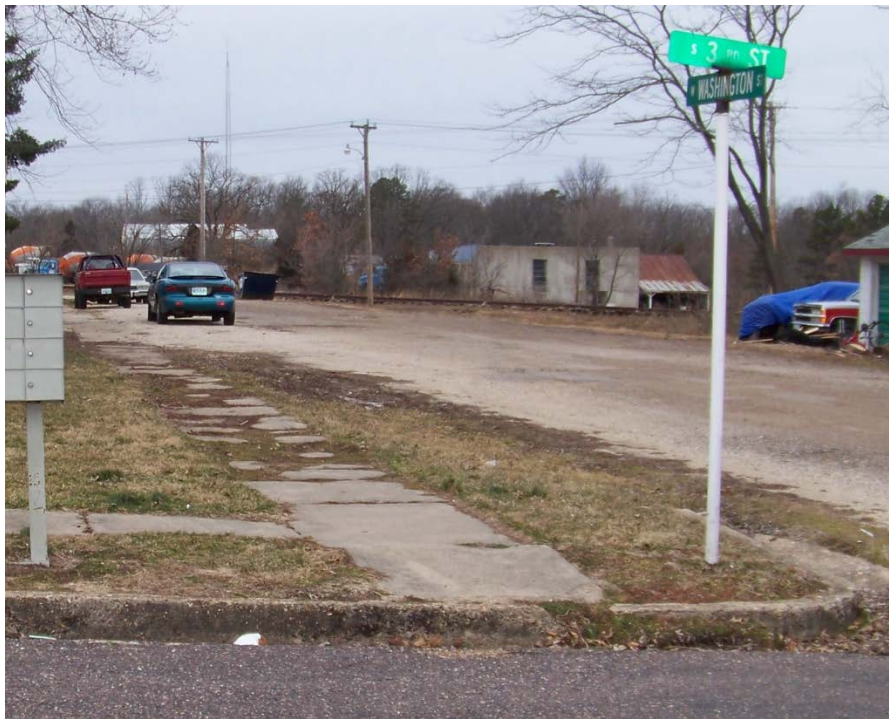
Poor Condition: W. Washington Avenue west of S. 3<sup>rd</sup> Street, south side looking west

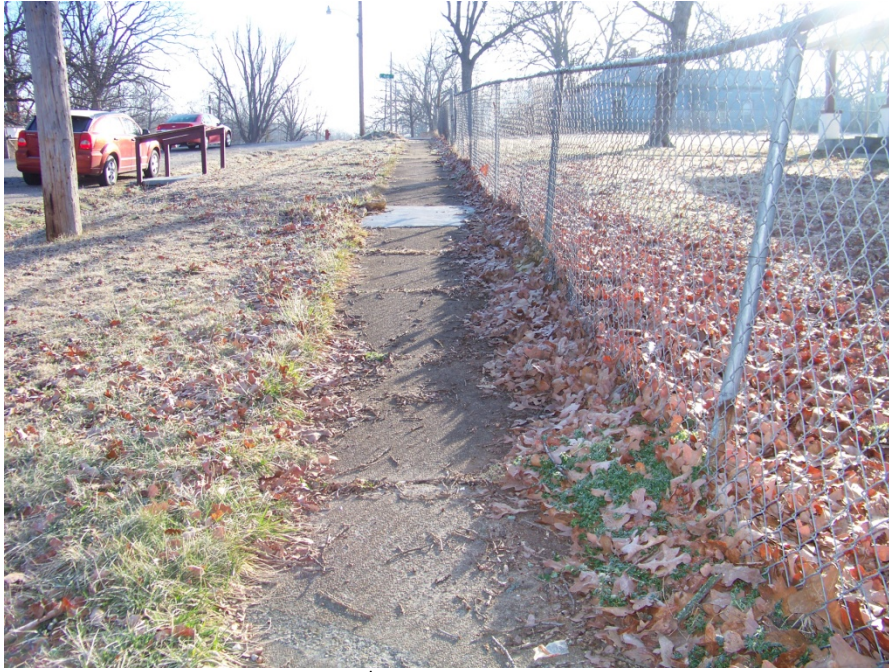
Fair Condition: E. 4<sup>th</sup> Street, south side looking east

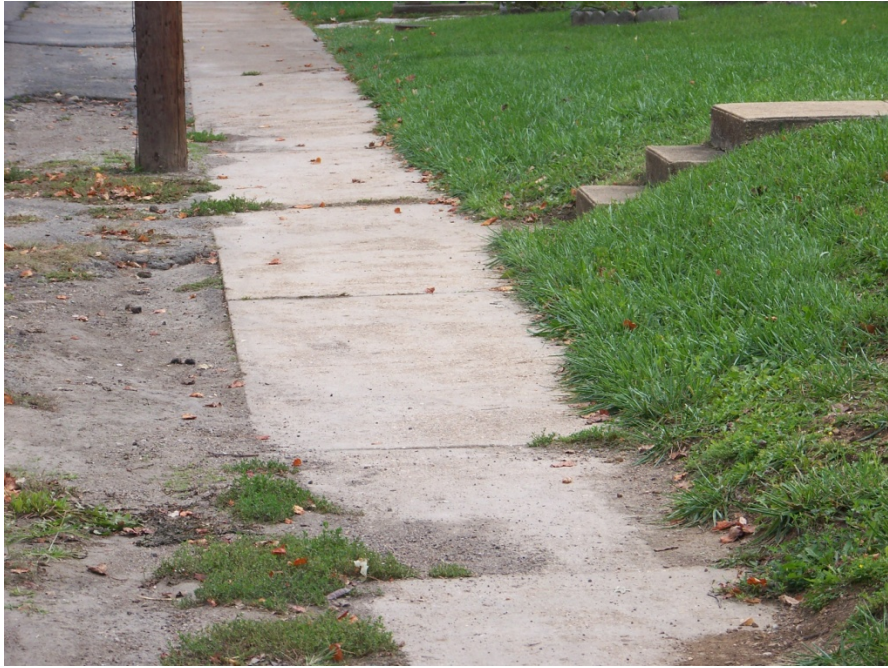
Fair Condition: E. Jefferson Street between S. Water Street and Mill Street, looking southeast

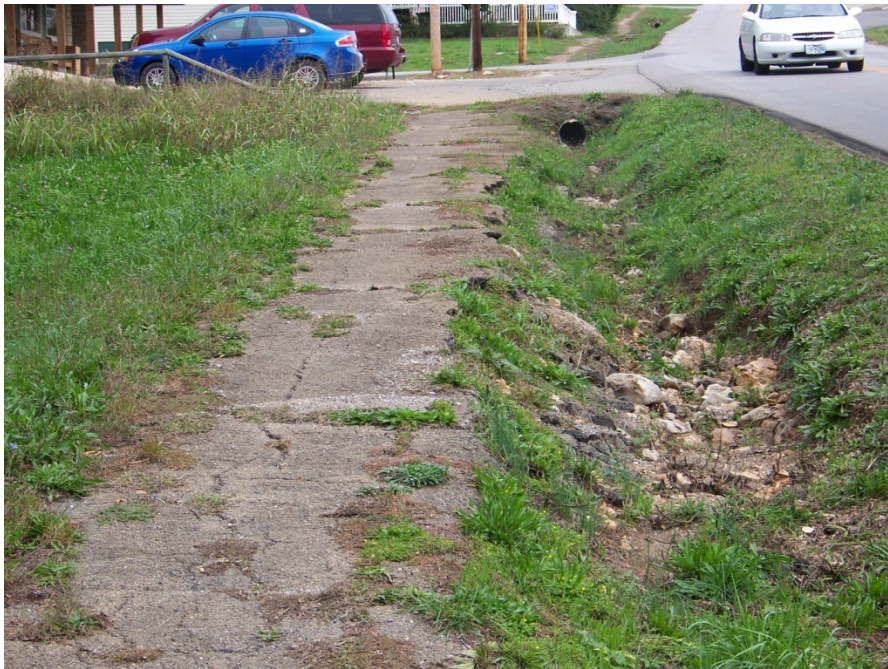
Poor Condition: N. Missouri Street between Rosemary Ave and Cordia Ave, looking northeast

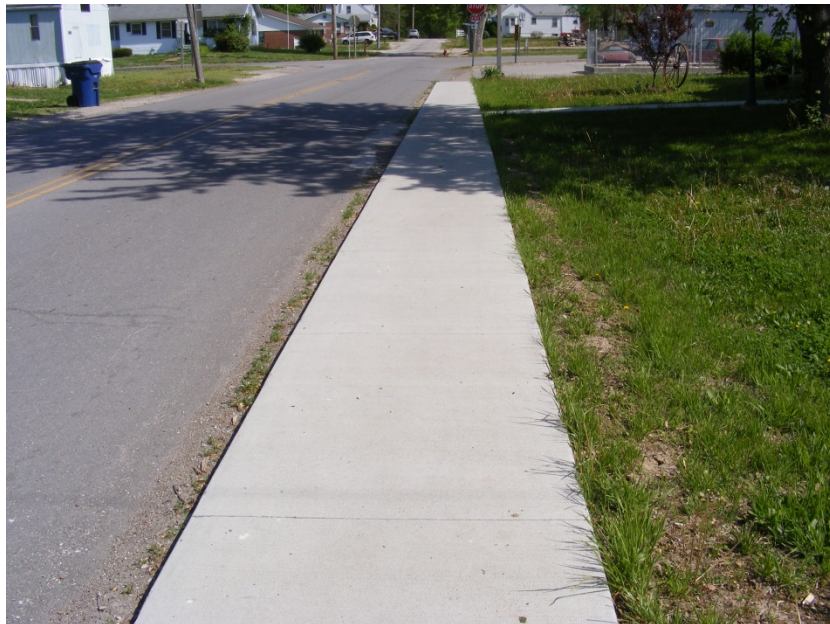
Good Condition: Main Street, east side looking north toward Missouri Avenue.

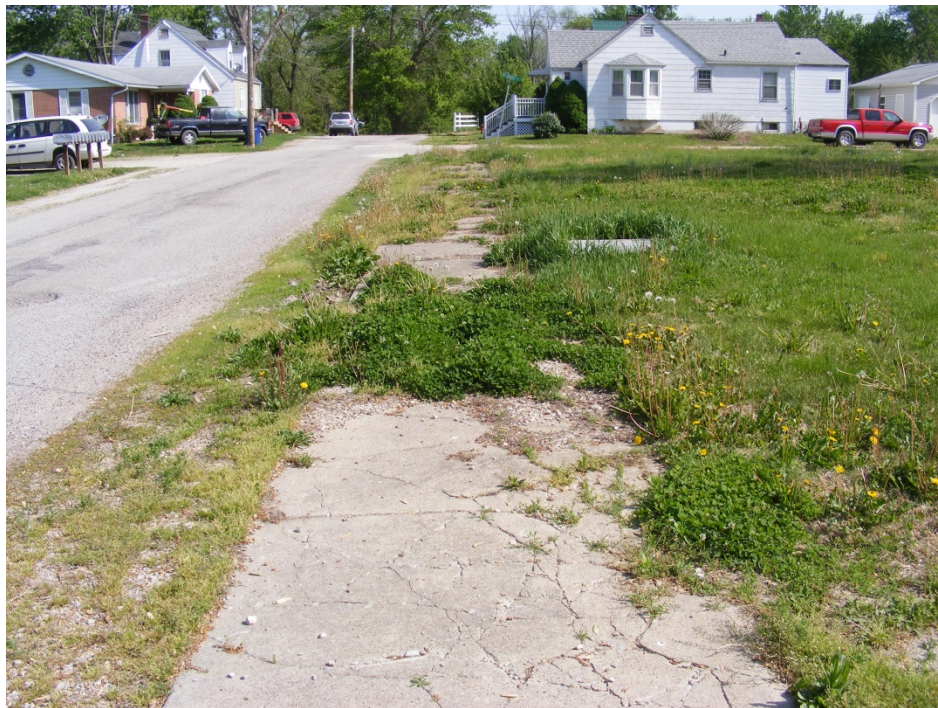
Poor Condition: Main Street, north of Missouri Avenue looking north.

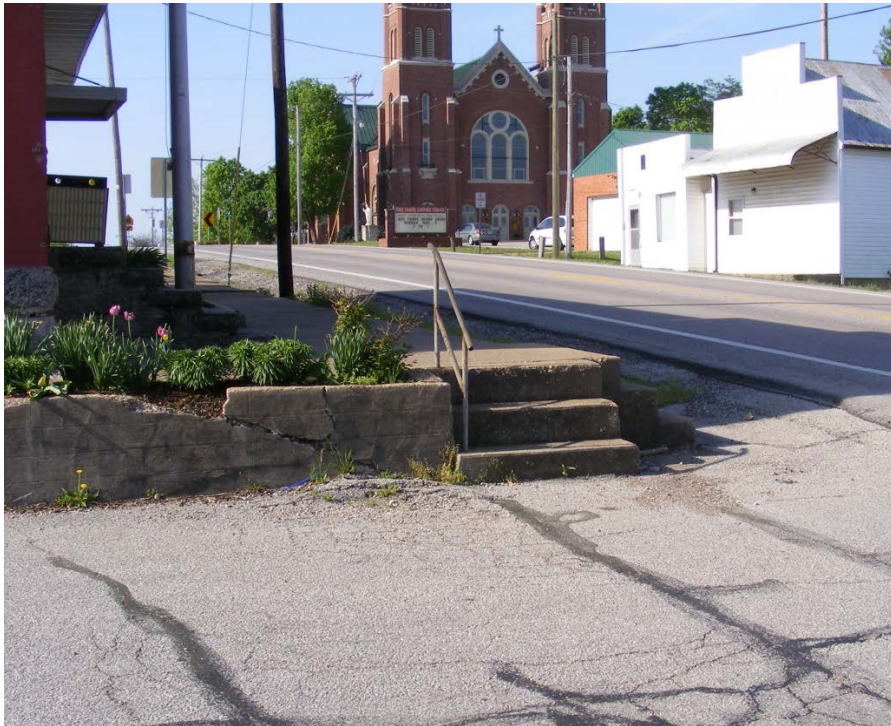
Poor Condition: Intersection of Locust Street (Highway 63) and Gilbert Avenue, southeast corner looking south.

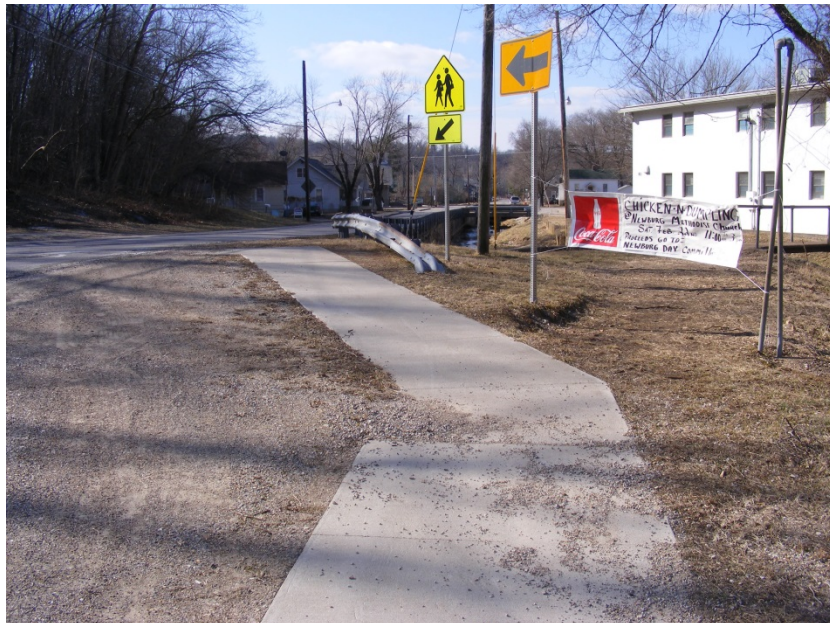
Good Condition: School crossing west side of Main Street (Highway T) near the intersection of Wolf Pride Drive

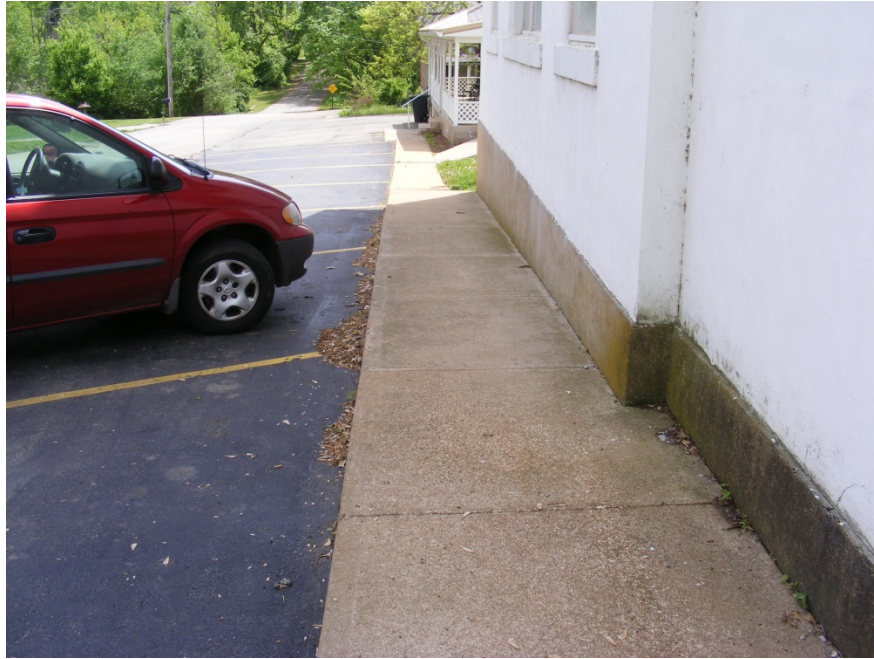
Fair Condition: Alexander Street, south side looking east toward College Street.
