## Appendix E

### PHASE I: SIDEWALK SURVEY

# City of Sullivan Sidewalk Inventory

This inventory was completed in January 2012 by the city of Sullivan, with assistance from the Meramec Regional Planning Commission. Data for the map was gathered through a “windshield” survey and is only intended to be a general representation of sidewalk condition.

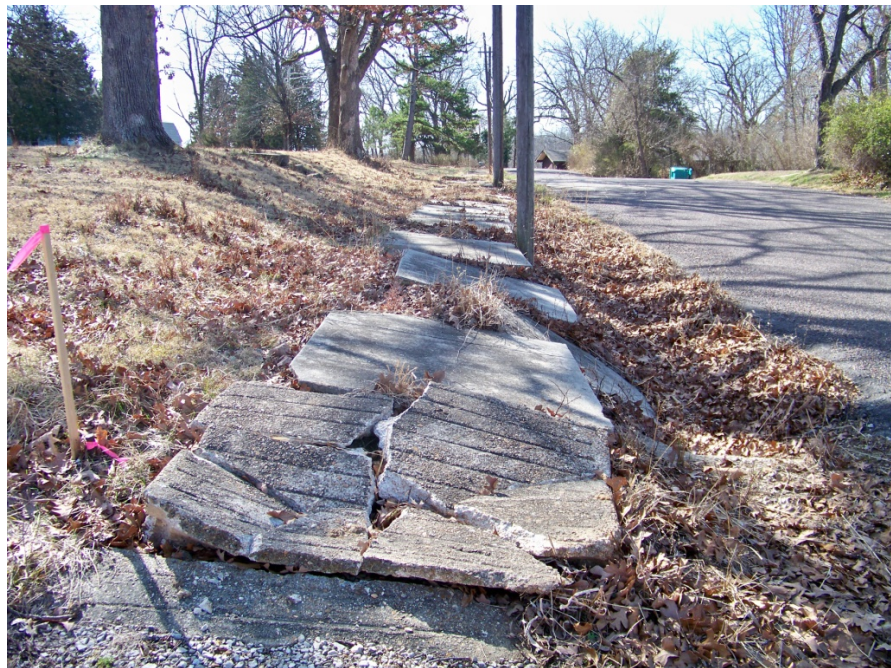
Fair Condition: Taylor Street, west side looking south

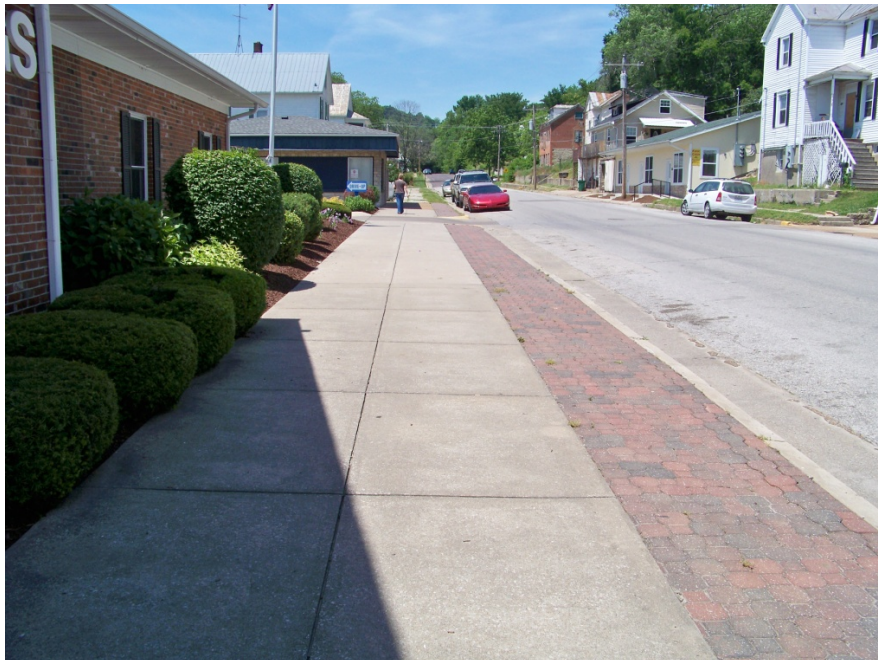
Good Condition: West Fifth Street, south side looking west

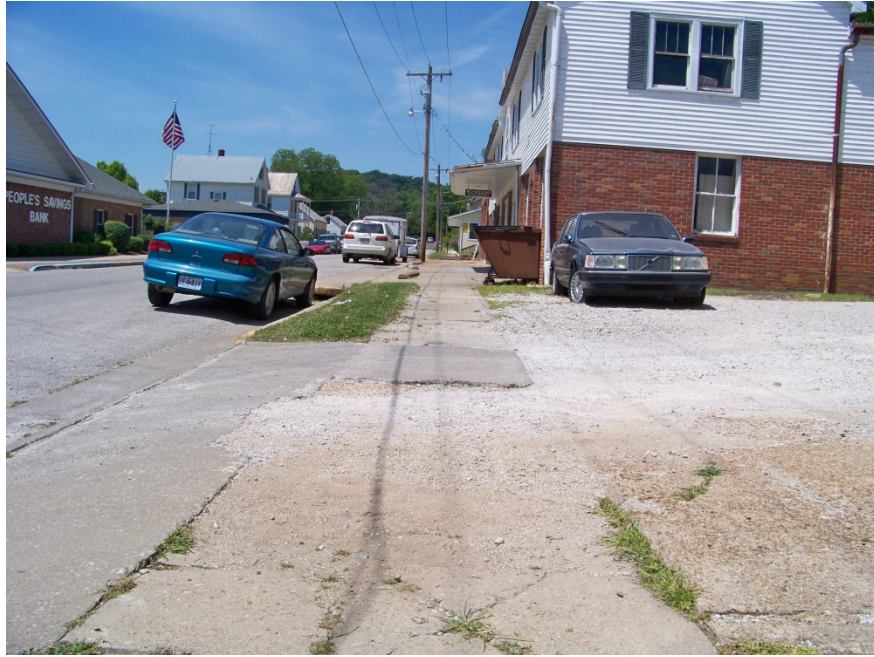
Fair Condition: West Fifth Street, north side looking west

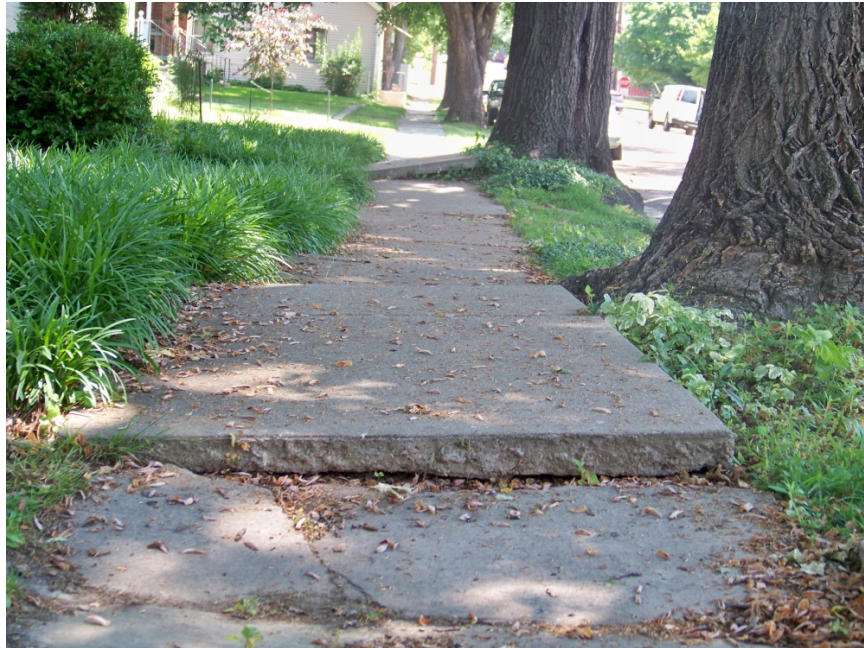
Poor Condition: West Third Street, north side looking east

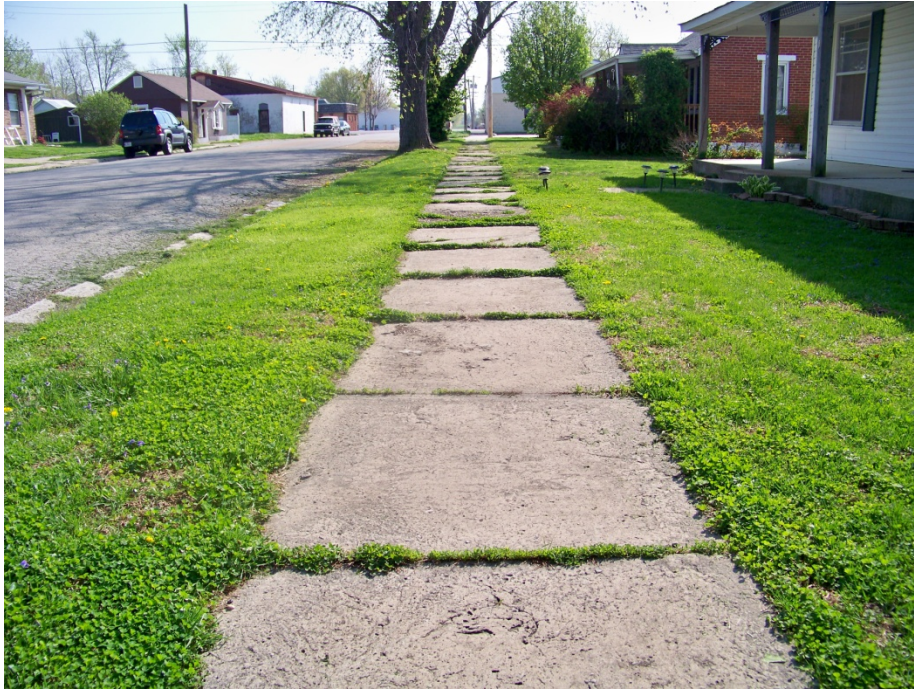
Good Condition:  
Third Street,  
south side  
looking east

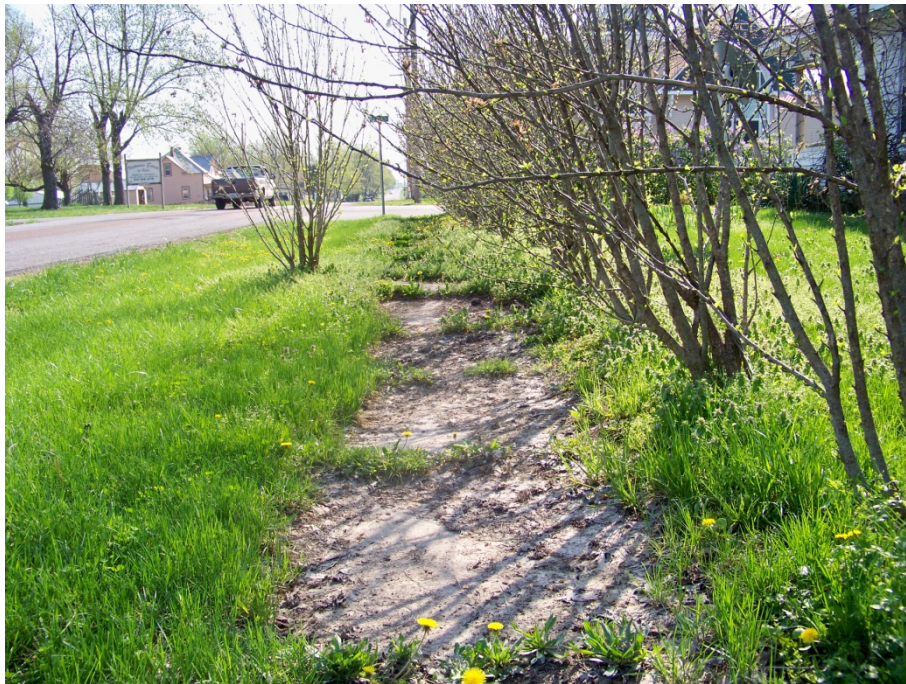
Fair Condition: Second Street, south side looking east

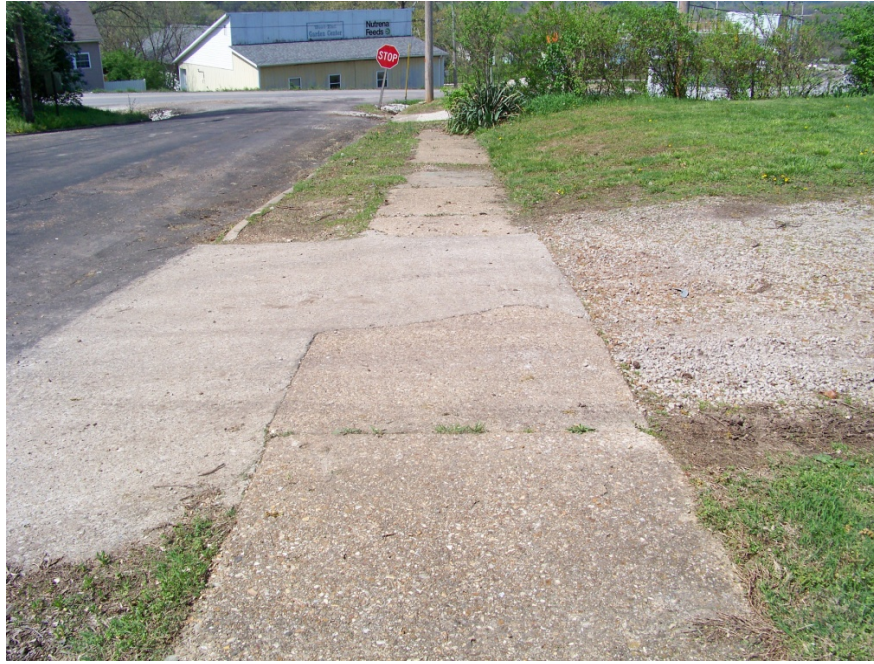
Good Condition: Corner of U.S. Hwy 50 (Main) and Third Street, south side looking east

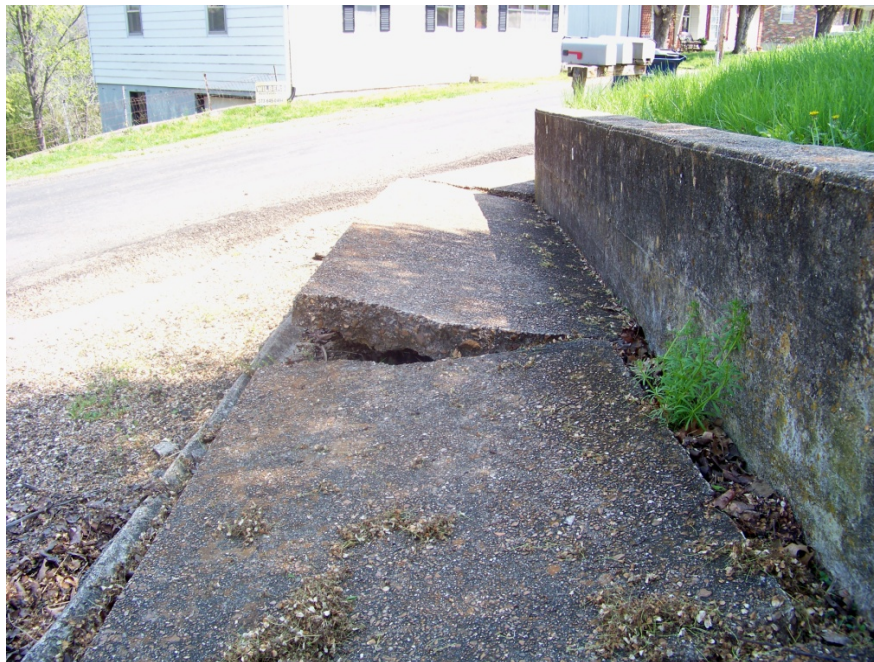
Fair Condition: Benton Street, north side looking west

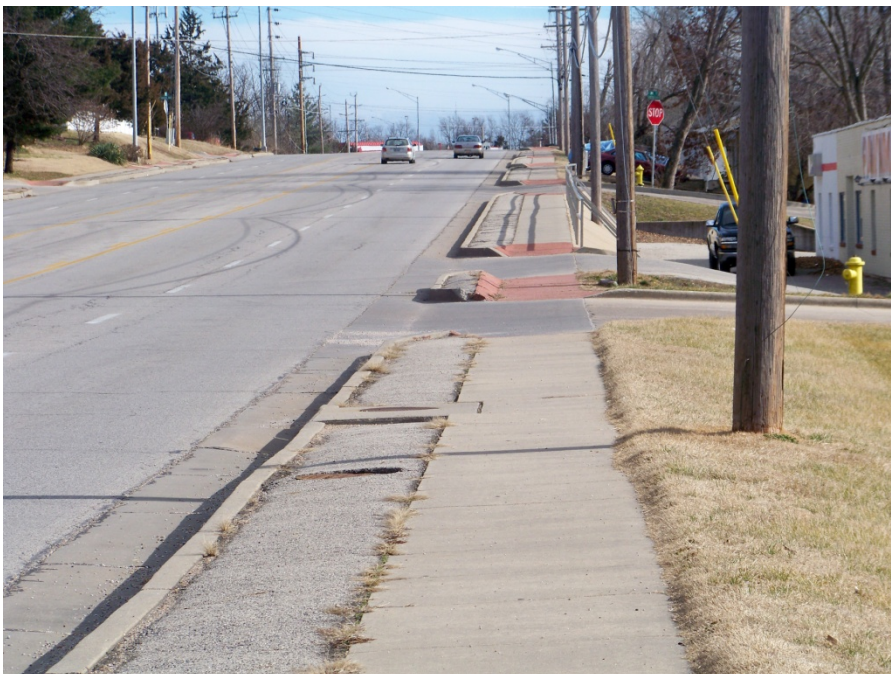
This sidewalk, located on the south side of Hwy. 72, is in good condition.

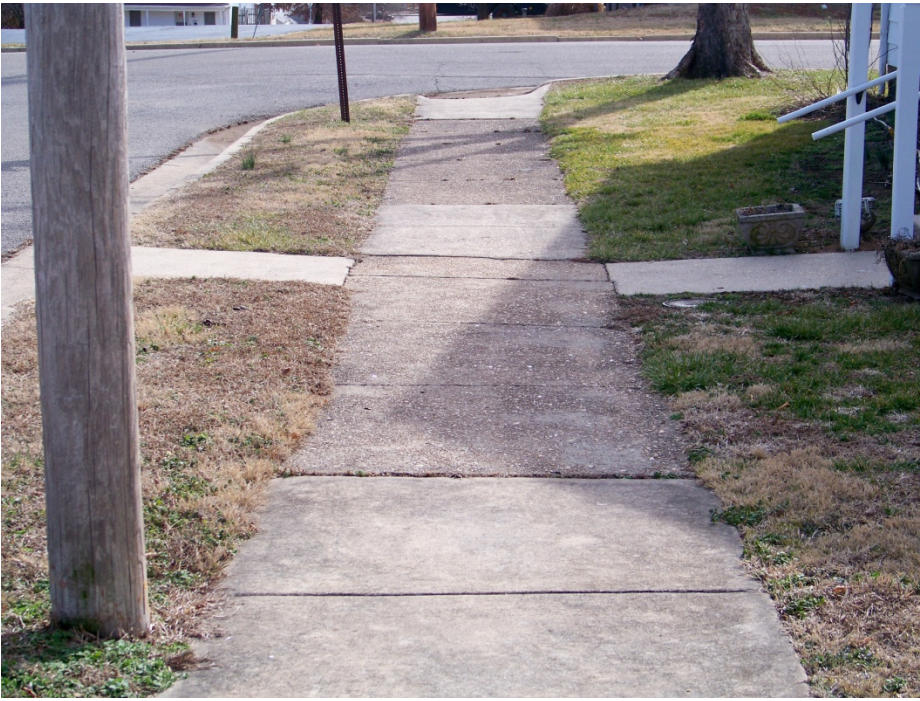
This sidewalk, in fair condition, is located on Cedar Street.

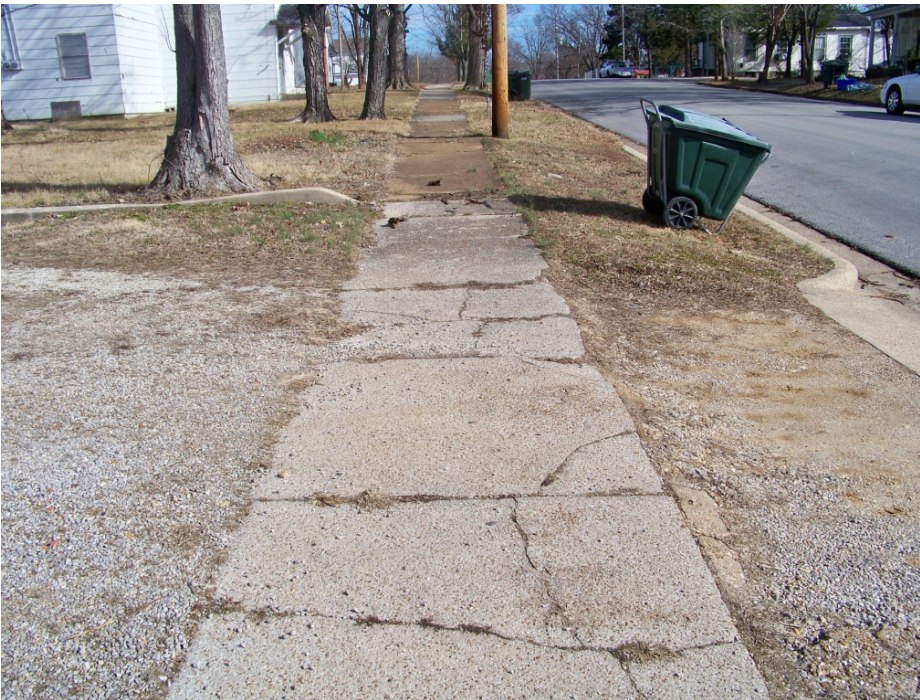
Sidewalks on portions of Olive Street are in poor condition.

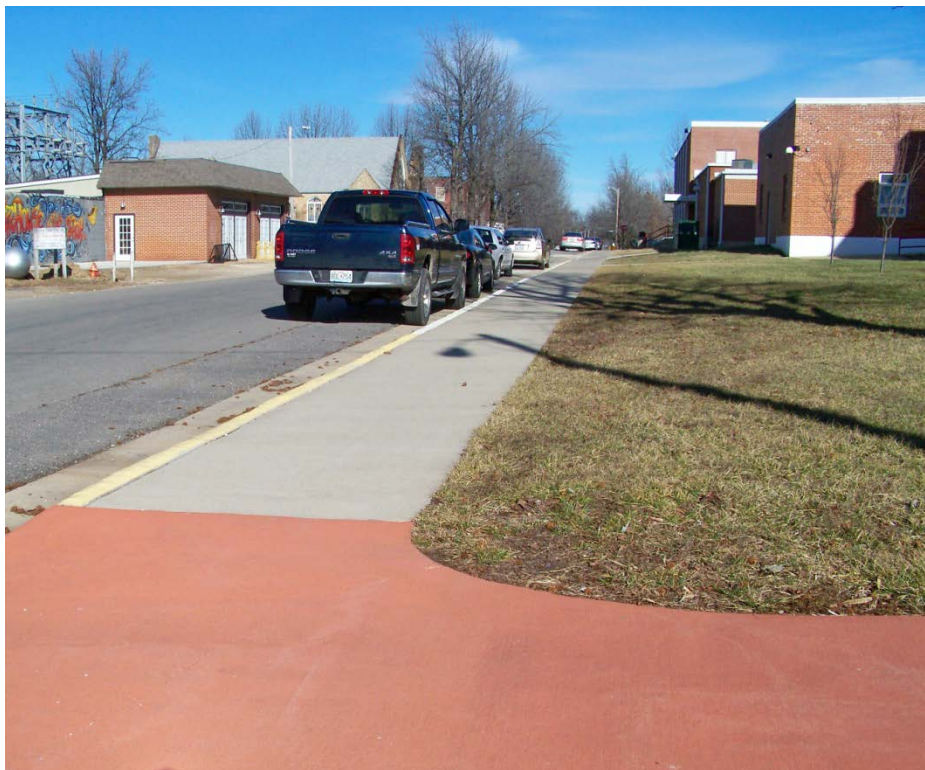
This sidewalk, located on the north side of Washington Street, is in good condition.

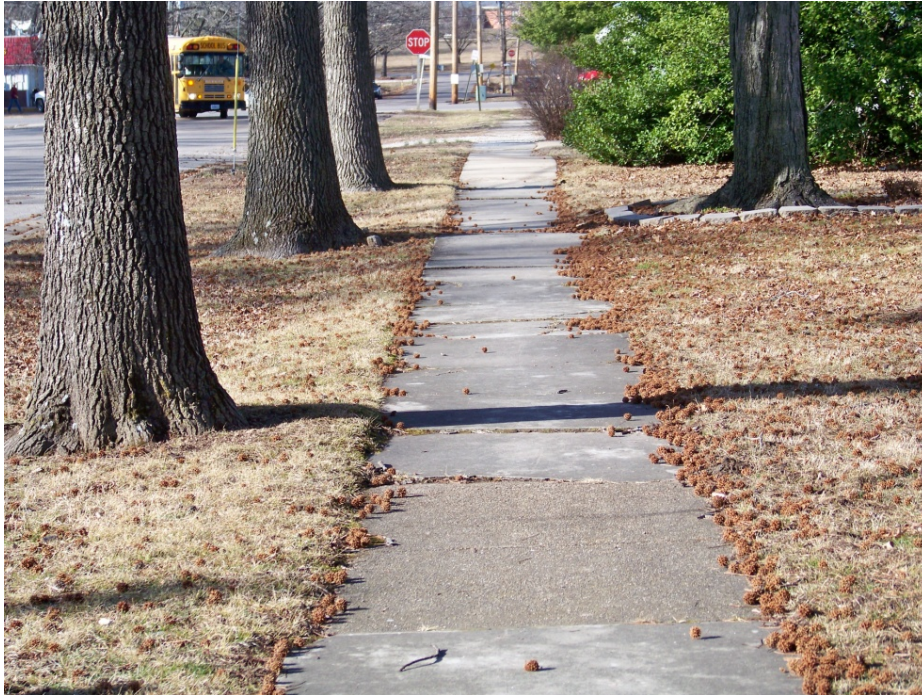
This sidewalk, in fair condition, is located on Seymour Street.

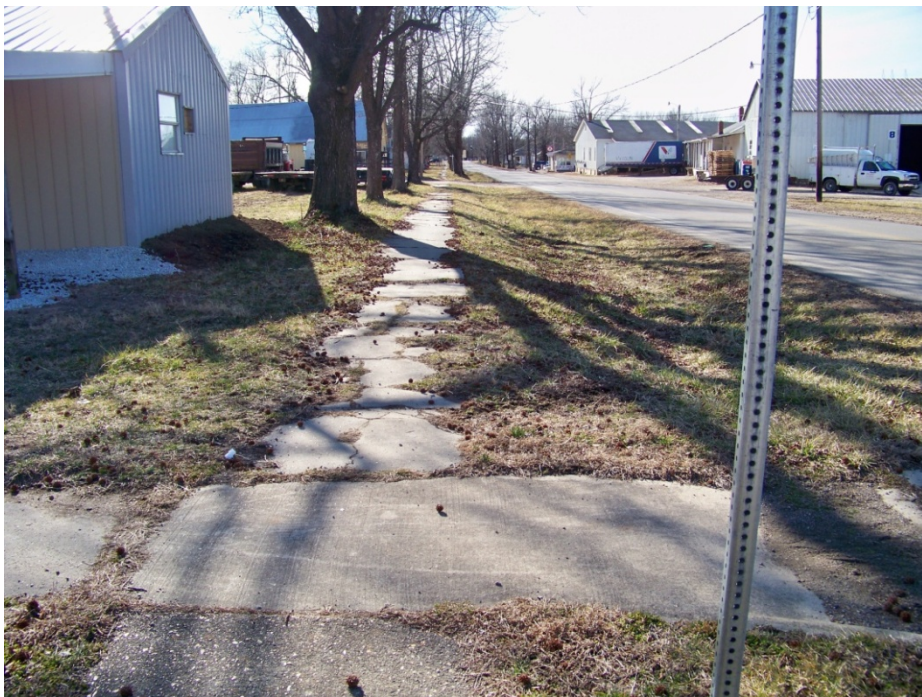
A large portion of the sidewalks in St. James are in poor condition, such as these along W. Washington Street.

The city is currently seeking to expand existing sidewalks into un-served areas as well as where gaps exist and repair poor condition sidewalks. Expansion/improvement is targeted for the following areas:

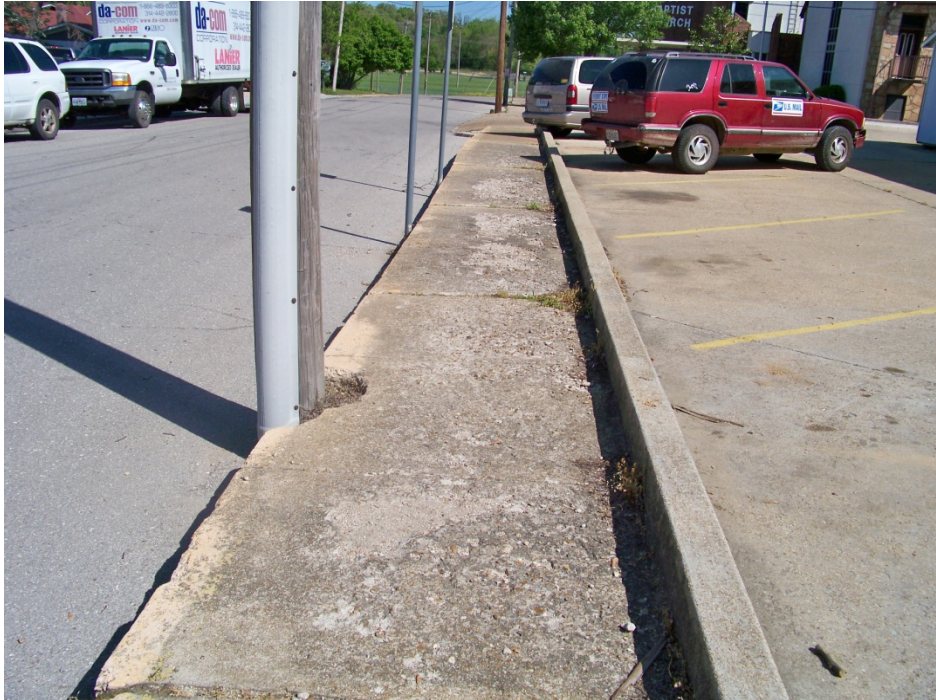
Good Condition: Olive Street, east side looking north

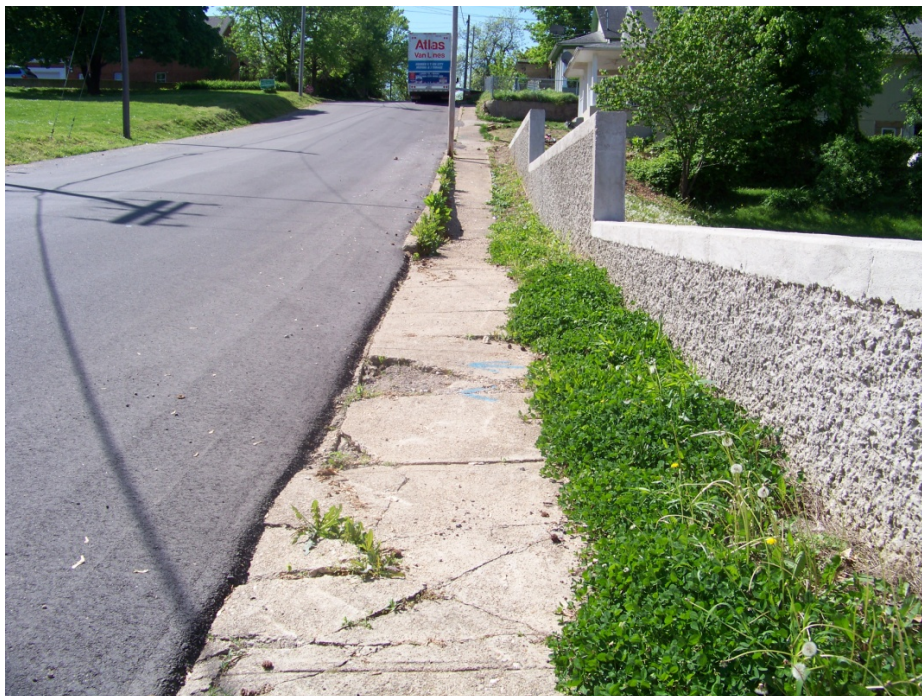
Fair Condition: North Benton Street, east side looking north

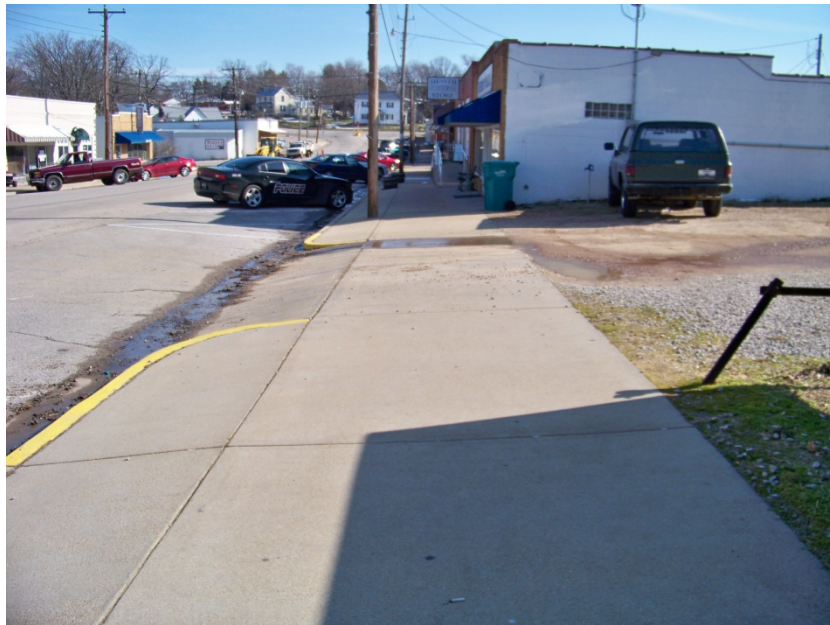
Good Condition: E. Pine Street, south side looking east toward Walnut Street

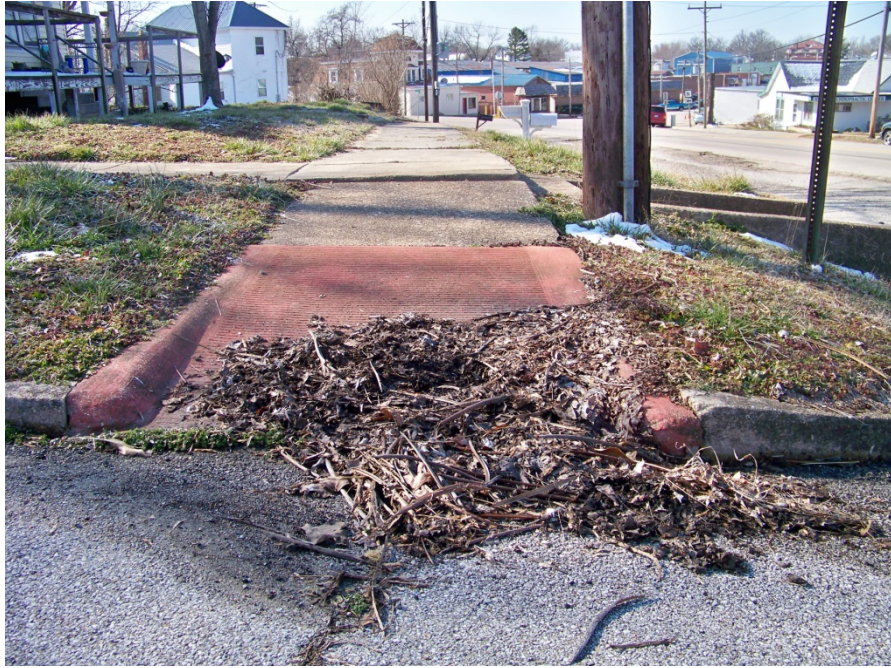
Fair Condition: Intersection E. Pine Street and Olive Street, southeast corner

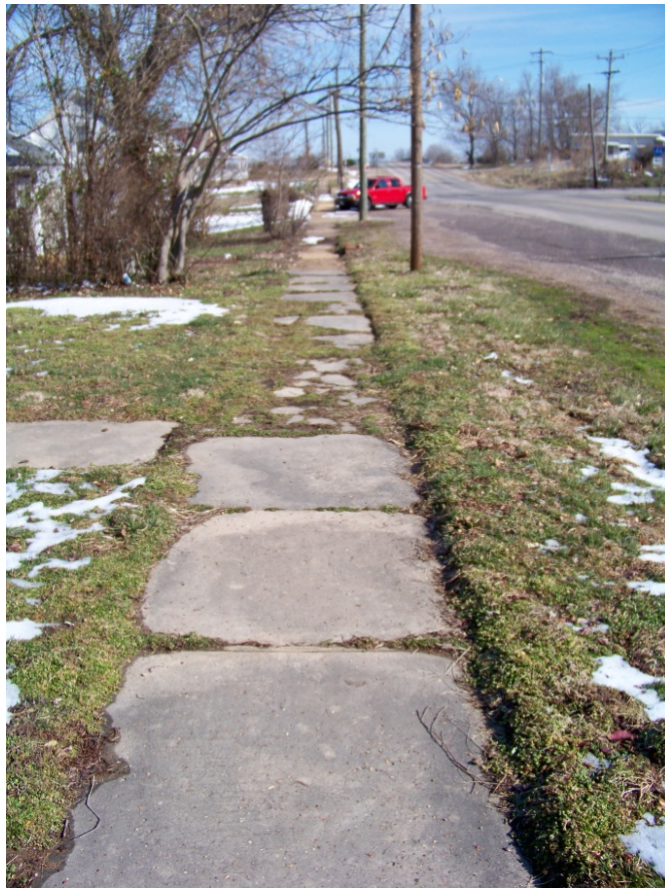
Poor Condition: E. Pine Street, west side looking north toward N. Old U.S. Highway 66

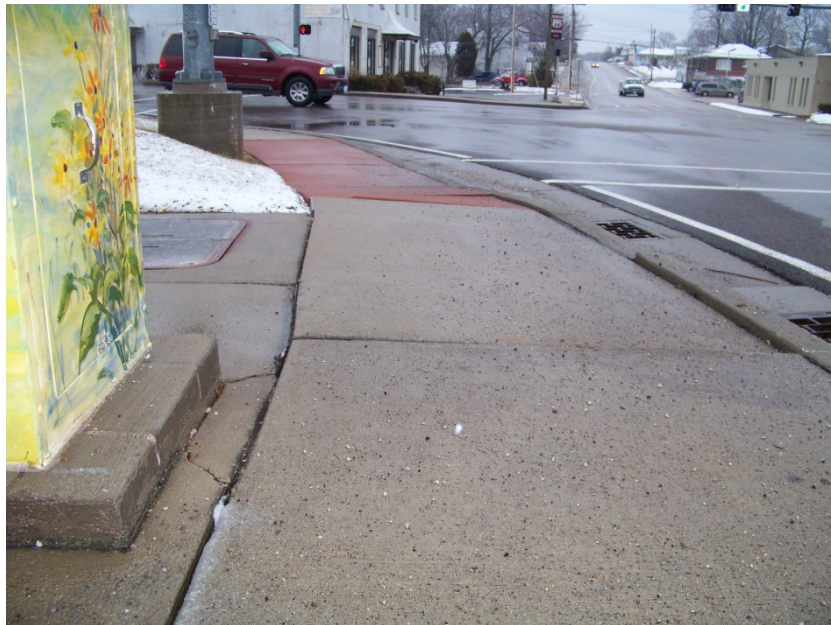
Good Condition: Intersection of North Franklin St and West Washington Blvd

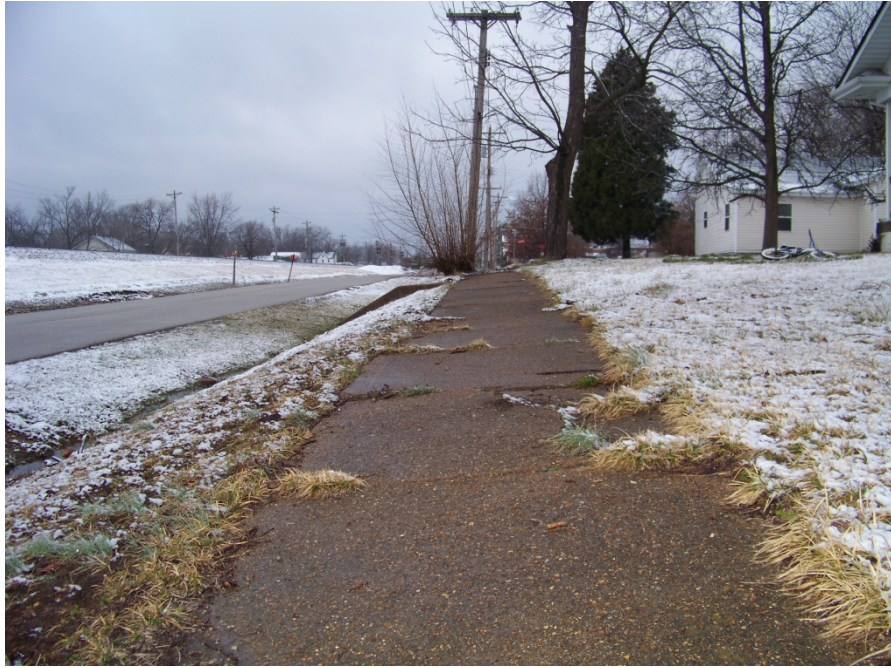
Fair Condition: West Main Ave, north side looking west

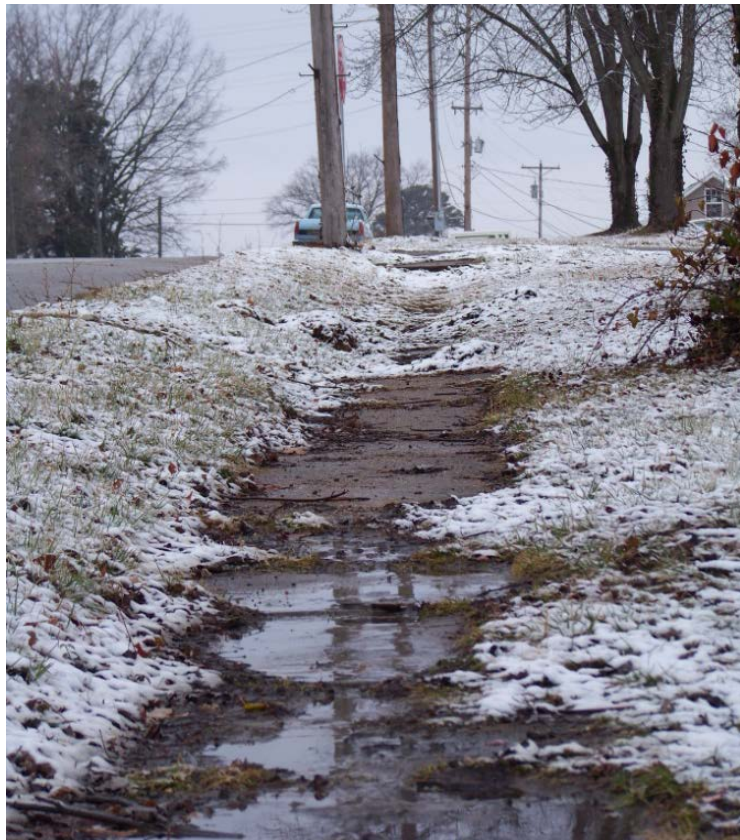
Poor Condition: Washington Blvd, north side looking west

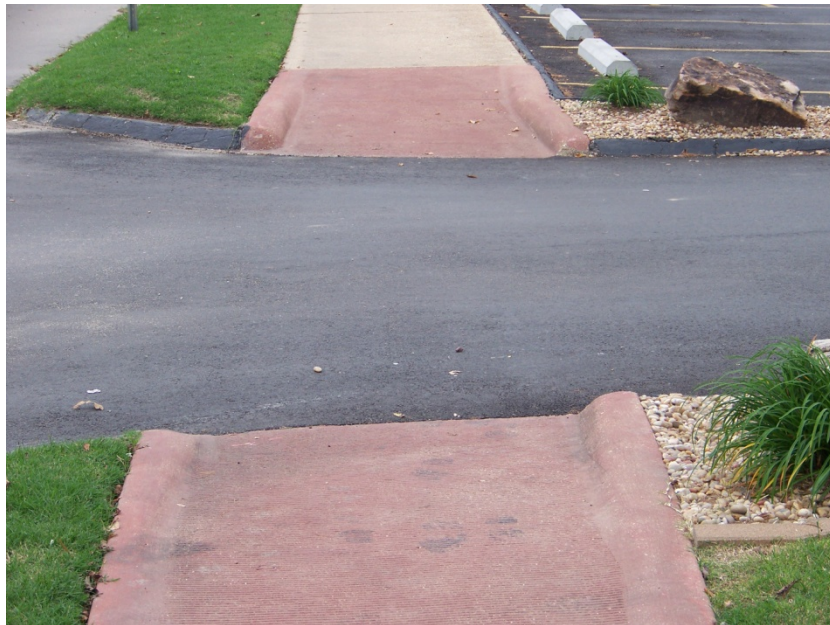
Good Condition: Main Street, south side looking east toward S. 4<sup>th</sup> Street

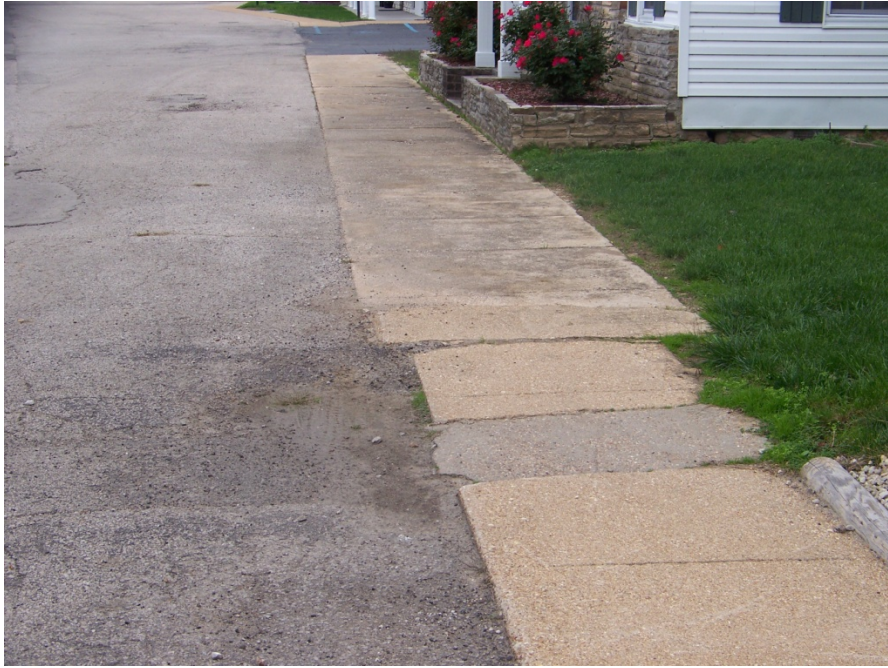
Fair Condition: Cedar Street, south side looking east from Hickory Street

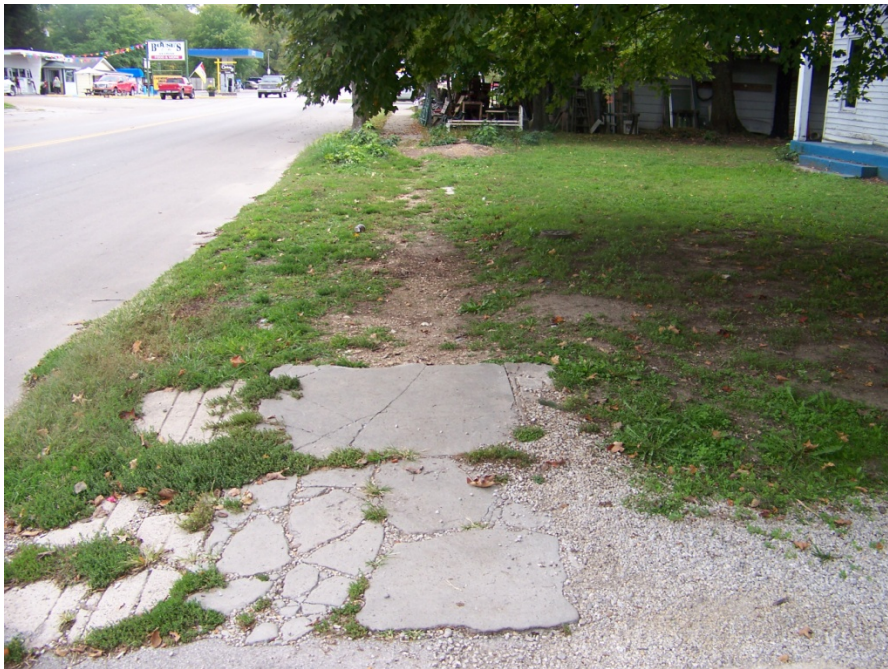
Poor Condition: Main Street, north side looking west toward S. Spring Street

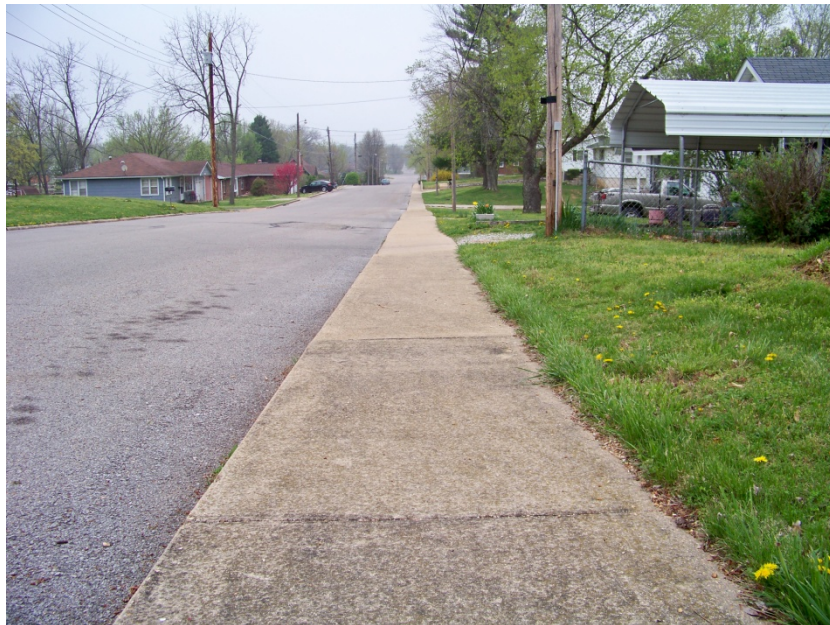
Good Condition: South end of Jackson Street, east side looking north

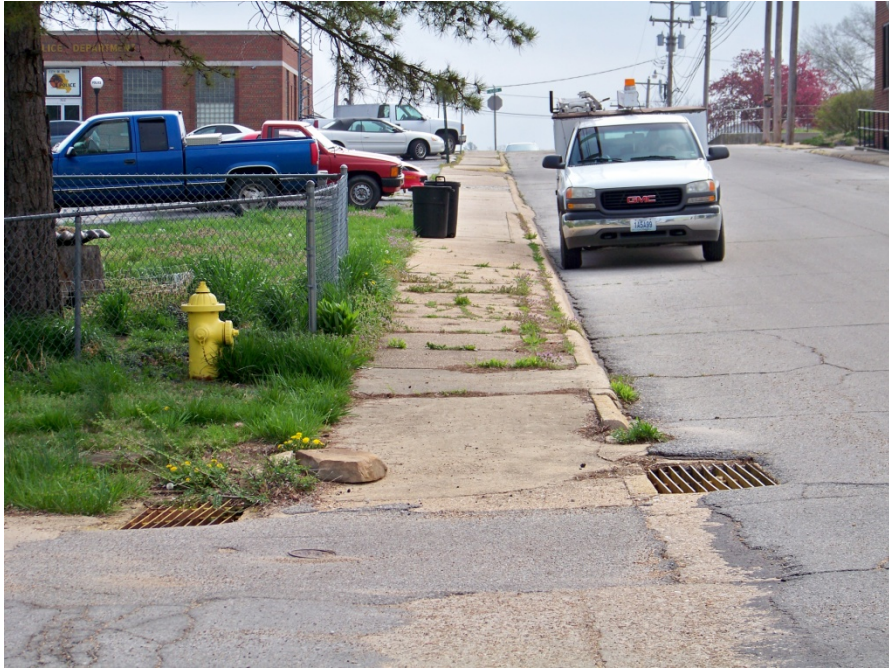
Fair Condition: Intersection of N. Henderson and 5<sup>th</sup> Street, north side looking west

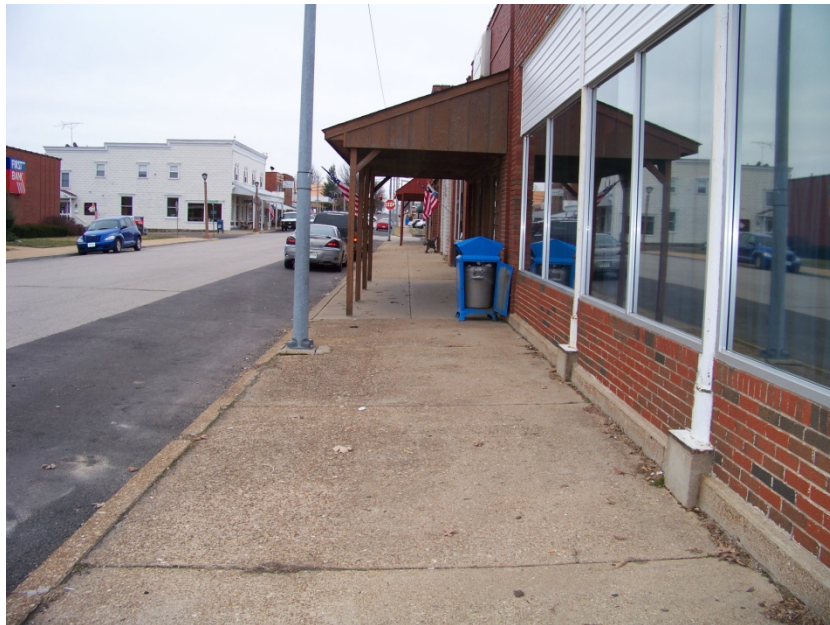
Good Condition: S. 1<sup>st</sup> Street, west side looking south toward E. Washington Avenue

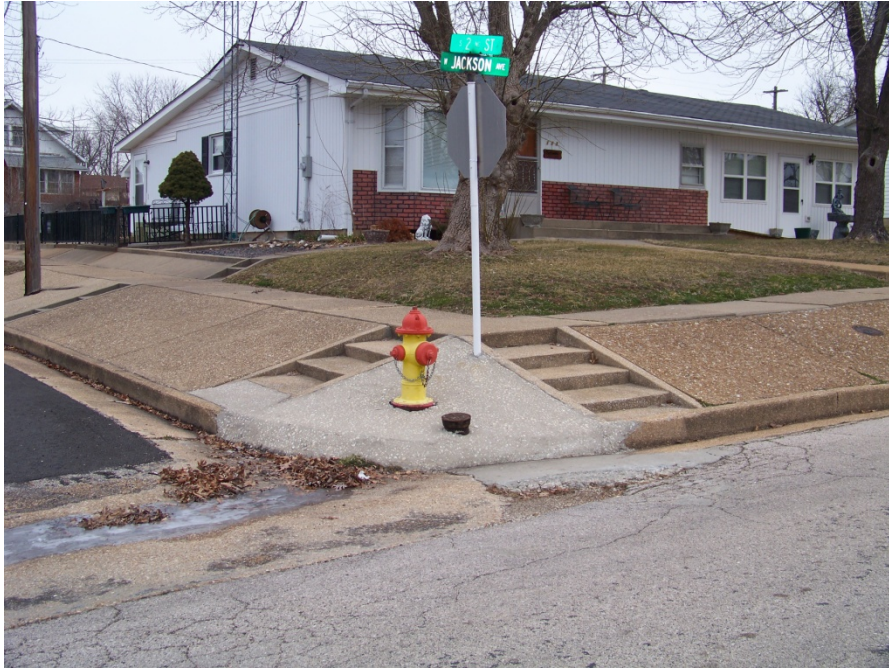
Fair Condition: Intersection of W. Jackson Avenue and S. 2<sup>nd</sup> Street, looking northeast

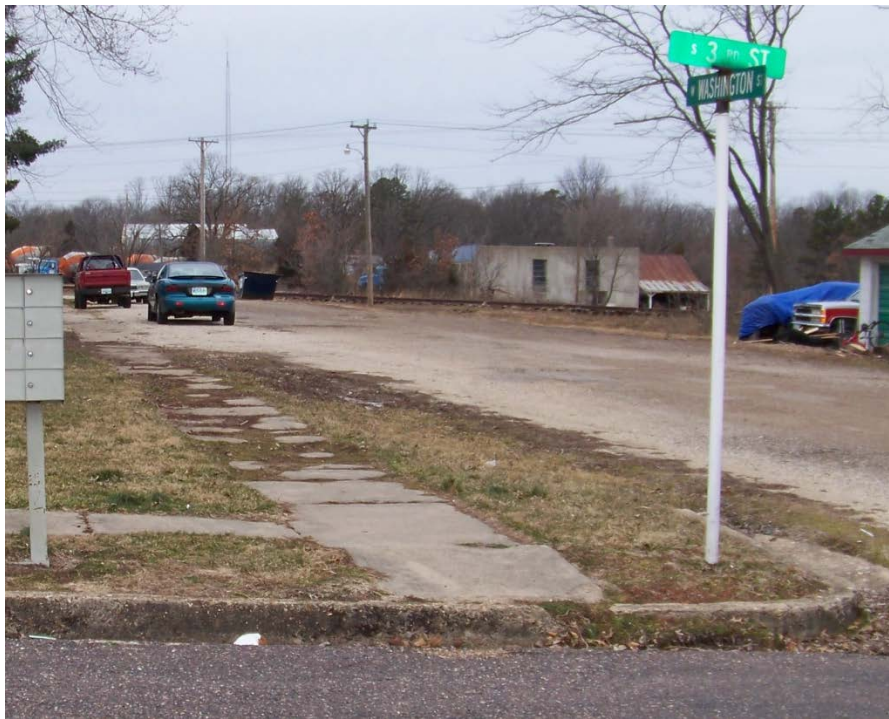
Poor Condition: W. Washington Avenue west of S. 3<sup>rd</sup> Street, south side looking west

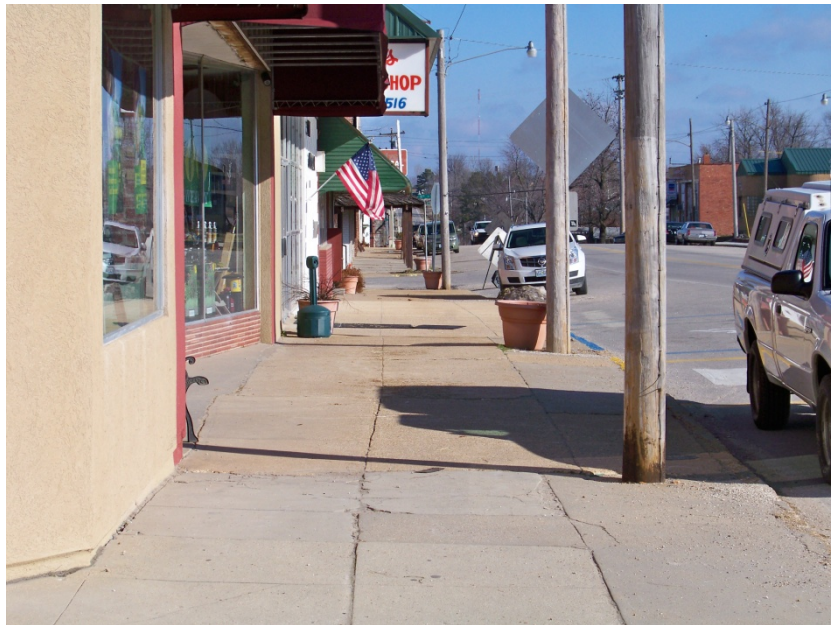
Good Condition: North Commercial Street, west side looking north

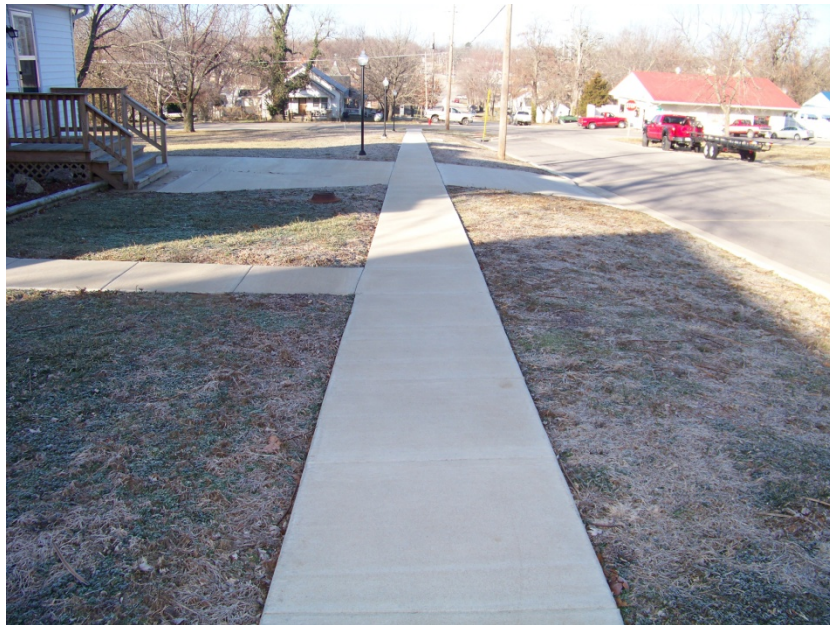
Good Condition: E. 3<sup>rd</sup> Street, south side looking west

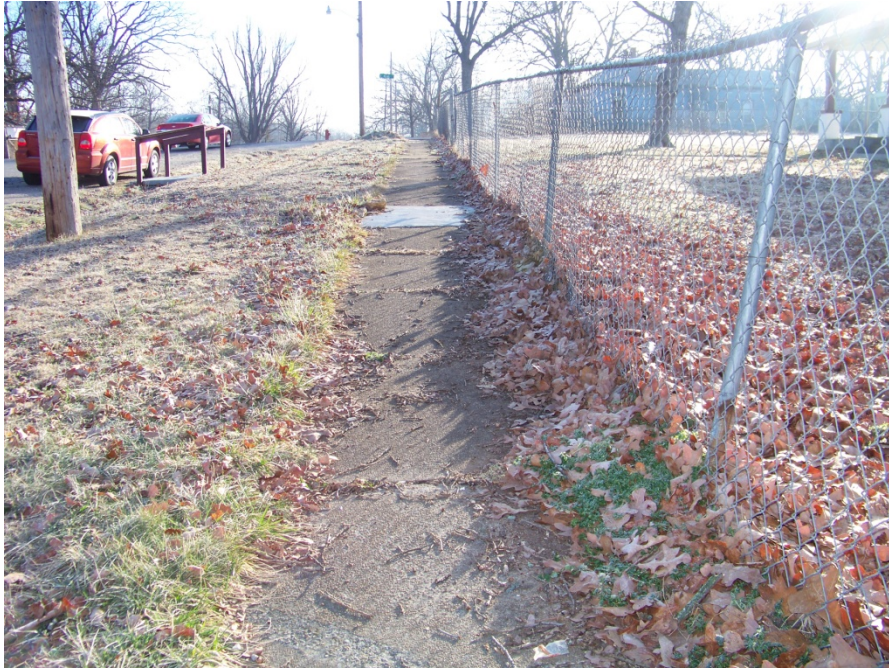
Fair Condition: E. 4<sup>th</sup> Street, south side looking east

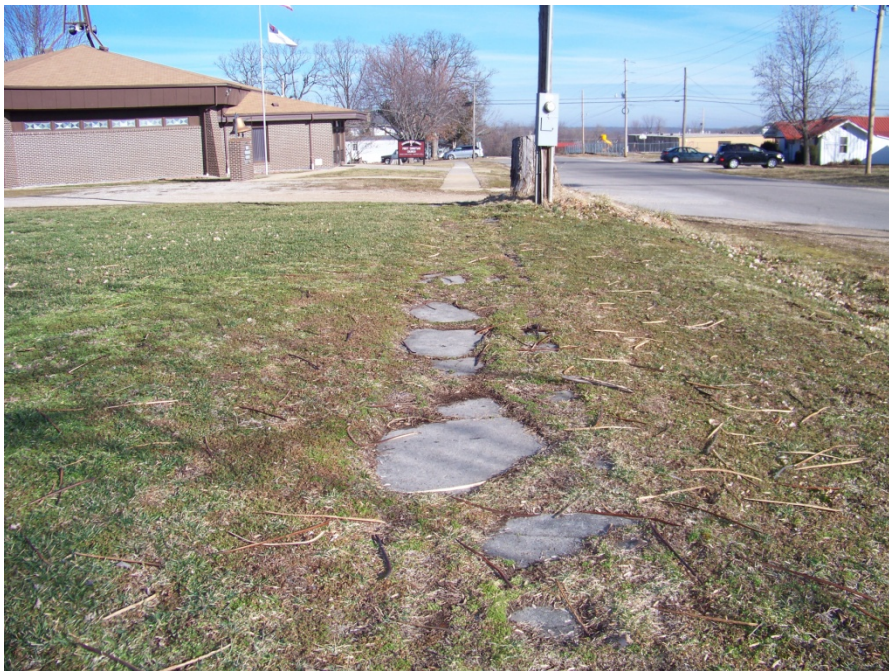
Poor Condition: S. Walnut Street, west side looking north

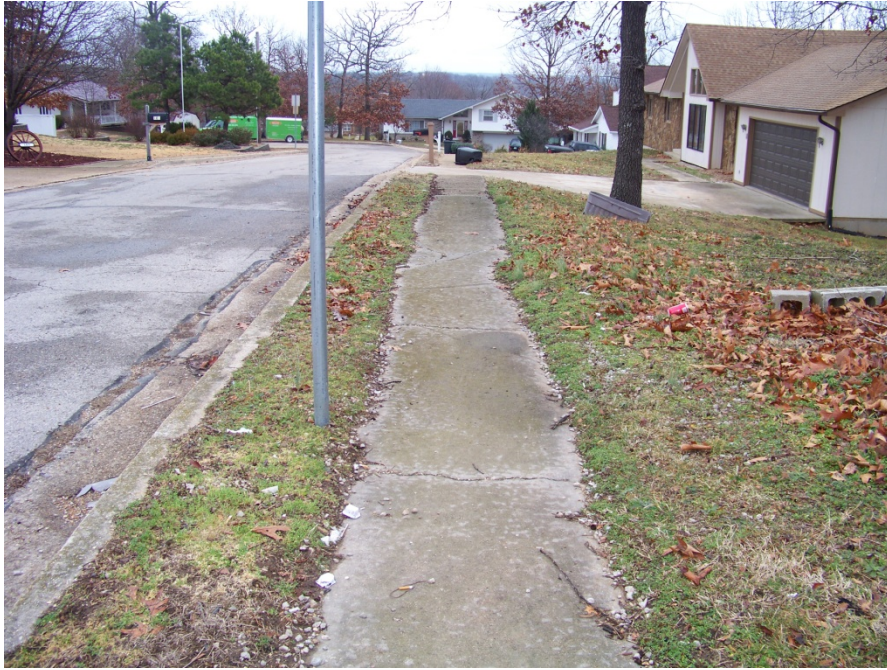
Fair Condition: Woodland Lane, south side looking east

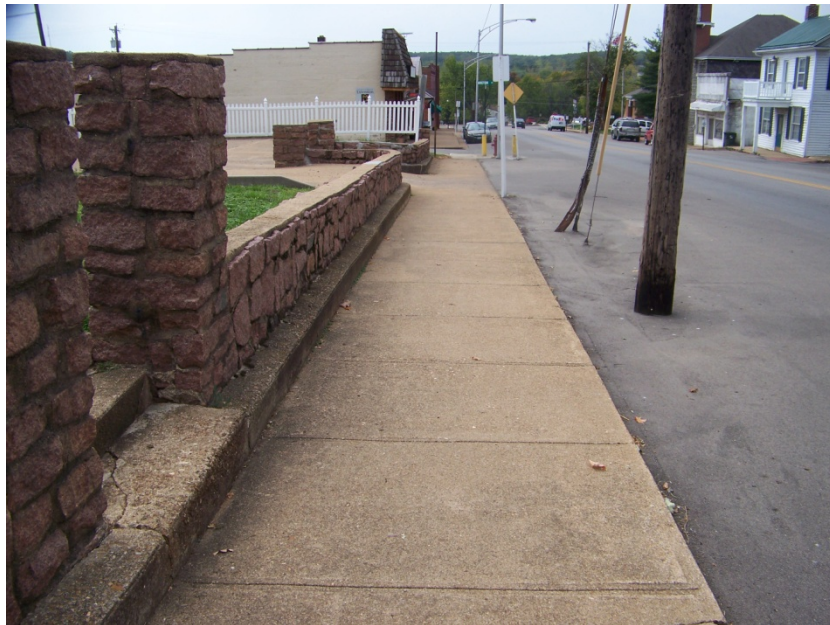
Good Condition: N. Missouri Street, between Brenton Street and Hickory Street looking west

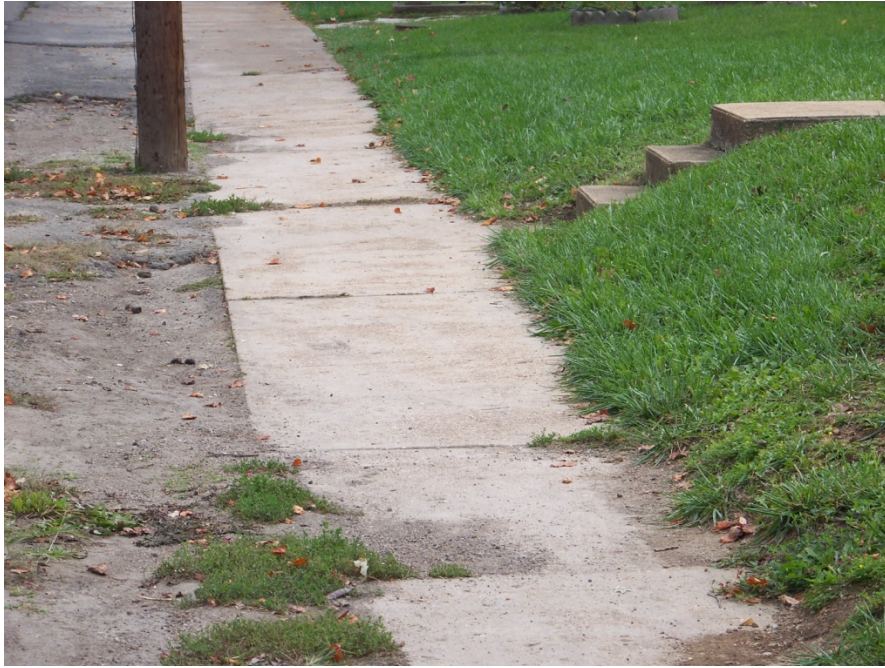
Fair Condition: E. Jefferson Street between S. Water Street and Mill Street, looking southeast

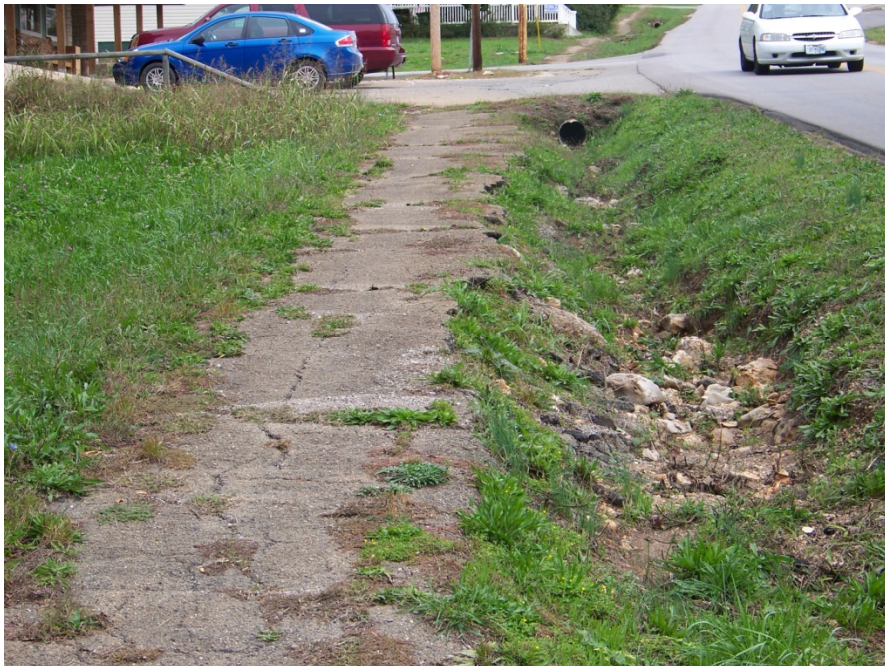
Poor Condition: N. Missouri Street between Rosemary Ave and Cordia Ave, looking northeast
