## Appendix E

### PHASE I: SIDEWALK SURVEY

# City of Sullivan Sidewalk Inventory

This inventory was completed in January 2012 by the city of Sullivan, with assistance from the Meramec Regional Planning Commission. Data for the map was gathered through a “windshield” survey and is only intended to be a general representation of sidewalk condition.

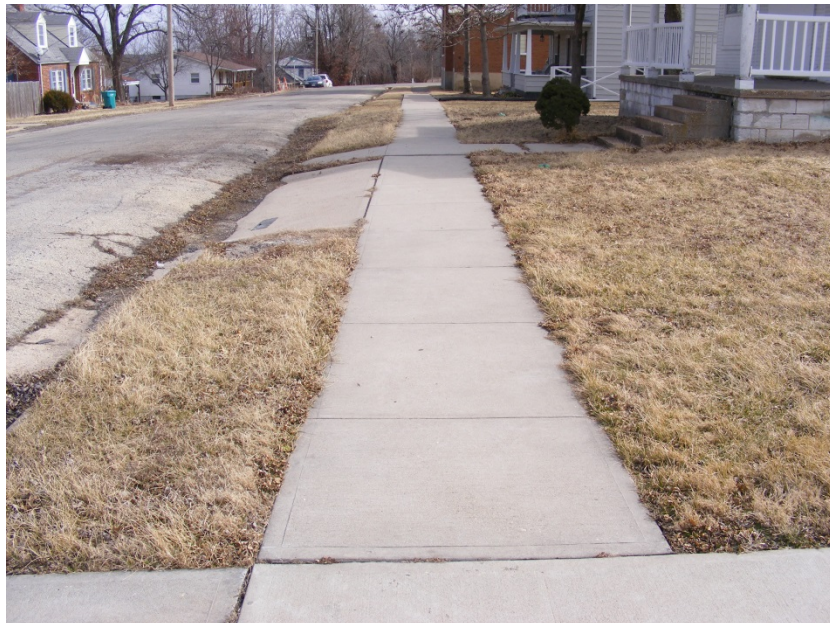
Good Condition: E. Kansas City Street, south side looking east from Main Street

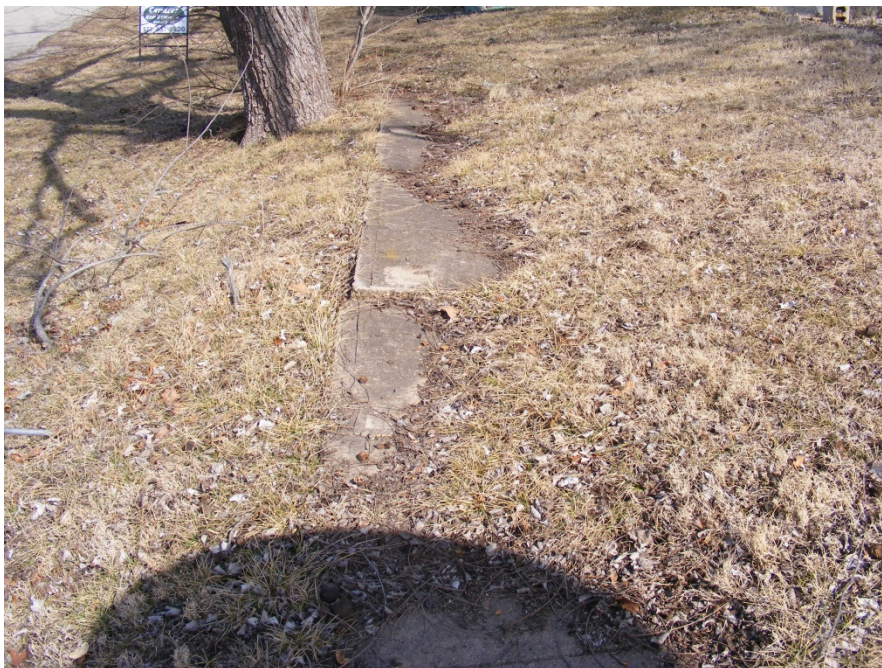
Poor Condition: N.W. corner of Taylor and East Missouri, looking north

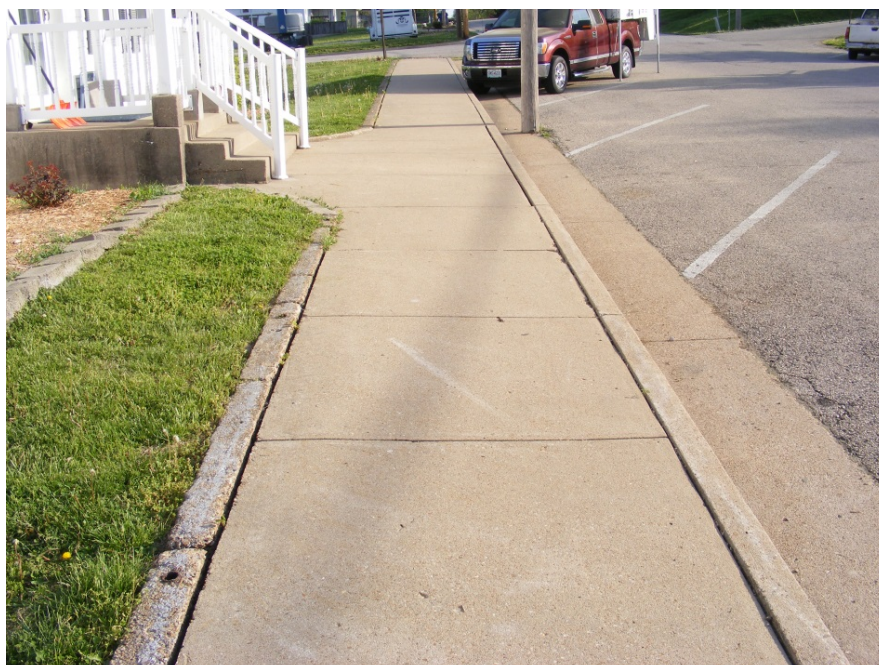
Good Condition: N. Main Street, west side looking north toward 6<sup>th</sup> Street

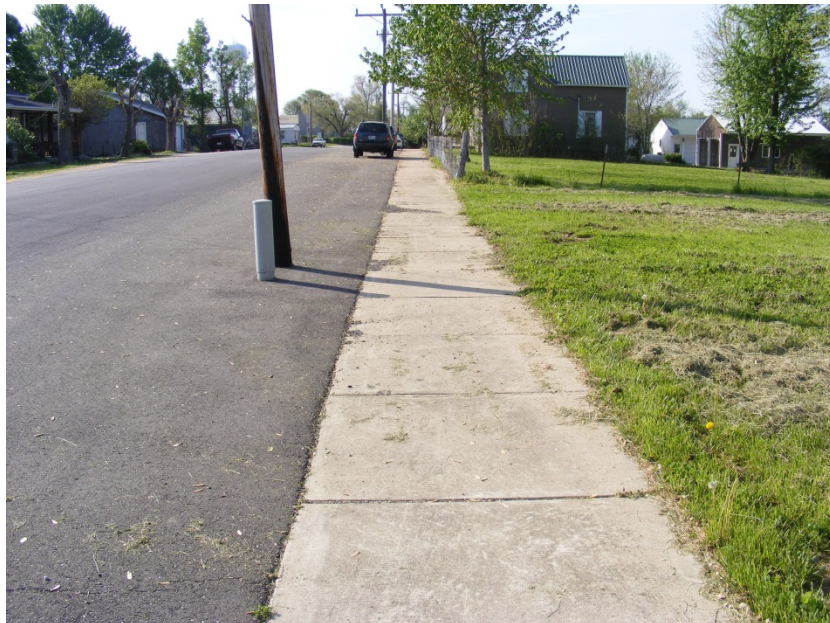
Good Condition: Holy Family Road, west side looking south.

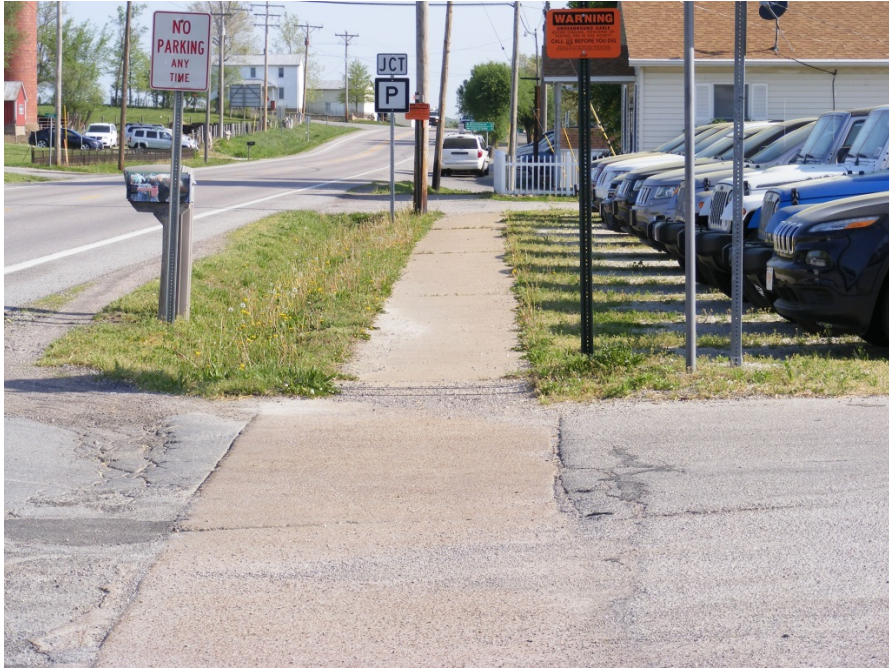
Fair Condition: Locust Street (Highway 63), west side looking north.

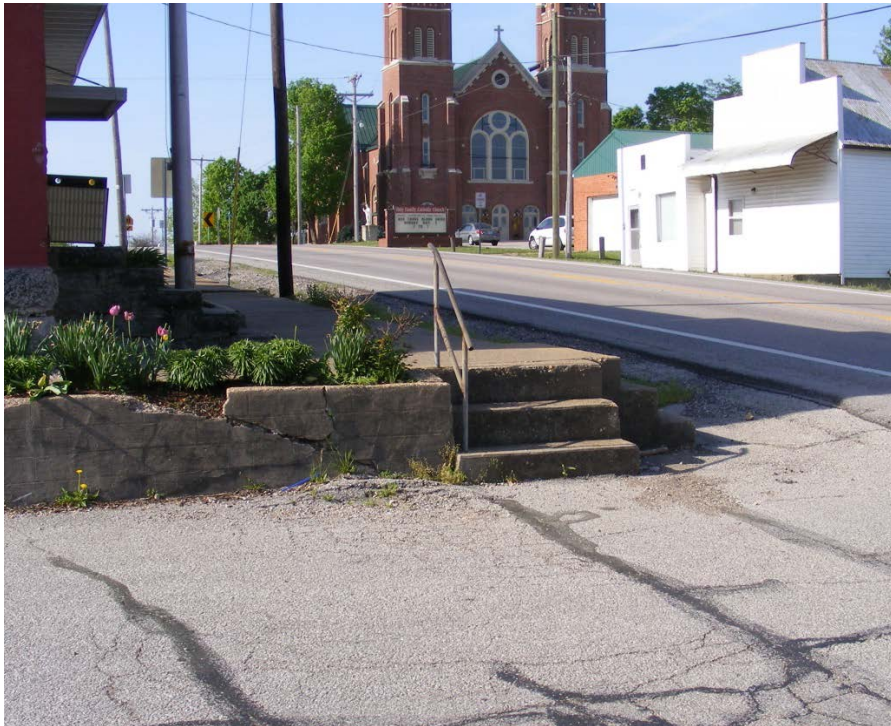
Poor Condition: Intersection of Locust Street (Highway 63) and Gilbert Avenue, southeast corner looking south.

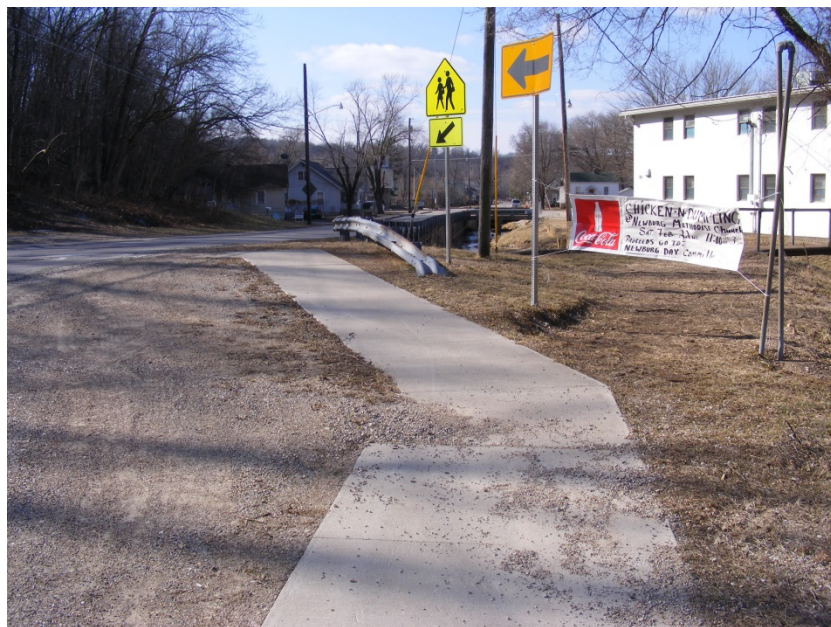
Good Condition: School crossing west side of Main Street (Highway T) near the intersection of Wolf Pride Drive

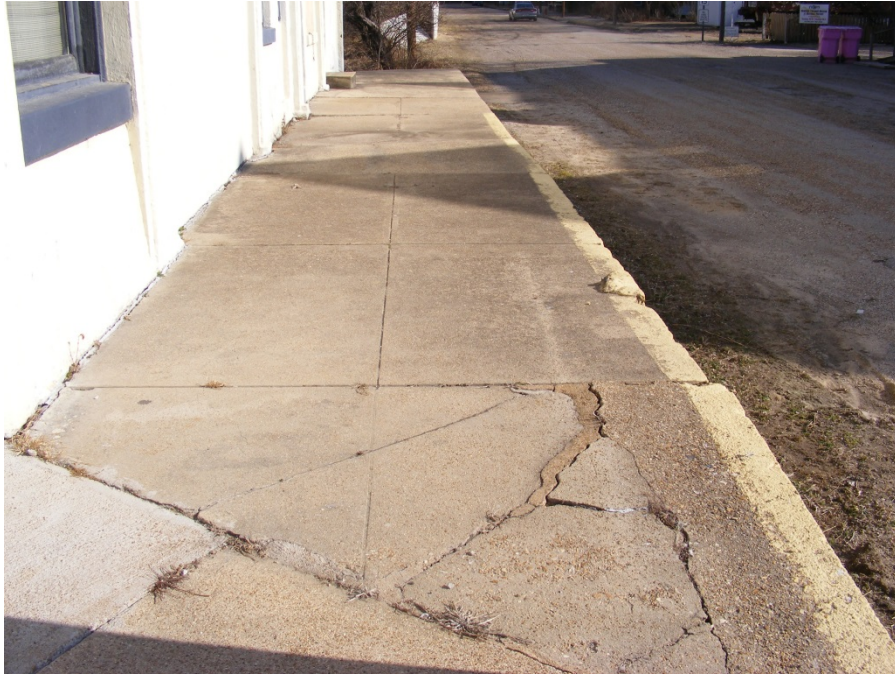
Fair Condition: N.W. corner of Front Street and Water Street, looking north

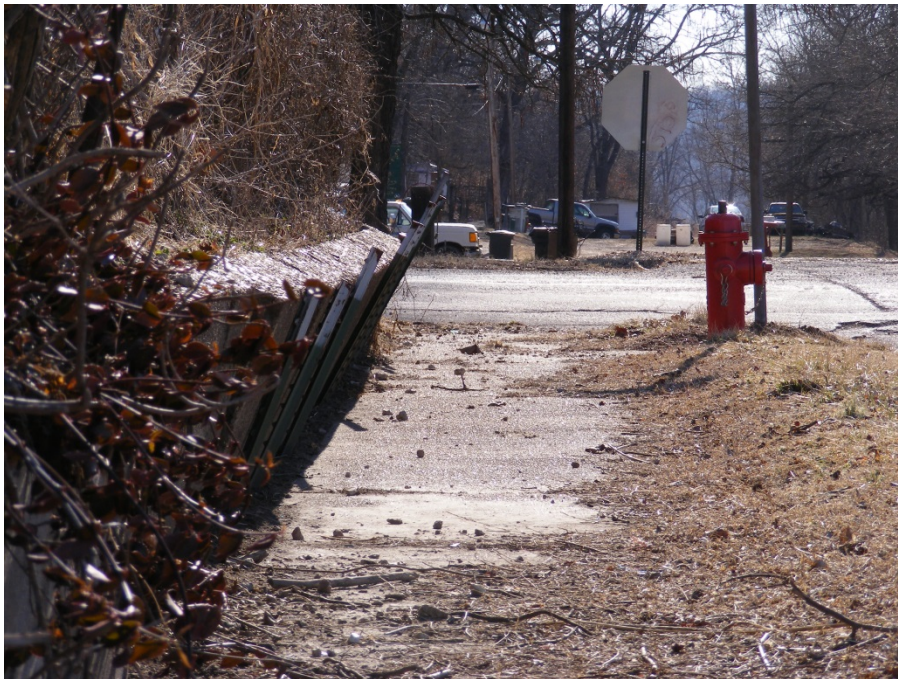
Poor Condition: N.W. corner of Front Street and Hollow Street, looking east

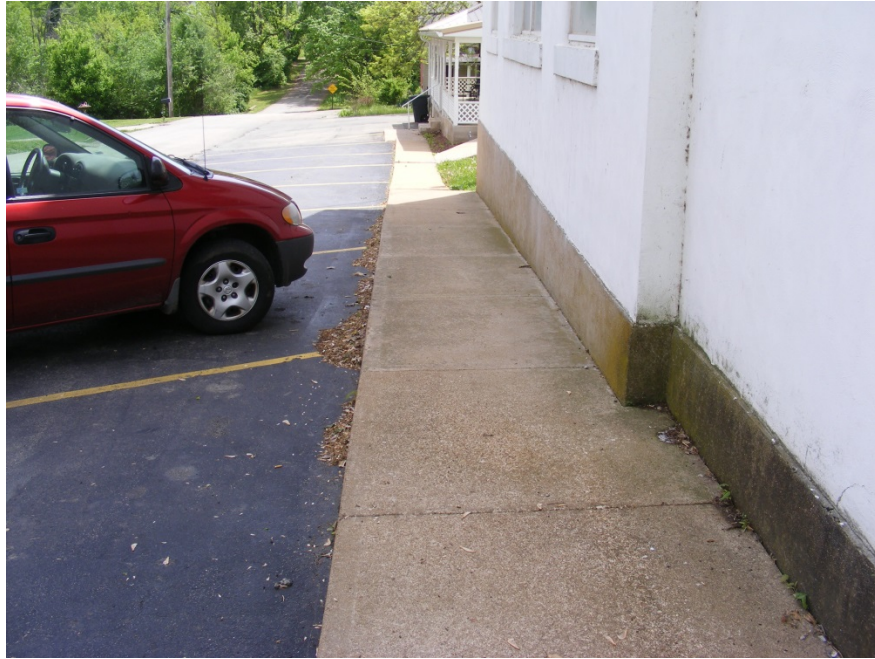
Fair Condition: Alexander Street, south side looking east toward College Street.
