Road Safety Audit: Mo 68/CRD 1050

Road Safety Audit (RSA) Details

Date: June 29, 2017

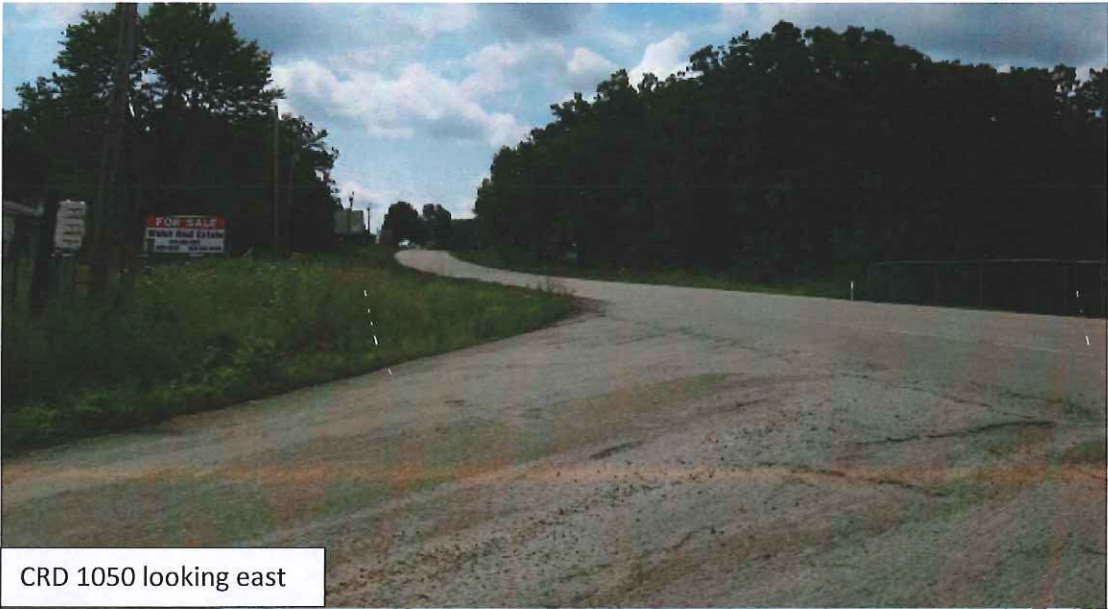
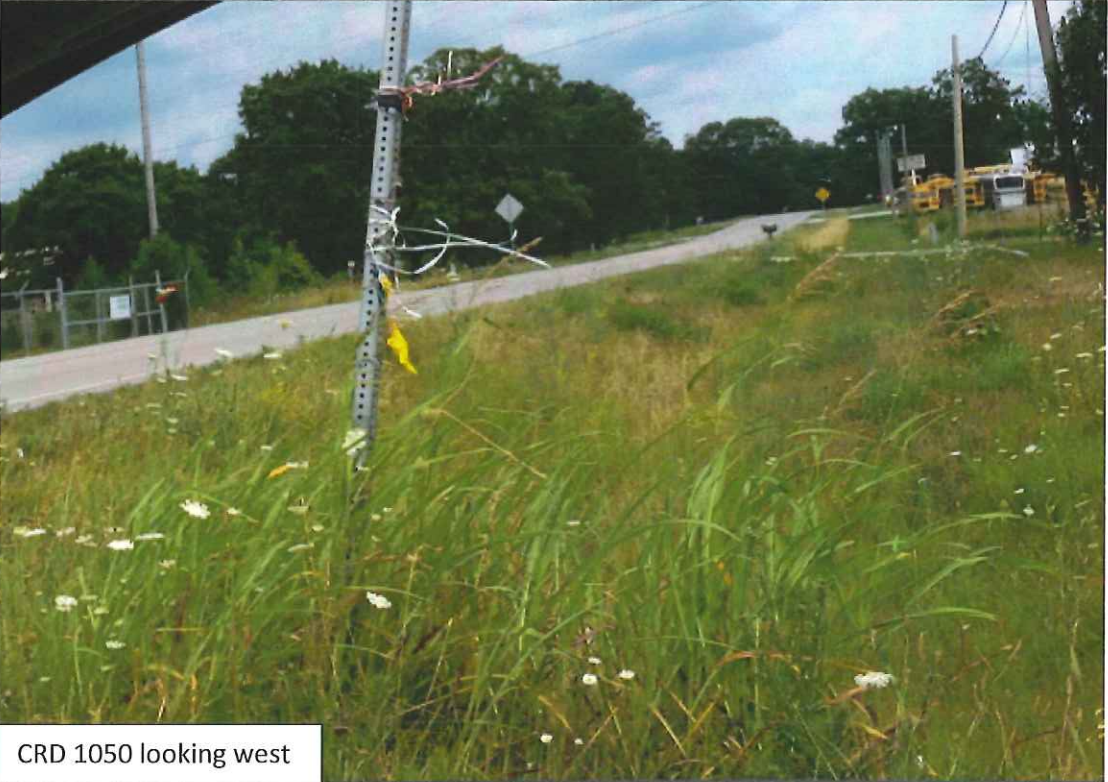
Figure 3: Sight distance from CRD 1050

CRD 1050 intersects Mo 68 at a slight skew across from the Intercounty Electric Cooperative facility. CRD 1050 is a chip seal route that connects Route EE to Mo 68. The entrance to Intercounty Electric is gravel. The stopping sight distance at the intersection for the EB MO 68 is 1,133' and WB Mo 68 is 1,021'. Both directions have more than double the minimum 495' required for a 55 mph roadway. The intersection sight distance for the EB direction is 1,153' and the WB direction is 1,080'; both exceed the minimum 610' (see figure 3).

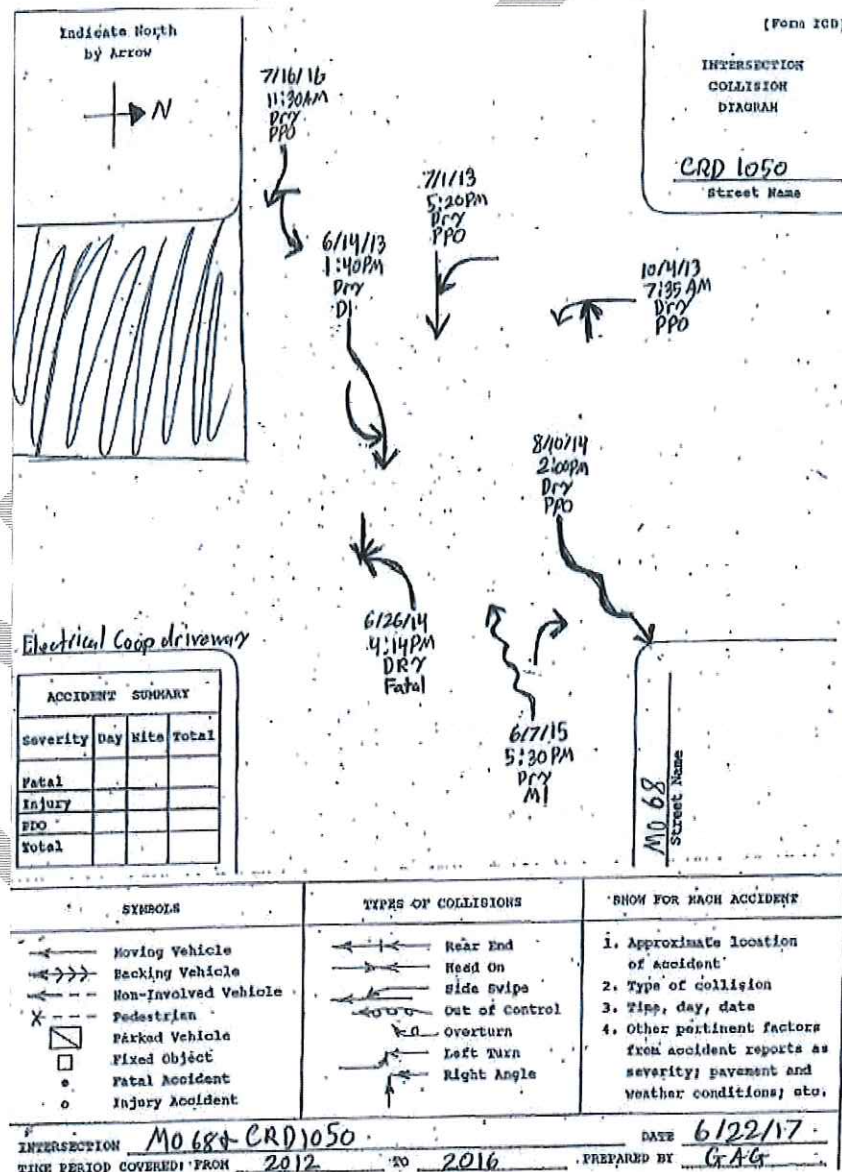
Figure 4: Crash Diagram

From 2012 to 2016 there were 7 crashes at this intersection; they were 1 fatal, 1 disabling injury, 1 minor injury and 4 property damage only crashes. All of the crashes occurred during the day on dry pavement. The fatal crash involved a westbound left vehicle failing to yield to an eastbound motorcycle. The disabling injury involved two eastbound vehicles, vehicle one was attempting to turn left onto CRD 1050 and was struck by vehicle 2 trying to pass. The crashes were equally spread among 3 crash types: Left Turn, Left Turn Right Angle, and Out of Control. See figure 4 for the intersection crash diagram. See Appendix A for detailed crash information.

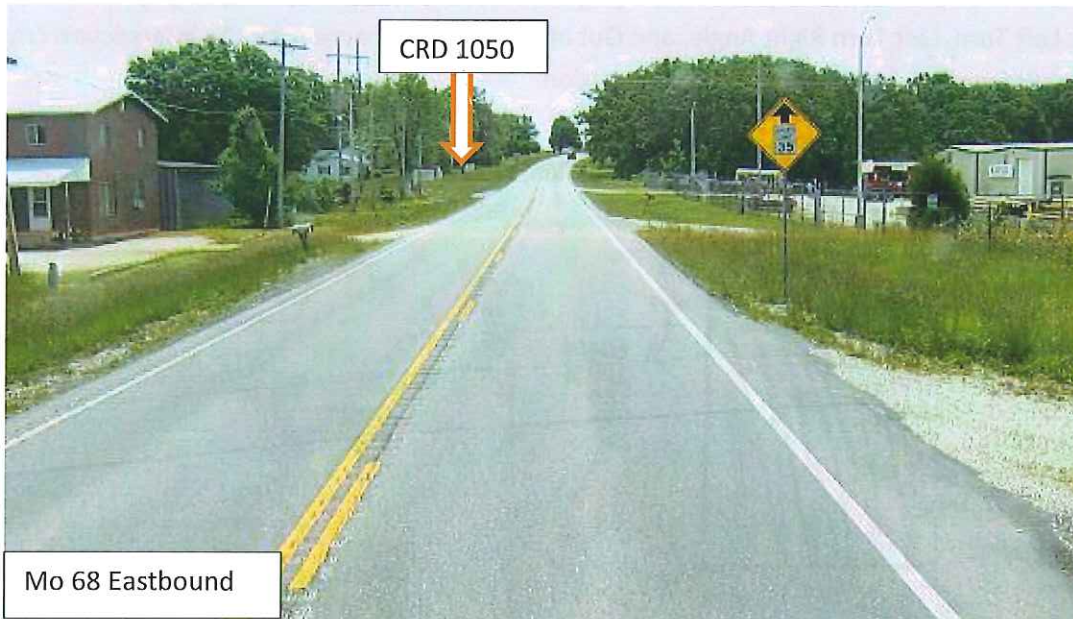
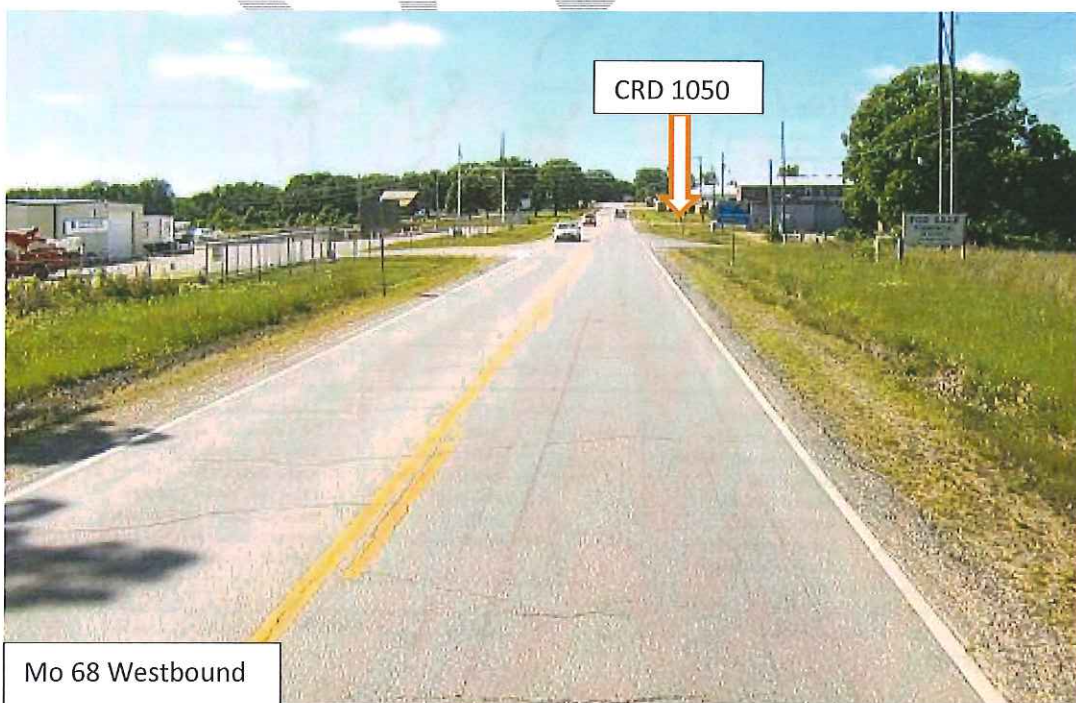
- 1) *Passing Zone* -This section of 68 is striped for passing which can cause a conflict, if a vehicle attempts to pass a vehicle that has slowed to turn left or if a vehicle pulling out of the side road does not look both directions, before turning right. The team suggested striping this section of 68 as a no passing zone.

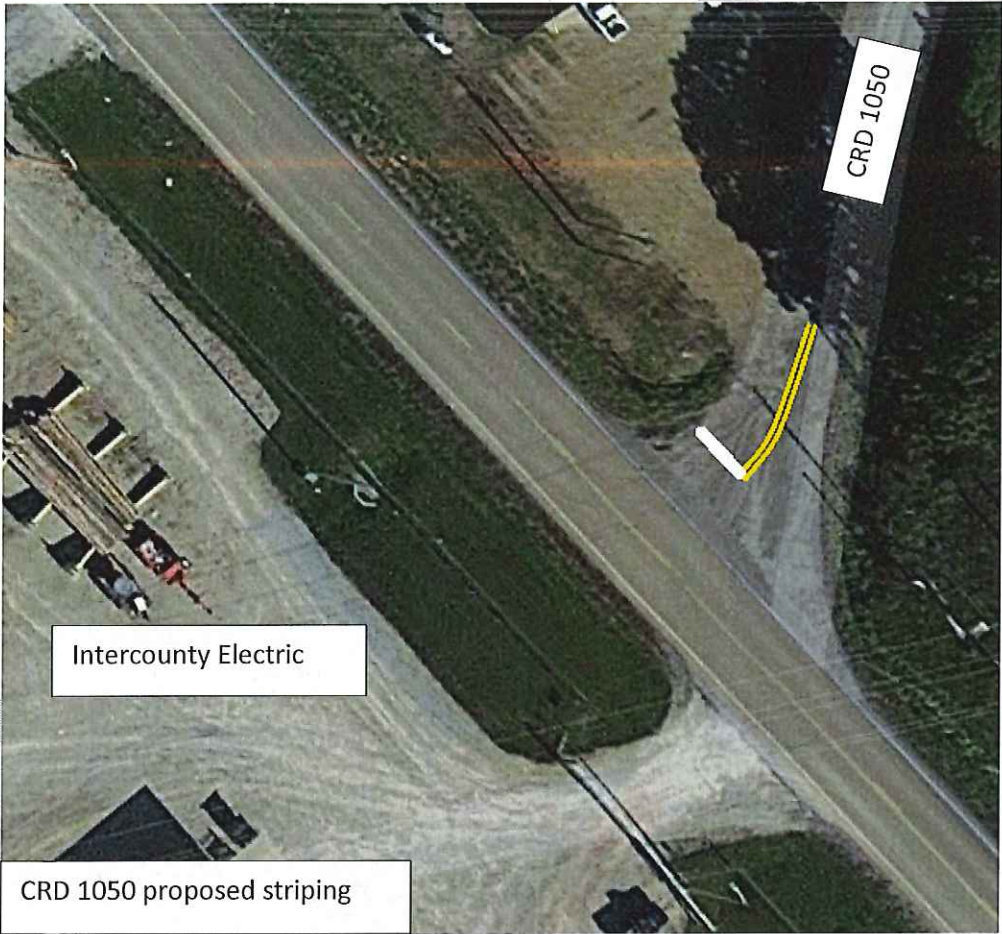
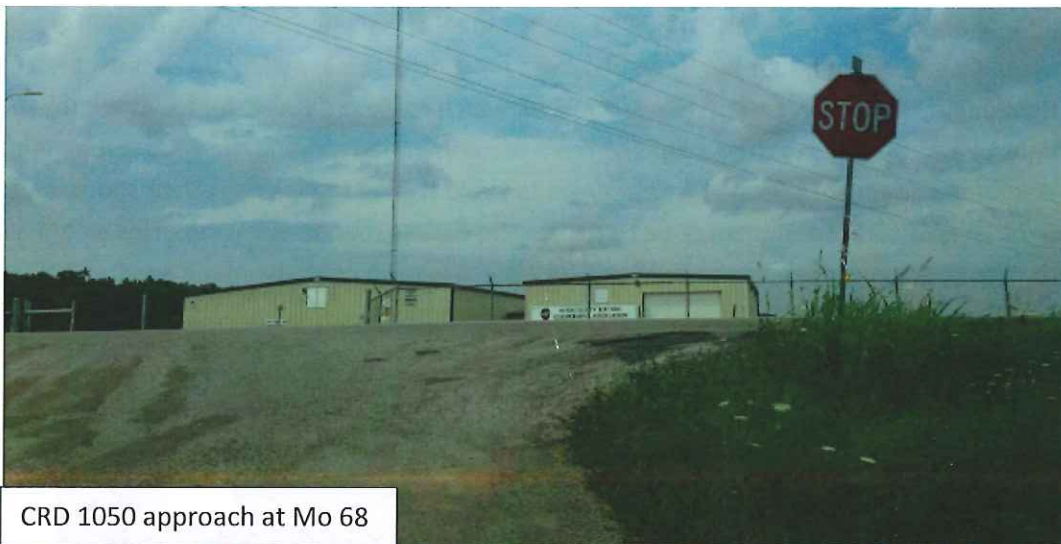
CRD 1050 approach at Mo 68

2) *County Road Approach* – CRD 1050 intersects Mo 68 at a slight skew with an uphill grade. The skew is slight enough that the team observed most drivers still pulling up to the intersection at a right angle. A few drivers did follow the skew which made it difficult for them to look to their right before pulling out to go left. The team recommended striping the county road approach to encourage drivers to pull in at a right angle to avoid having to look over their shoulder to look right. A long term solution may be to realign the county road to the west. This would allow the road to come in perpendicular to Mo 68 and the approach could be made level.

The higher cost solution of relocating the county road can be re-evaluated after the low cost solutions have been in place for a few years. Relocating the county road would require additional right of way and would impact the Phelps County maintenance facility. Since the need for relocating the approach may be eliminated by implemented the other suggestions, it is recommended that this be re-evaluated in a few years.

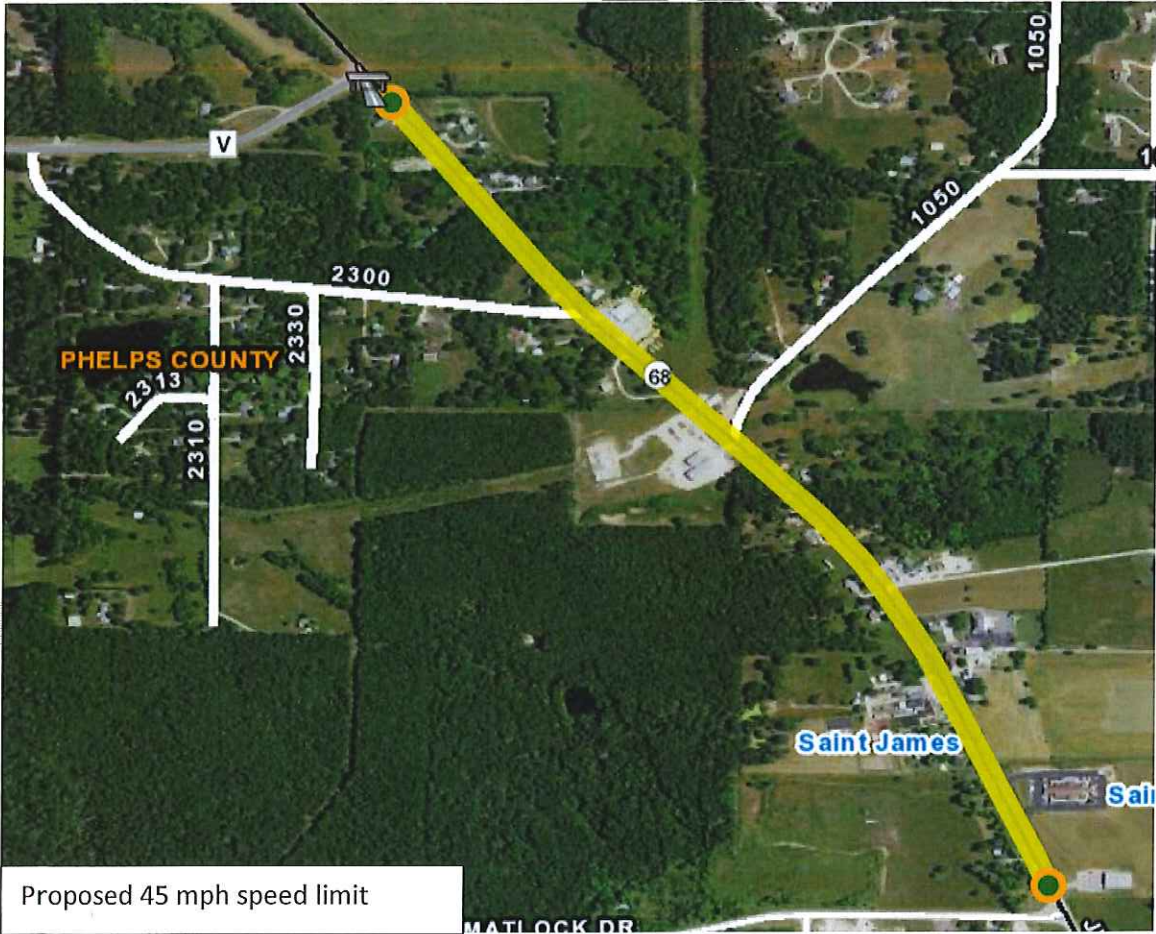
3) *Speed Limit* – Currently, the speed limit on Mo 68 is set at 55 mph. A speed study was completed at this location. The study found that 85 percent of the traffic was traveling 57mph or less. The most commonly occurring speed was 50 mph. Speeds as high as 63 mph were recorded. As the RSA team drove the corridor, they felt that changing the speed limit on Mo 68 from Route V to Matlock drive to 45 mph was more appropriate, since the road becomes more urbanized east of Route V. Lowering to speed limit will take the cooperation of law enforcement to encourage compliance. Studies have shown that lowering the speed limit has little effect on driver speed without enforcement; without enforcement a lower speed limit can have a negative effect on safety due to the increased speed differential between those who follow the speed limit and those that don't.

Local official and MoDOT will need to further investigate lowering the speed limit before making any changes. Lowering to speed limit will take the cooperation of law enforcement to encourage compliance. Studies have shown that lowering the speed limit has little effect on driver speed without enforcement; without enforcement a lower speed limit can have a negative effect on safety due to the increased speed differential between those who follow the speed limit and those that don't.

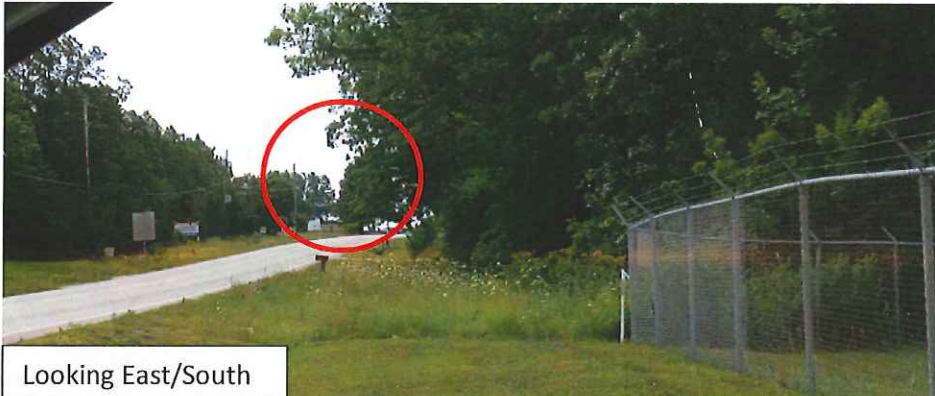
Looking East/South

- 4) *Trim Limbs*- As the team observed traffic from the Intercounty Electric entrance; they noticed that low hanging limbs could potential be blocking the sight distance for larger vehicles. The team suggested trimming the trees.

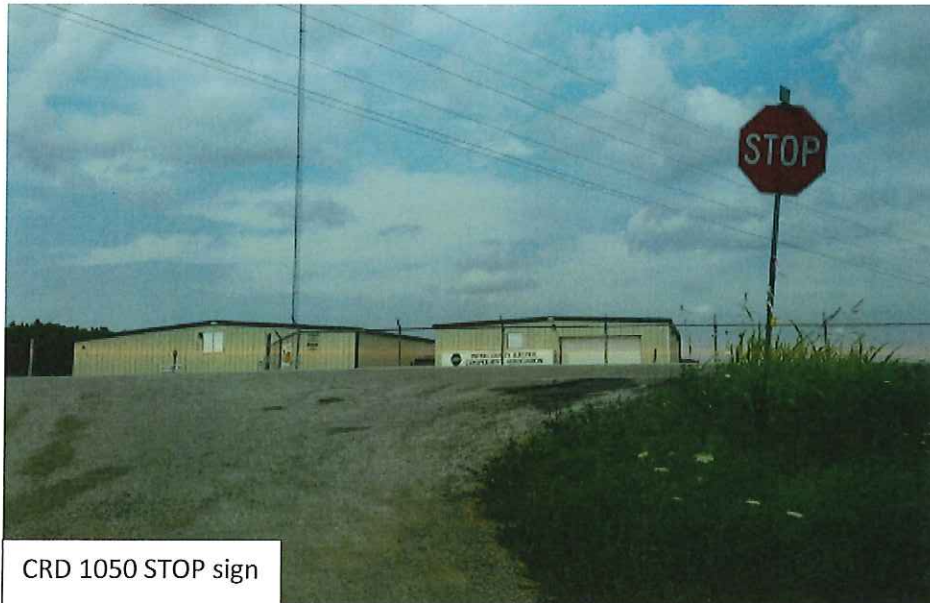
CRD 1050 STOP sign

- 5) *Replace Stop Sign* – The STOP sign on CRD 1050 was a bit out of plumb and had limited retro-reflectivity. The team recommended plumbing up the post and placing a new STOP sign.

Several of the suggestions noted by the RSA team were low cost improvements that can be addressed by MoDOT maintenance forces. MoDOT plans to take immediate action on the striping, trimming and STOP sign recommendations. These improvements should be completed by the end of 2017.
