## **Appendix E**

### **PHASE I: SIDEWALK SURVEY**

# City of Sullivan

## Sidewalk Inventory

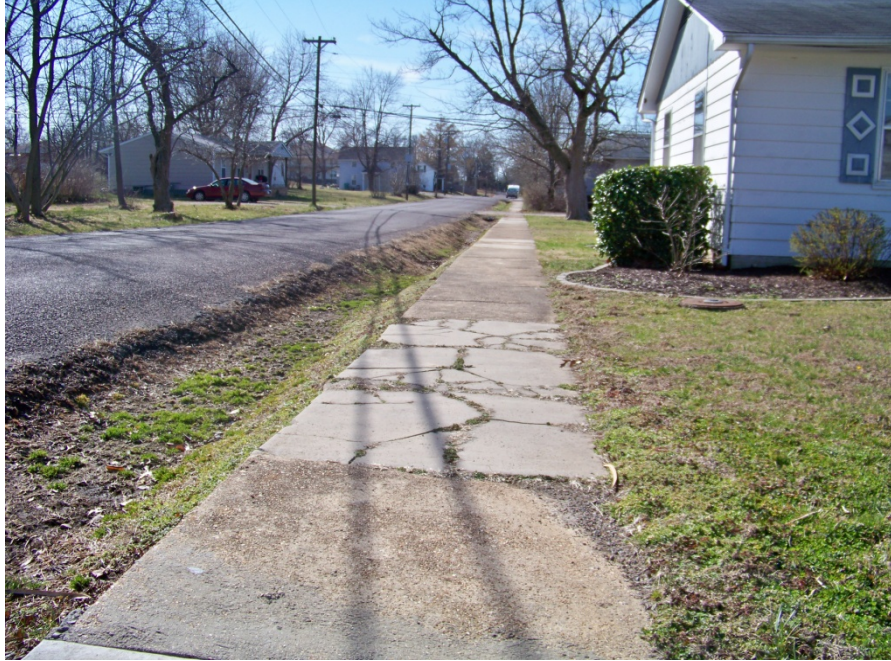
Fair Condition: Taylor Street, west side looking south

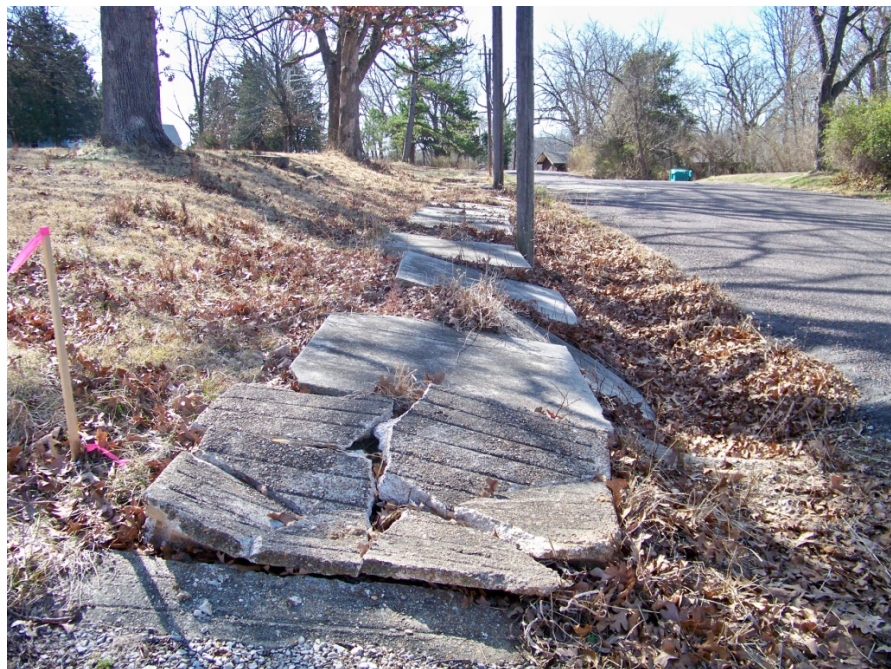
Poor Condition: Taylor Street, east side looking south

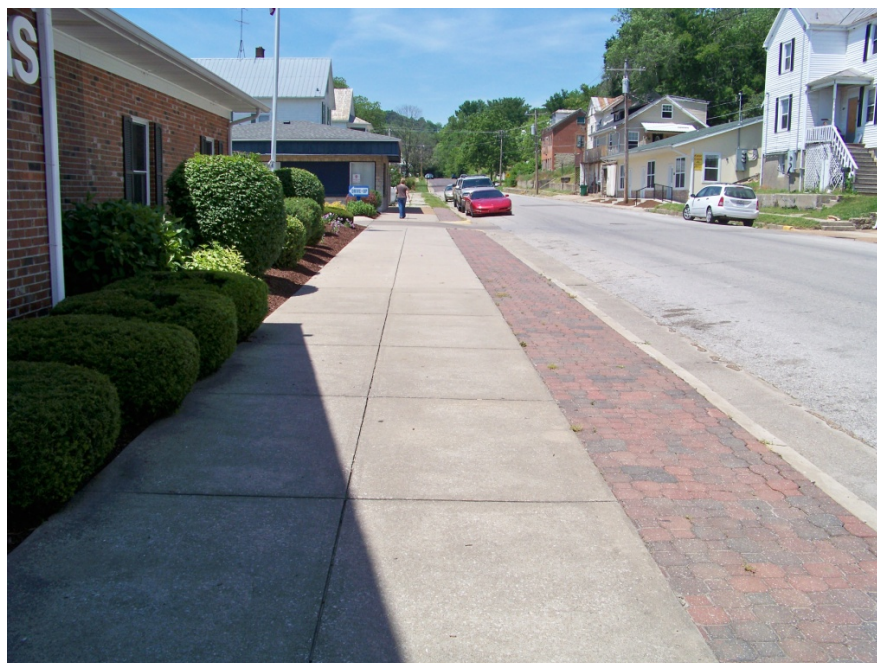
Good Condition: West Fifth Street, south side looking west

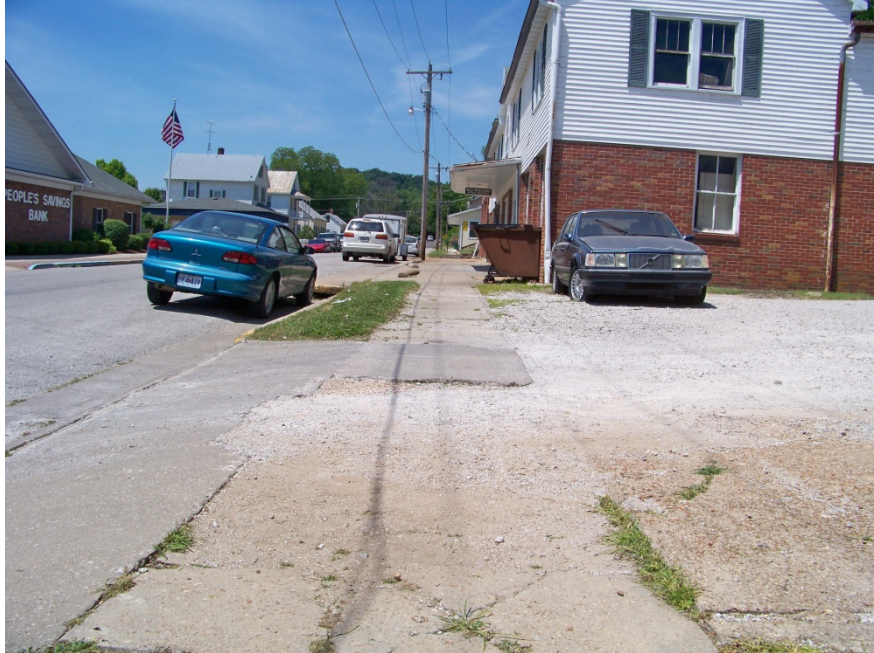
Fair Condition: West Fifth Street, north side looking west

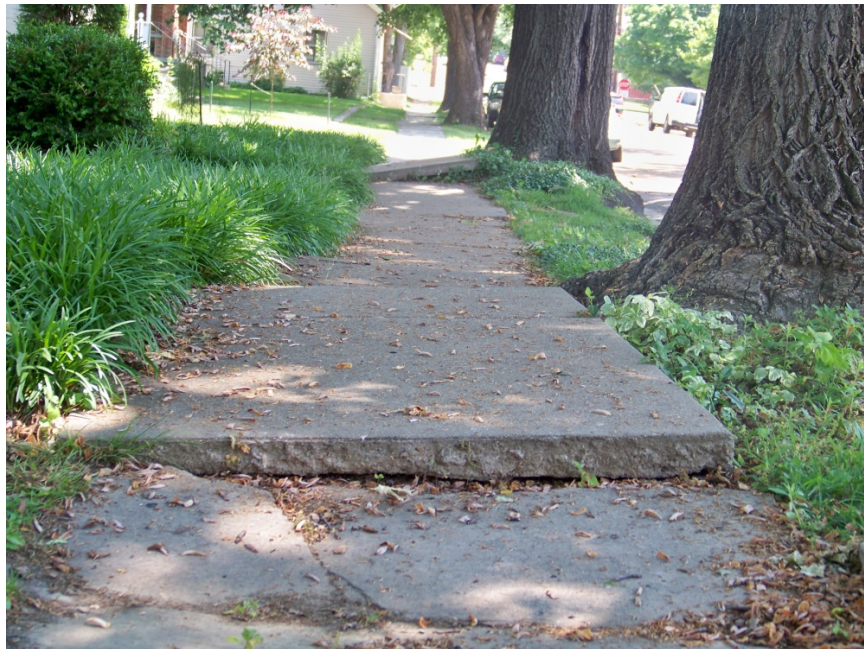
Poor Condition: West Third Street, north side looking east

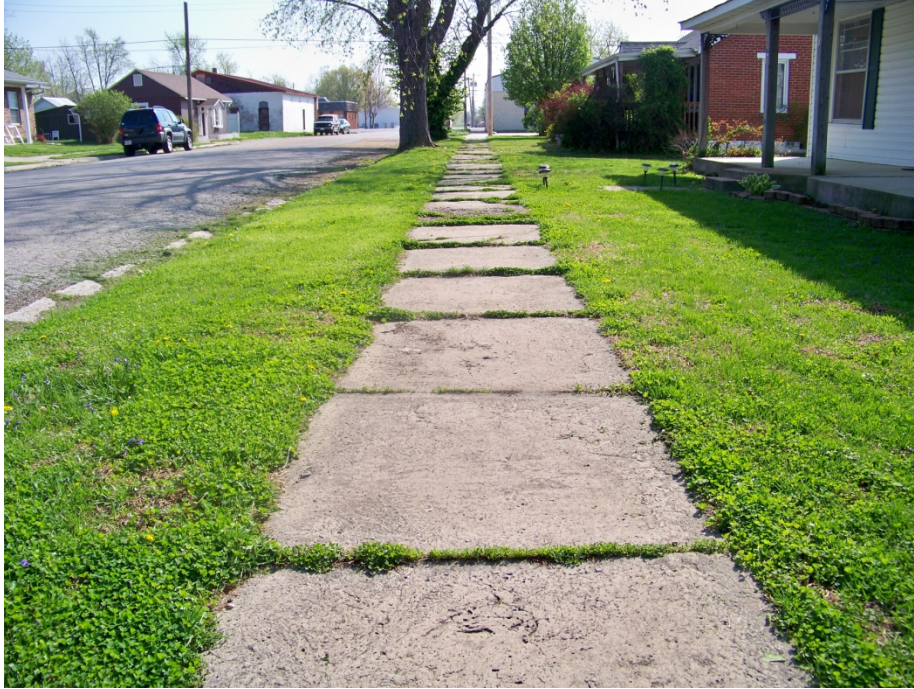
Fair Condition: Second Street, south side looking east

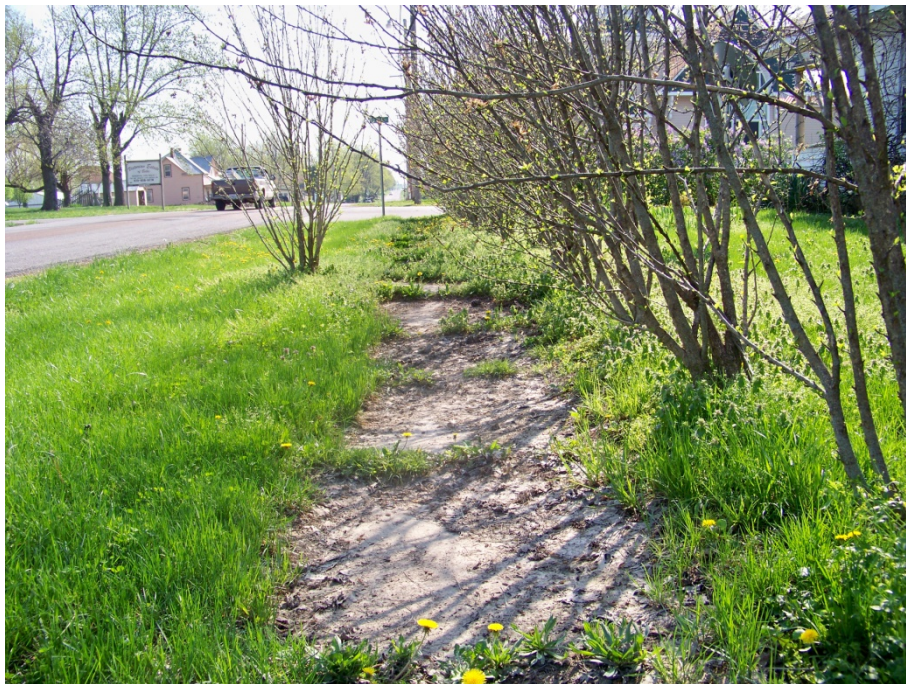
Poor Condition: First Street, north side looking west

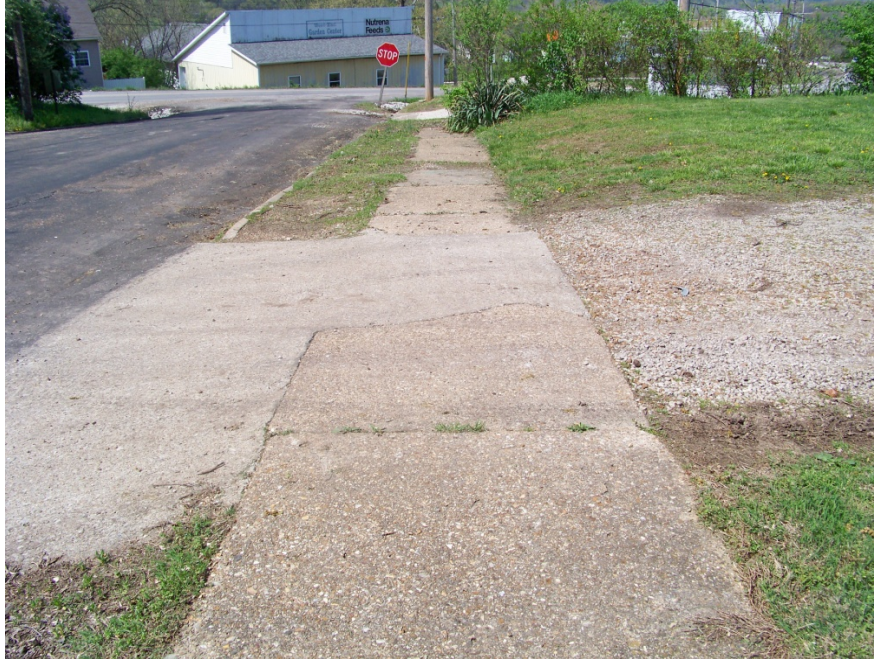
Fair Condition: Benton Street, north side looking west

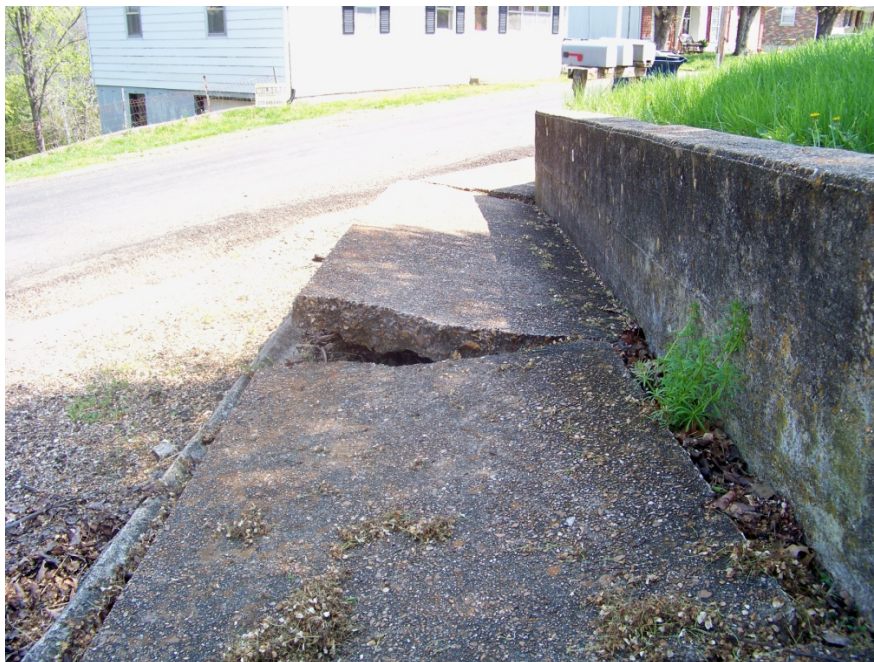
Poor Condition: Corner of Benton Street and Fifth Street, south side

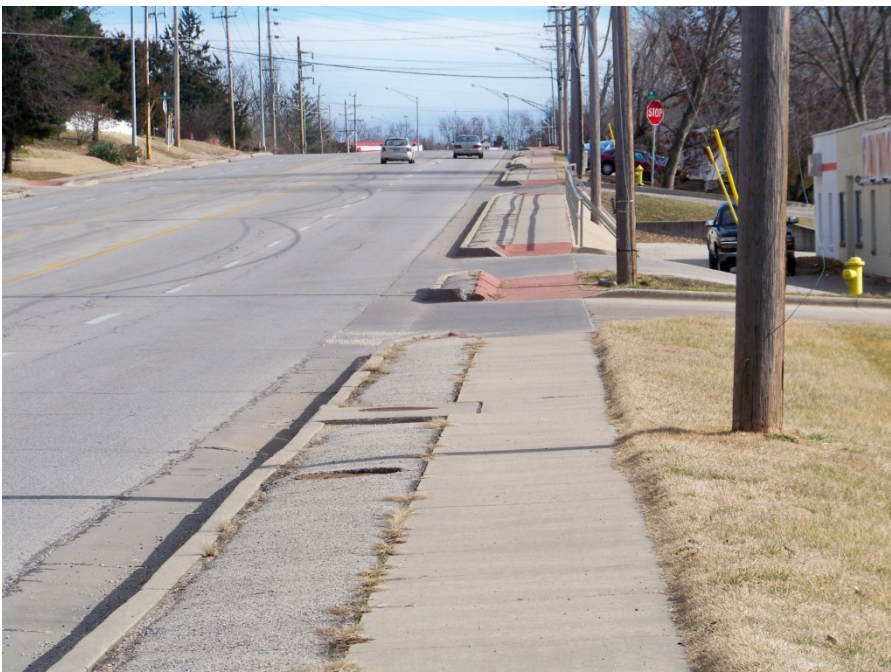
This sidewalk, located on the south side of Hwy. 72, is in good condition.

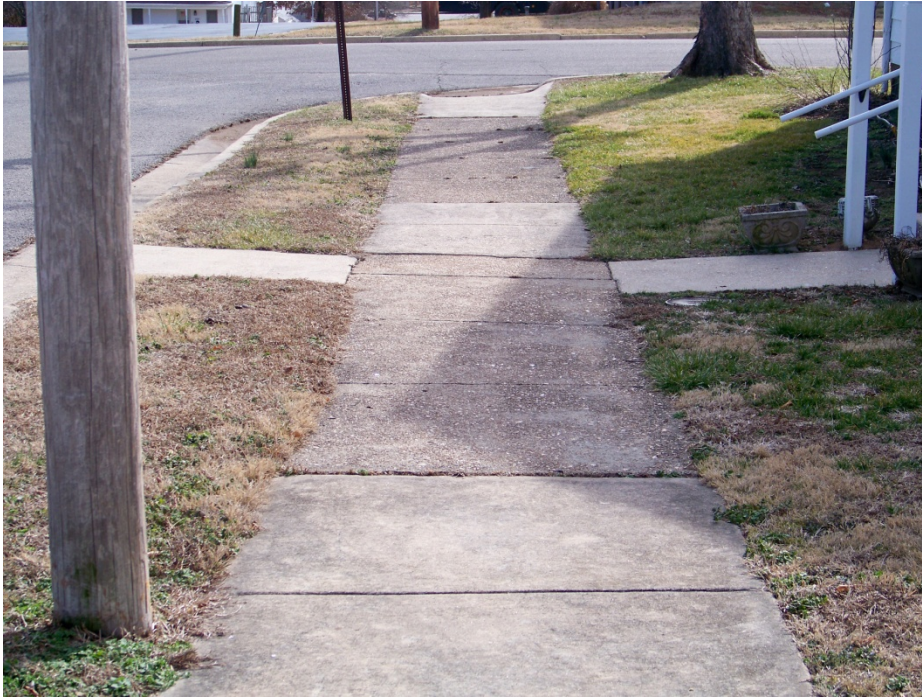
This sidewalk, in fair condition, is located on Cedar Street.

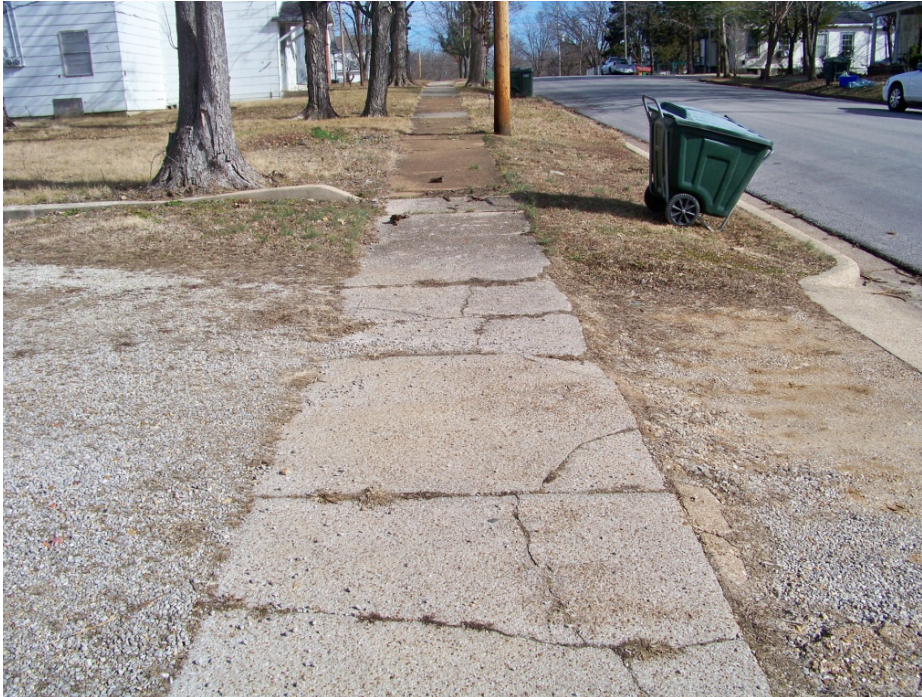
Sidewalks on portions of Olive Street are in poor condition.

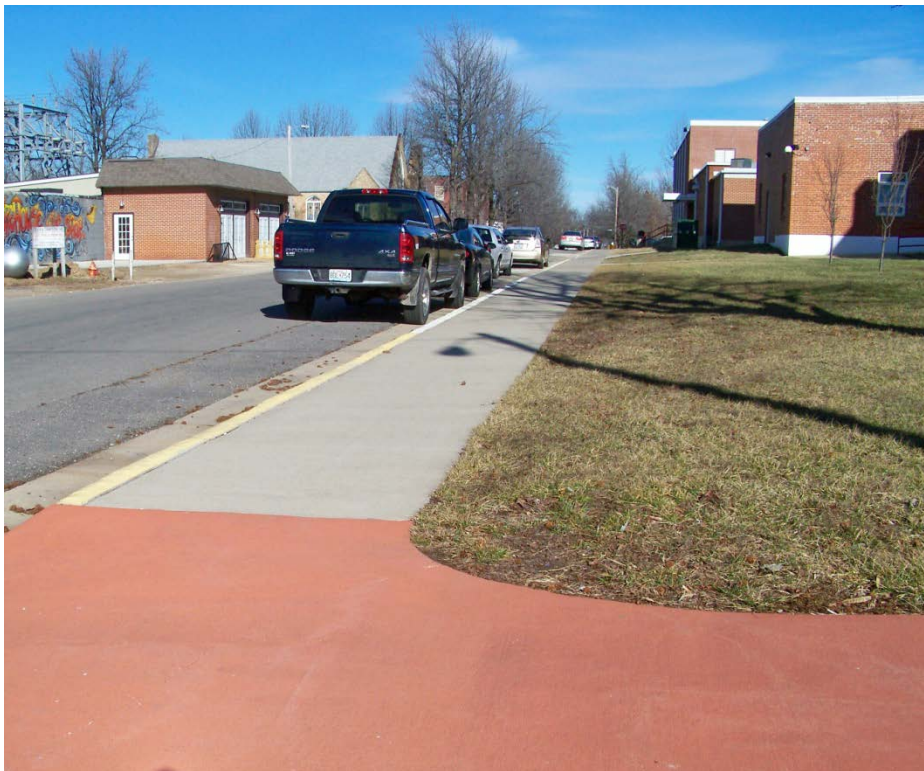
This sidewalk, located on the north side of Washington Street, is in good condition.

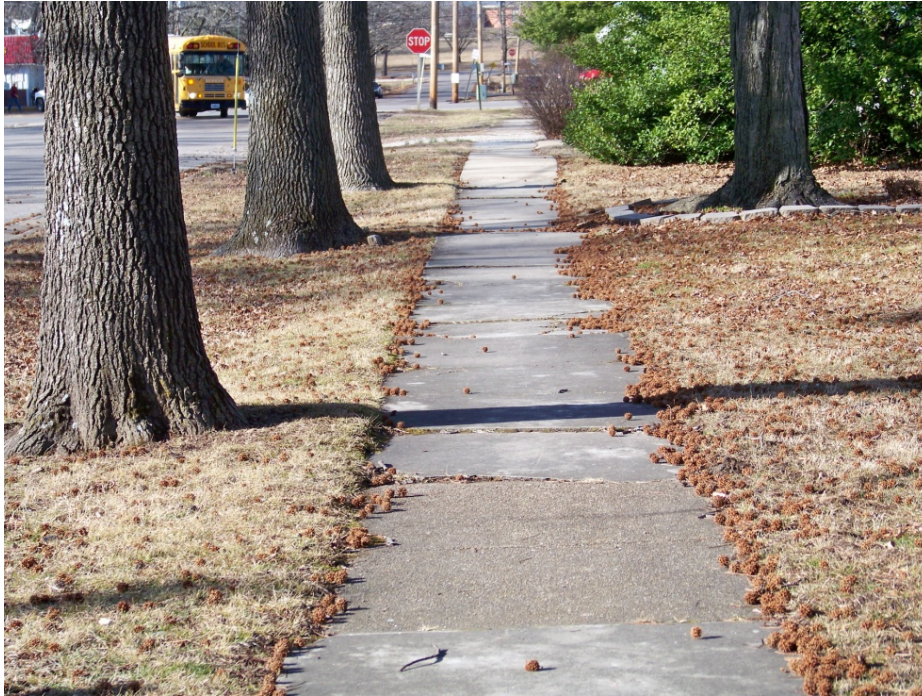
This sidewalk, in fair condition, is located on Seymour Street.

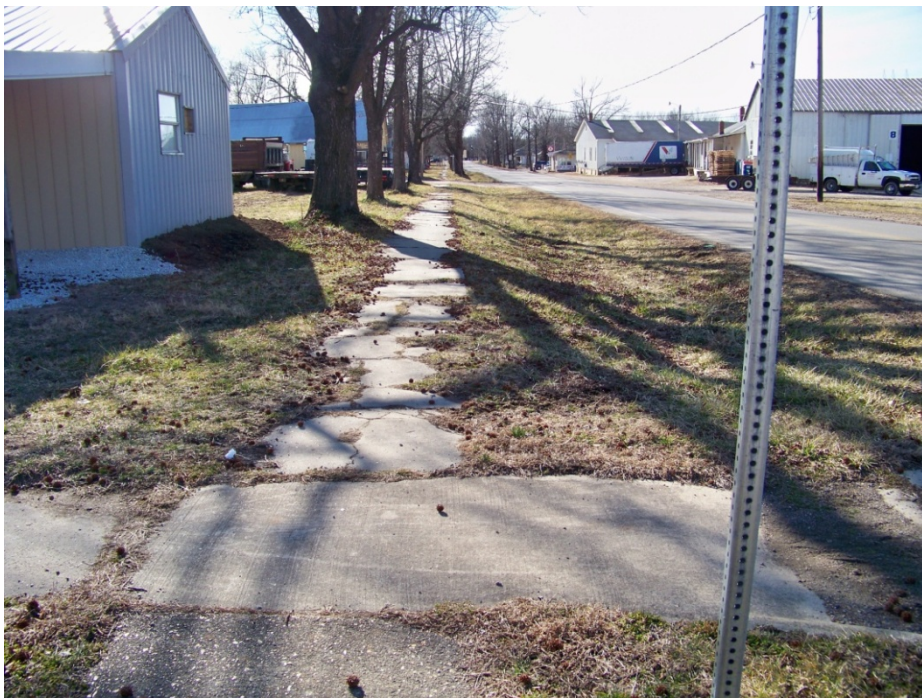
A large portion of the sidewalks in St. James are in poor condition, such as these along W. Washington Street.

The city is currently seeking to expand existing sidewalks into un-served areas as well as where gaps exist and repair poor condition sidewalks. Expansion/improvement is targeted for the following areas:

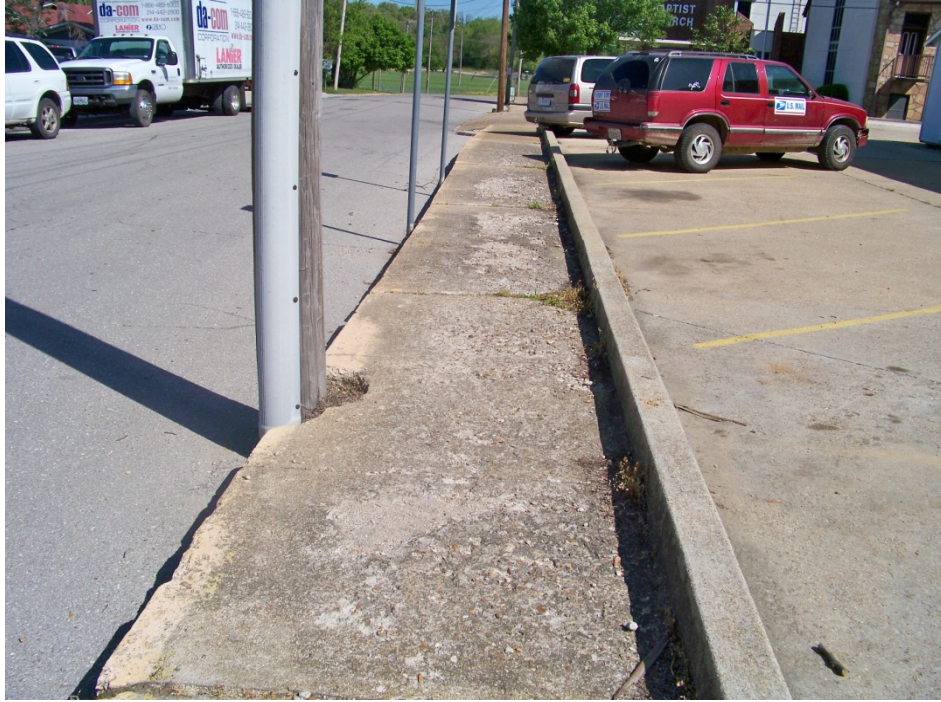
Fair Condition: North Benton Street, east side looking north

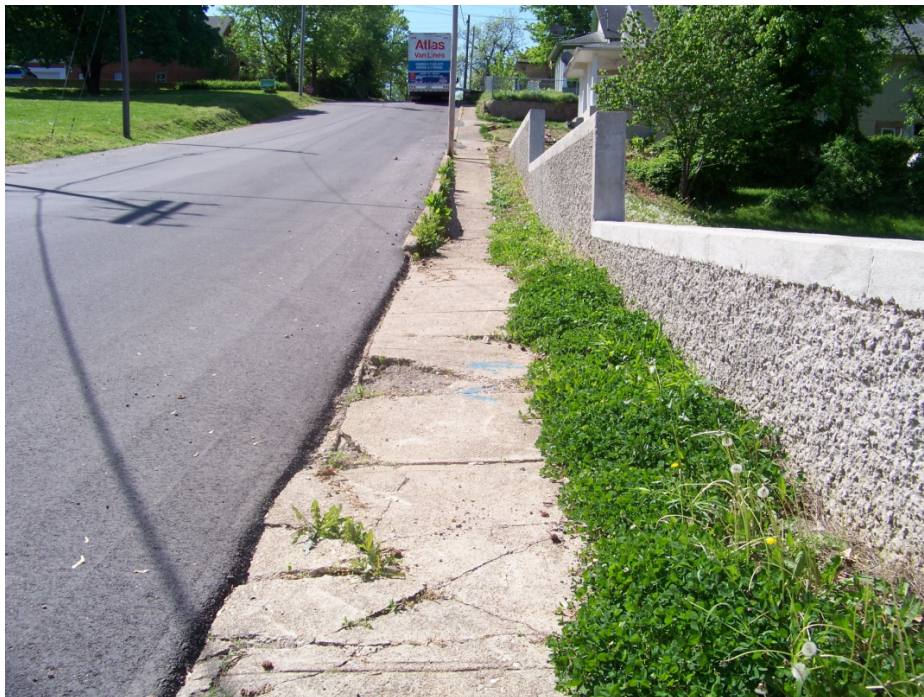
Poor Condition: South Benton Street, west side looking south

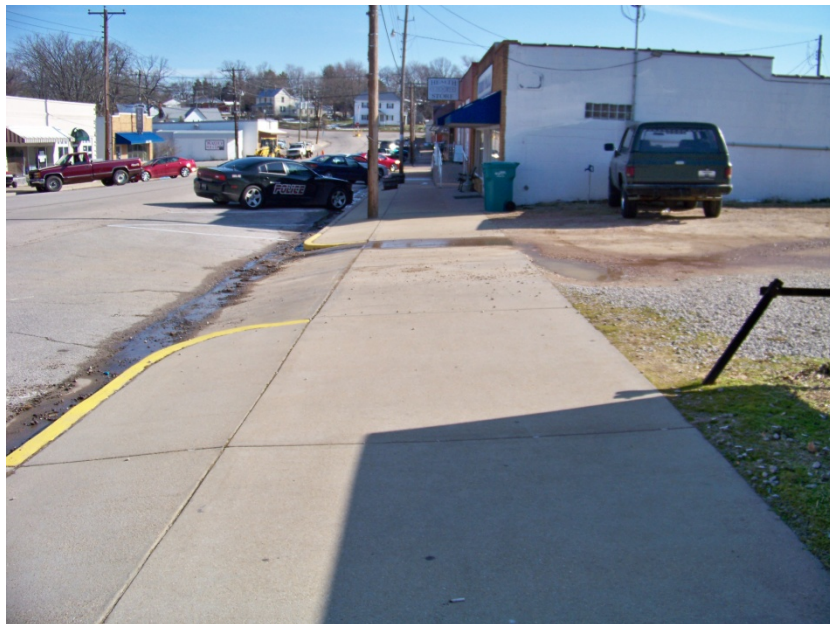
Good Condition: E. Pine Street, south side looking east toward Walnut Street

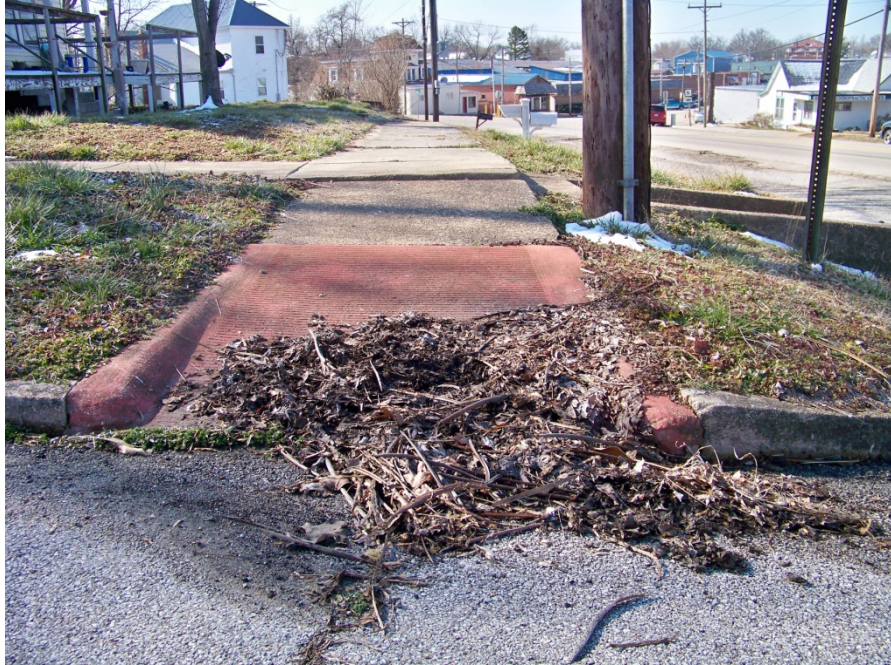
Fair Condition: Intersection E. Pine Street and Olive Street, southeast corner

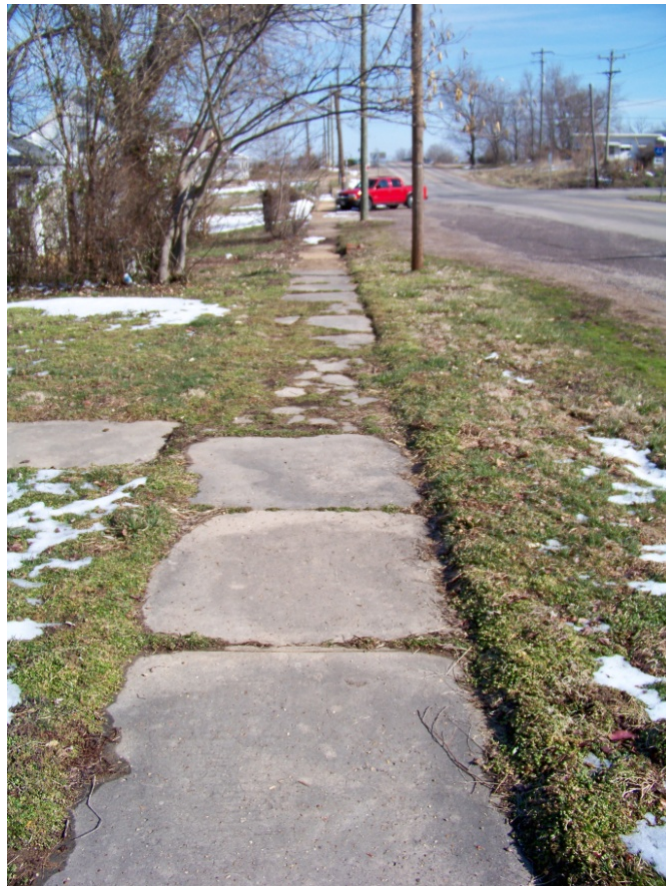
Poor Condition: E. Pine Street, west side looking north toward N. Old U.S. Highway 66

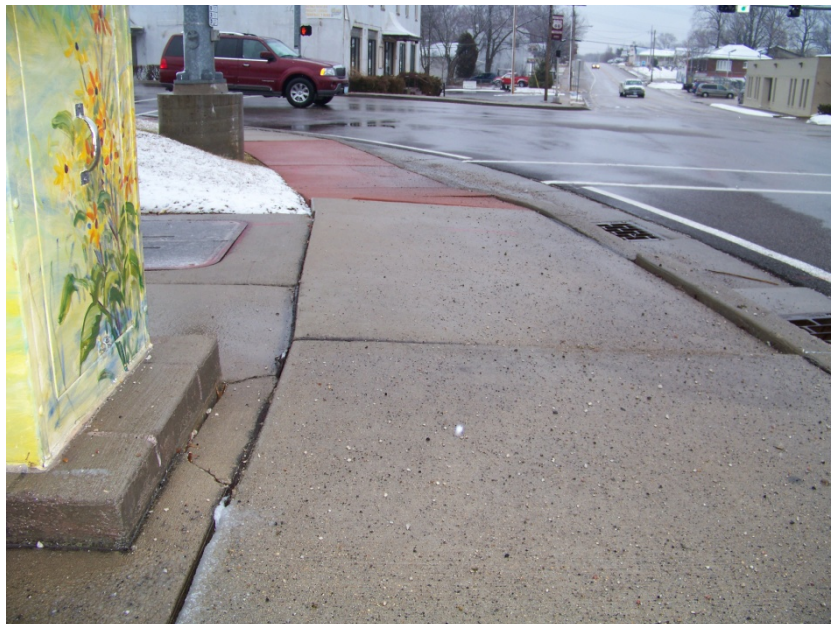
Good Condition: Intersection of North Franklin St and West Washington Blvd

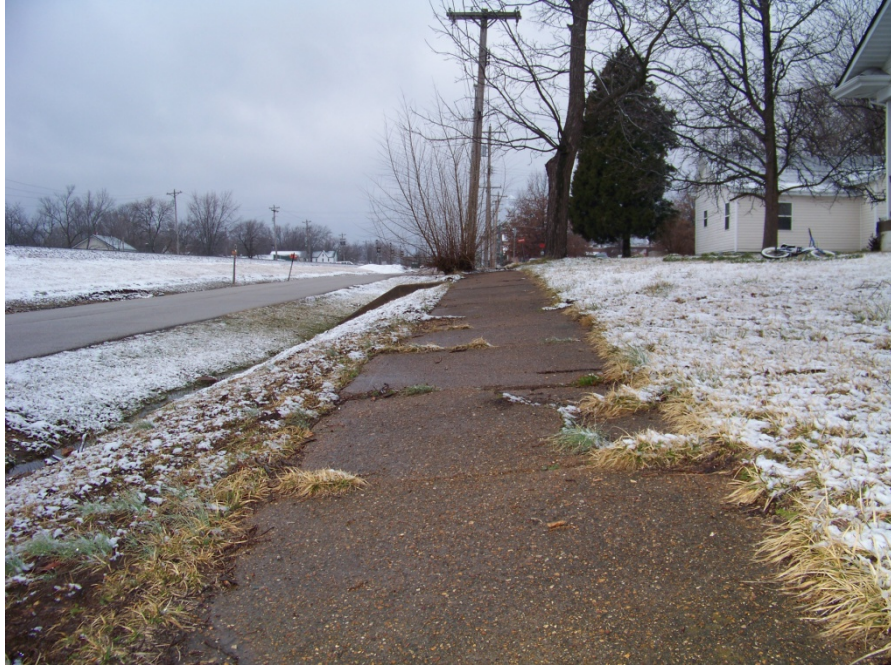
Fair Condition: West Main Ave, north side looking west

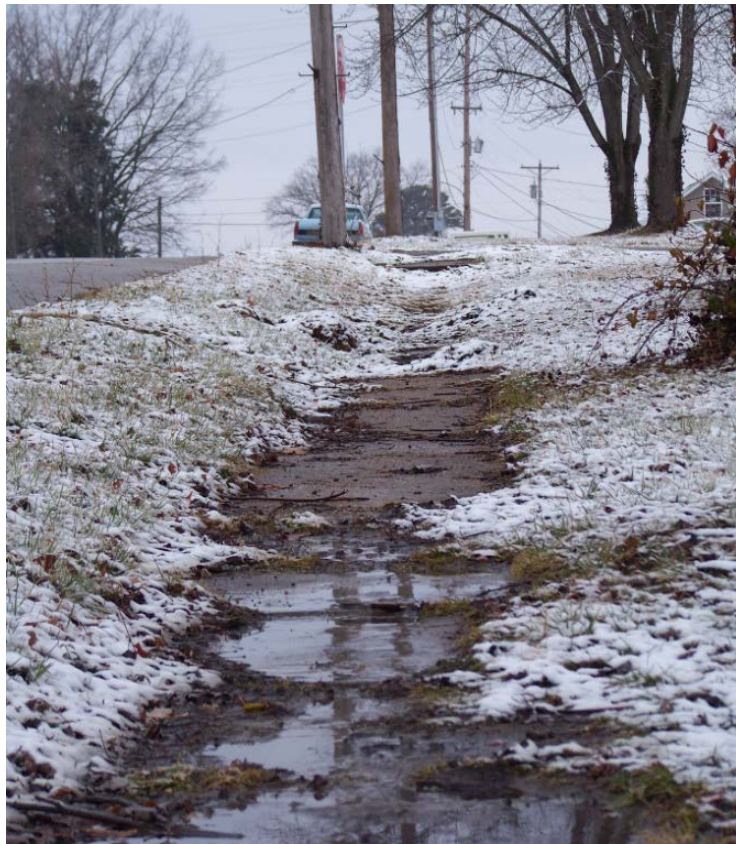
Poor Condition: Washington Blvd, north side looking west

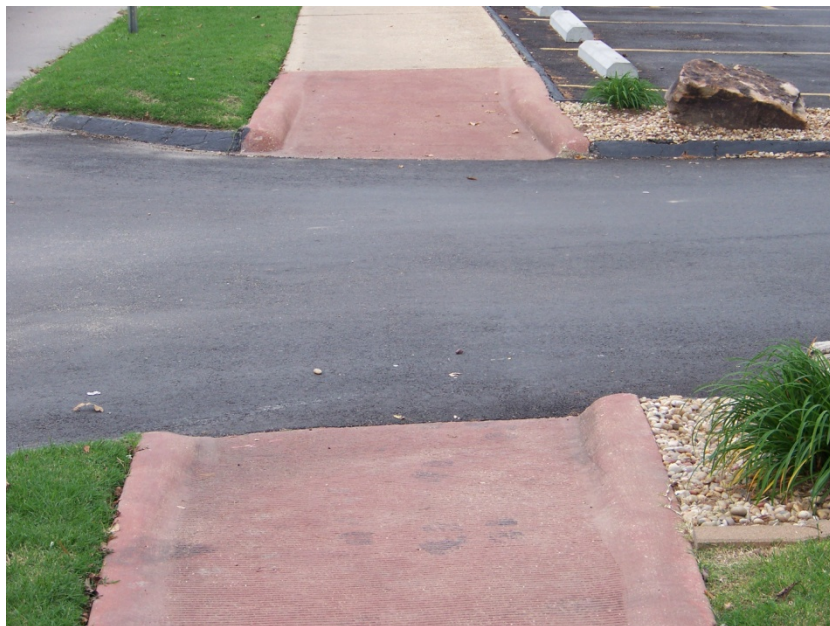
Good Condition: Main Street, south side looking east toward S. 4<sup>th</sup> Street

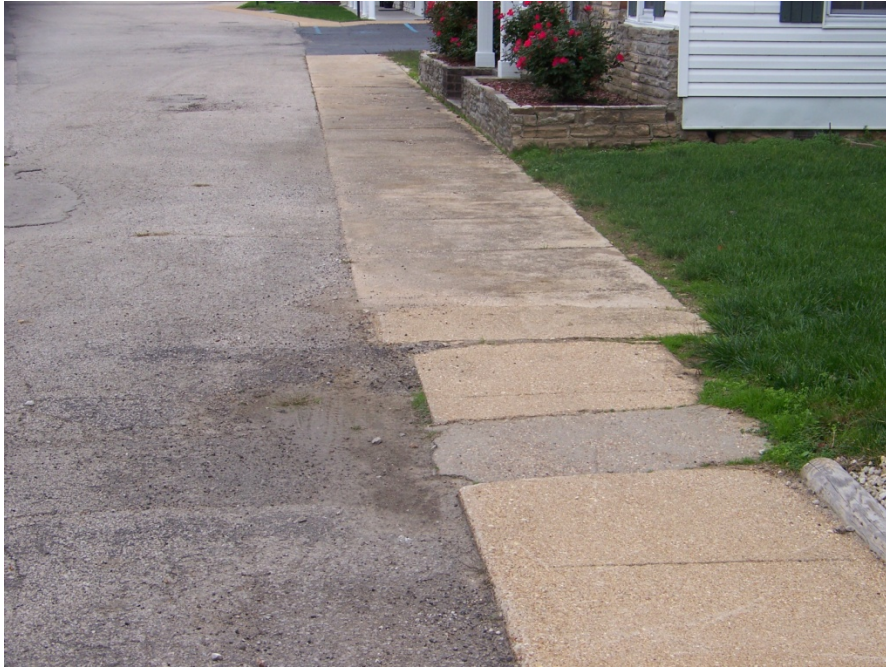
Fair Condition: Cedar Street, south side looking east from Hickory Street

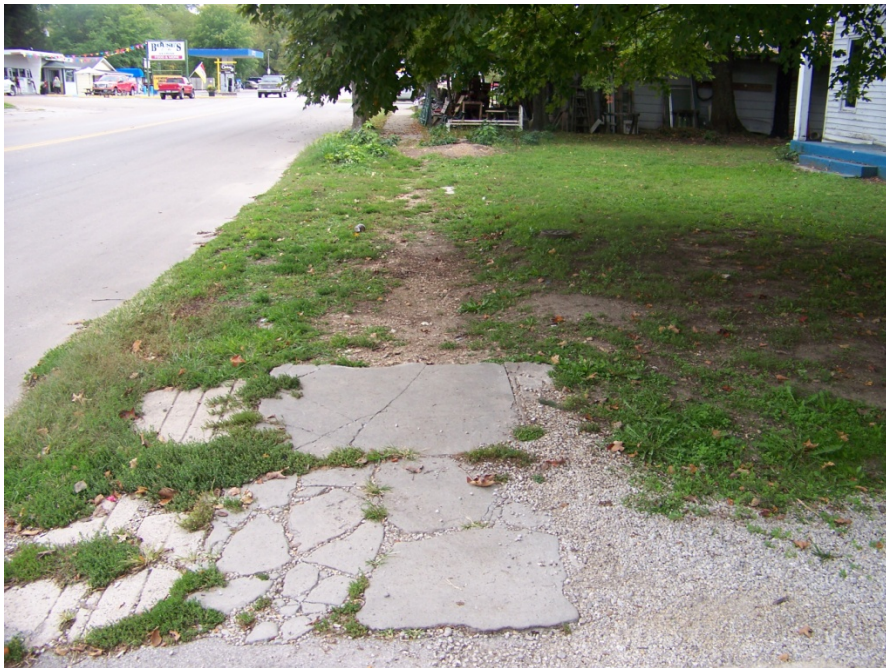
Poor Condition: Main Street, north side looking west toward S. Spring Street

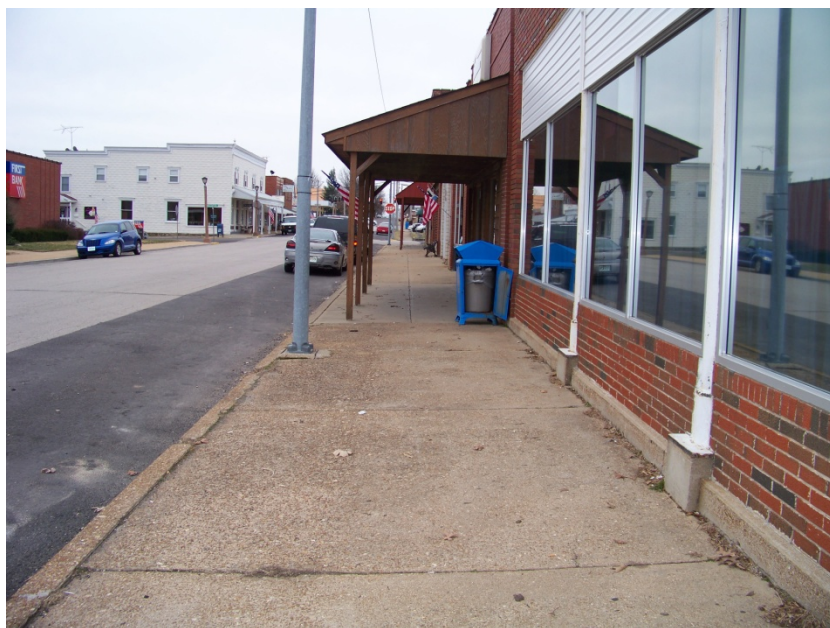
Good Condition: S. 1<sup>st</sup> Street, west side looking south toward E. Washington Avenue

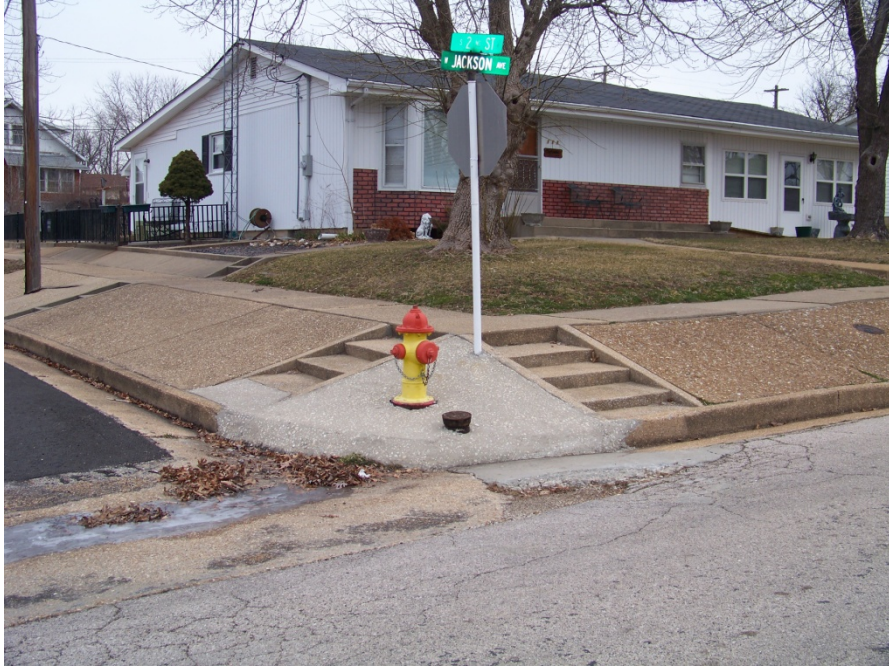
Fair Condition: Intersection of W. Jackson Avenue and S. 2<sup>nd</sup> Street, looking northeast

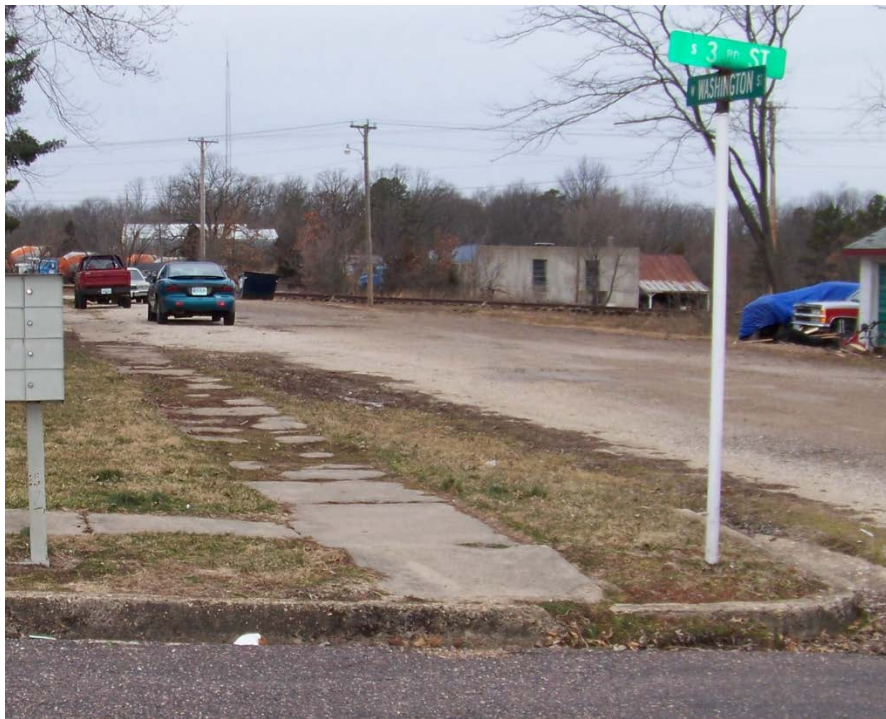
Poor Condition: W. Washington Avenue west of S. 3<sup>rd</sup> Street, south side looking west

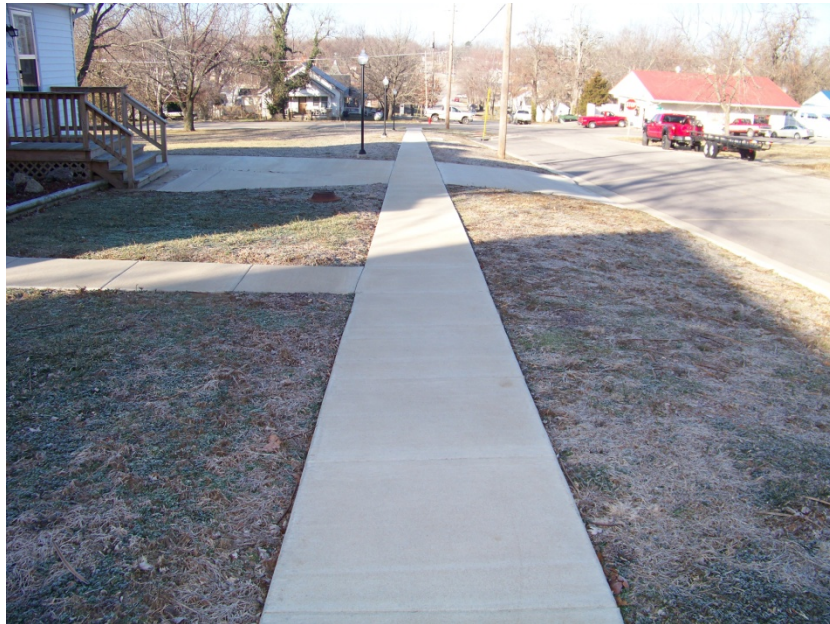
Good Condition: E. 3<sup>rd</sup> Street, south side looking west

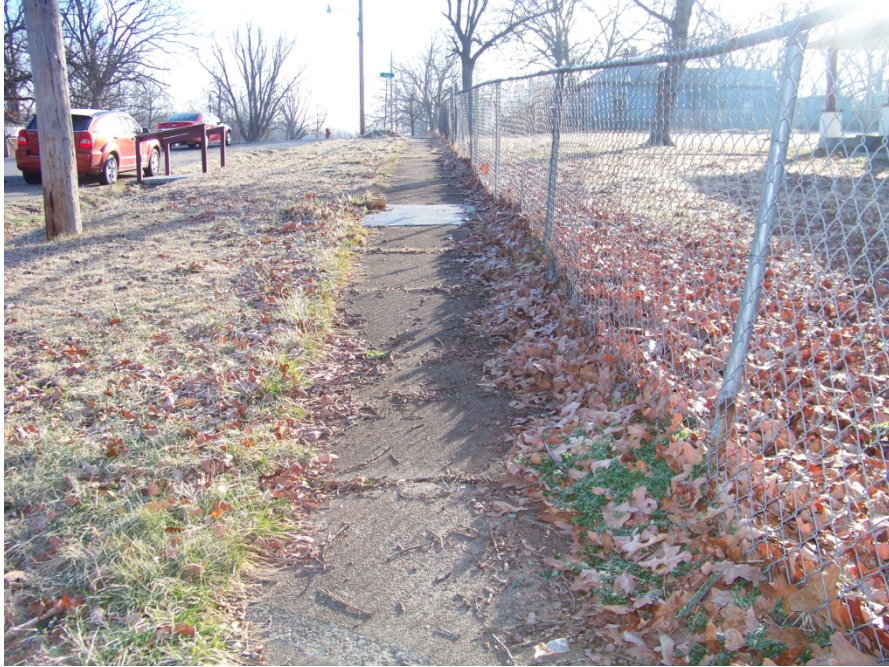
Fair Condition: E. 4<sup>th</sup> Street, south side looking east

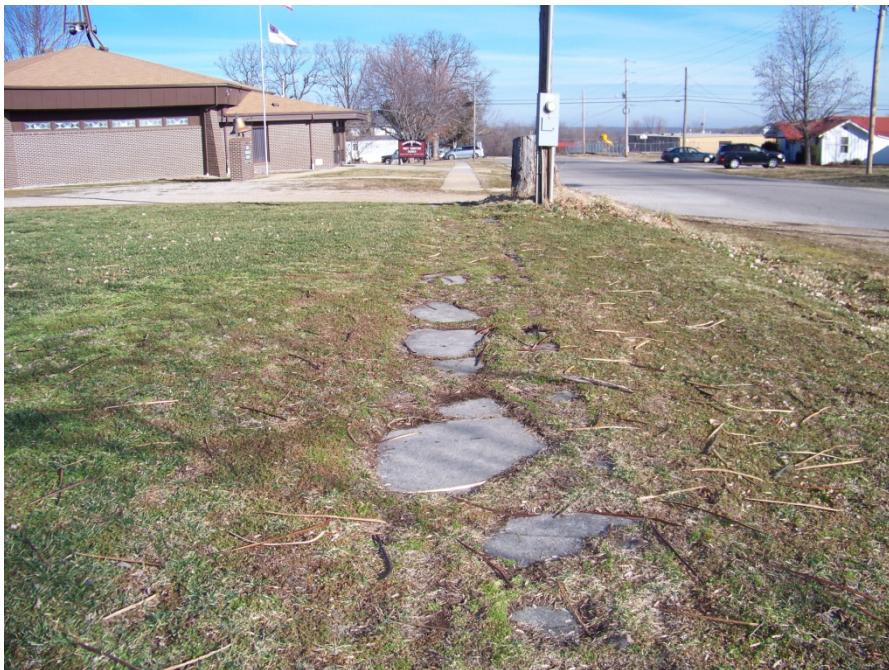
Poor Condition: S. Walnut Street, west side looking north

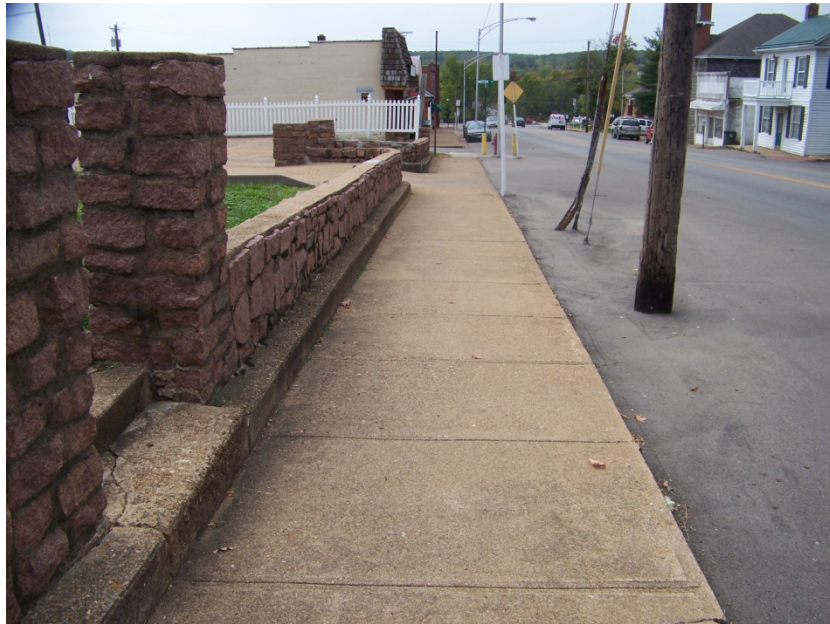
Good Condition: N. Missouri Street, between Brenton Street and Hickory Street looking west

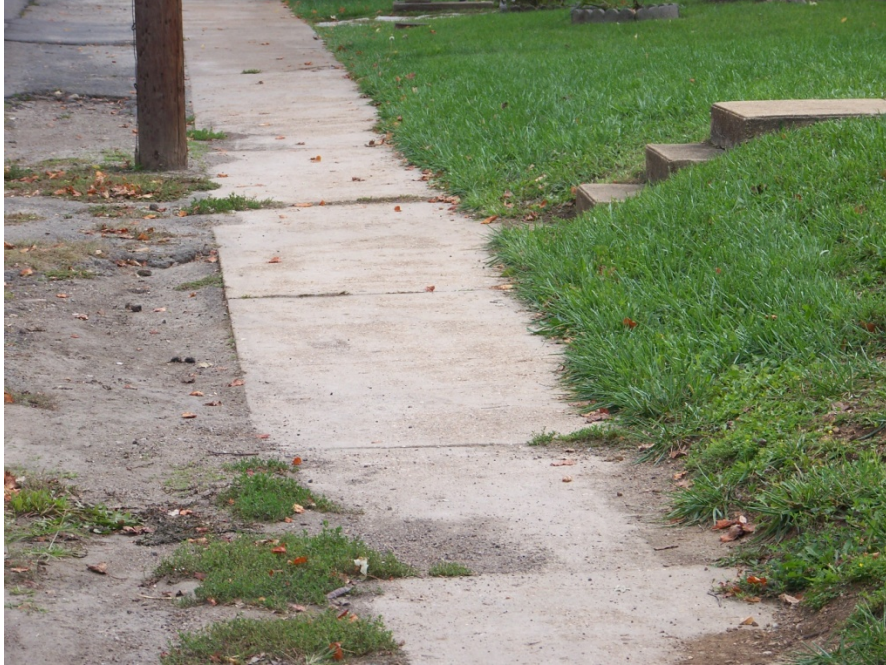
Fair Condition: E. Jefferson Street between S. Water Street and Mill Street, looking southeast

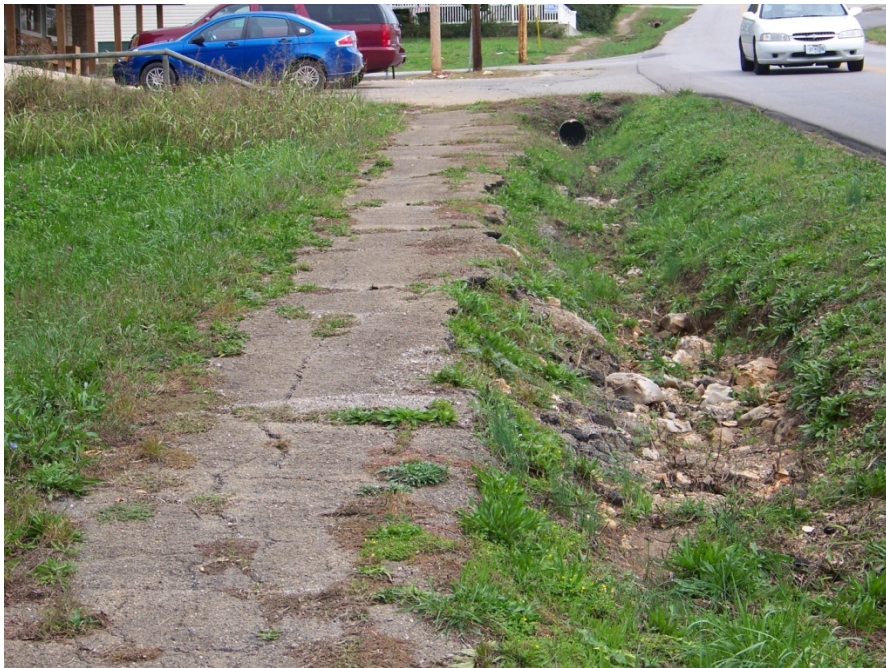
Poor Condition: N. Missouri Street between Rosemary Ave and Cordia Ave, looking northeast

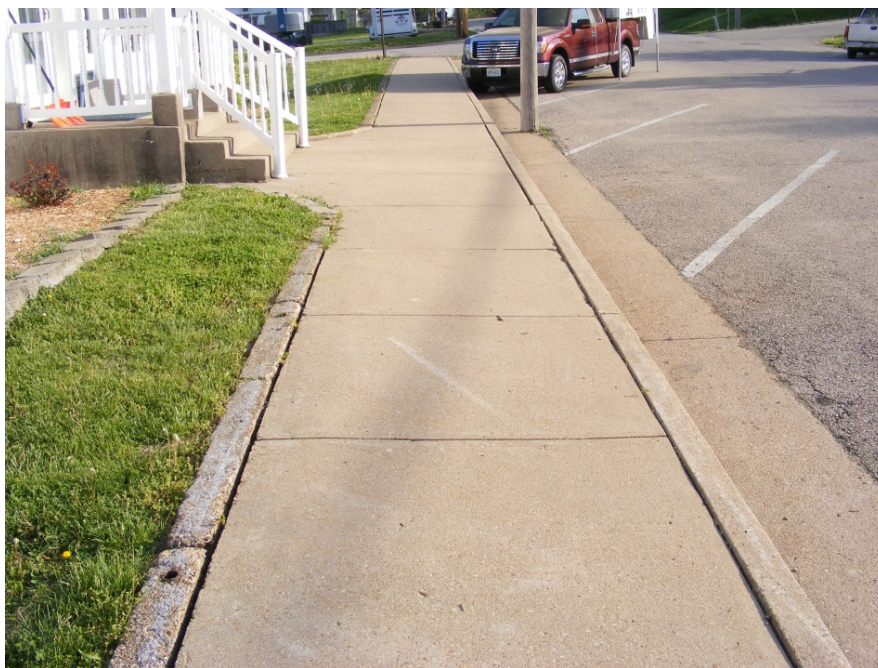
Good Condition: N. Main Street, west side looking north toward 6<sup>th</sup> Street

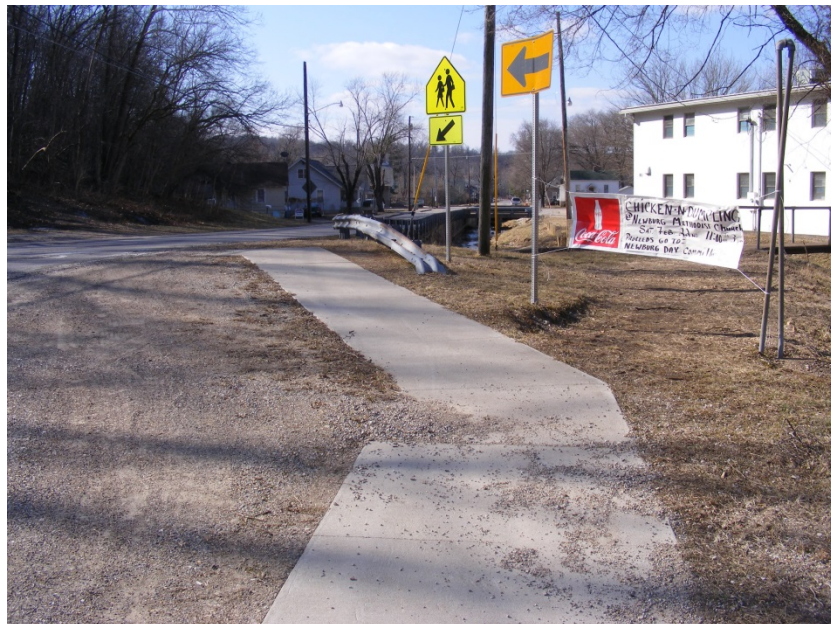
Good Condition: School crossing west side of Main Street (Highway T) near the intersection of Wolf Pride Drive

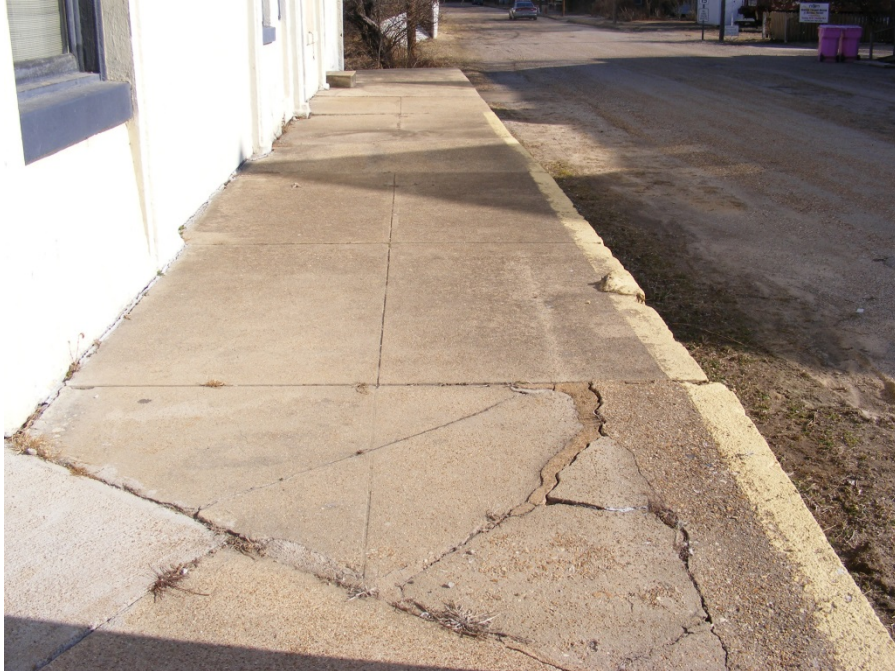
Fair Condition: N.W. corner of Front Street and Water Street, looking north
