## **Appendix E**

### **PHASE I: SIDEWALK SURVEY**

# City of Sullivan

## Sidewalk Inventory

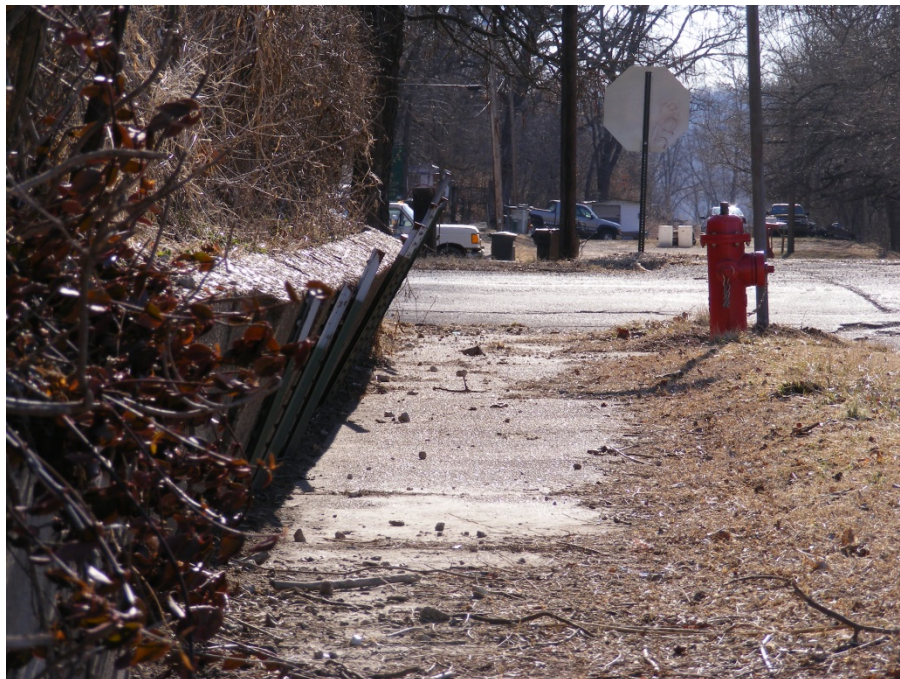
Poor Condition: N.W. corner of Front Street and Hollow Street, looking east

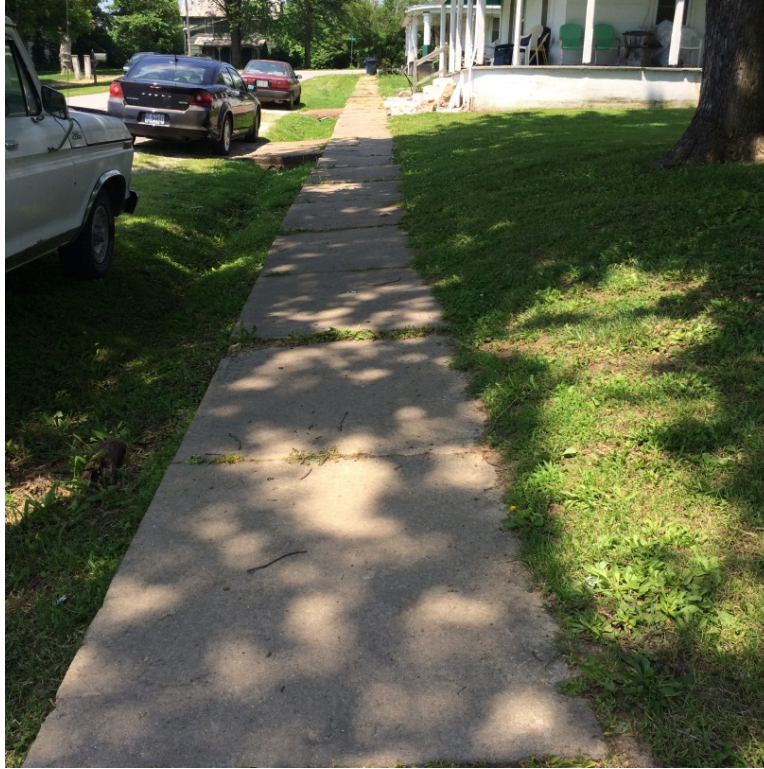
Fair Condition: West end of 5<sup>th</sup> Street

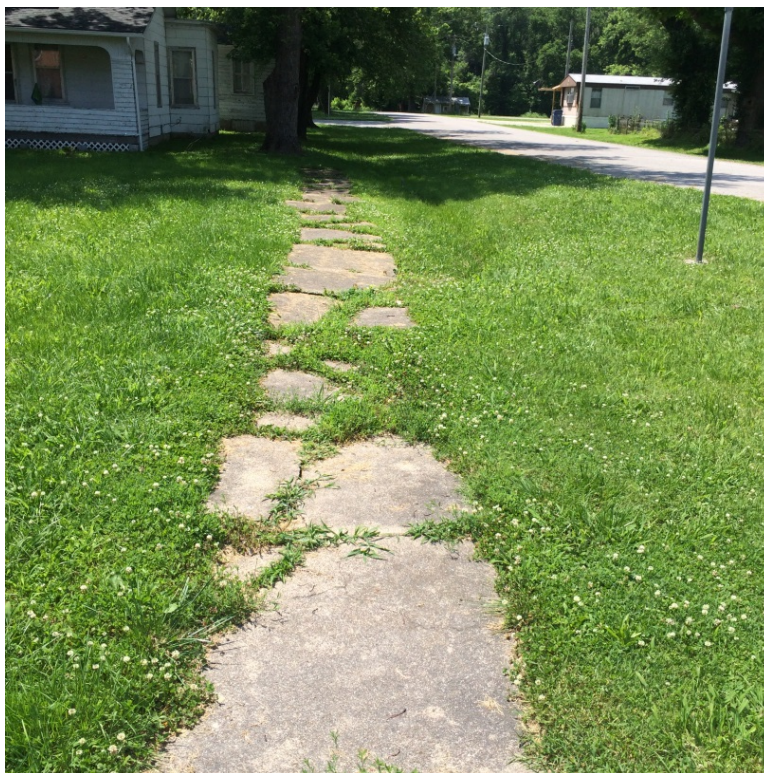
Poor Condition: Located at 2<sup>nd</sup> and Bertha streets.

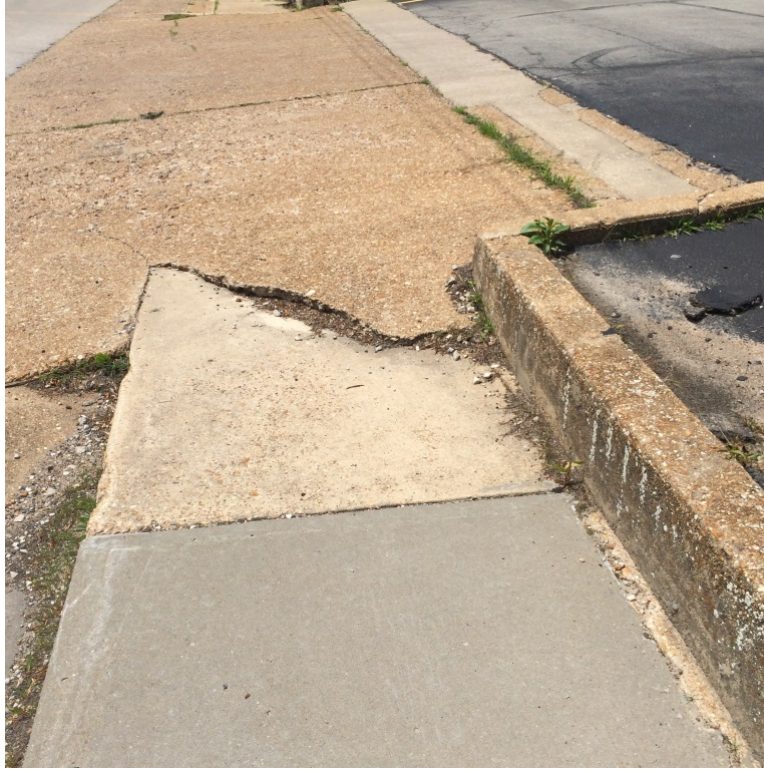
Fair Condition: East side of East Main close to downtown.

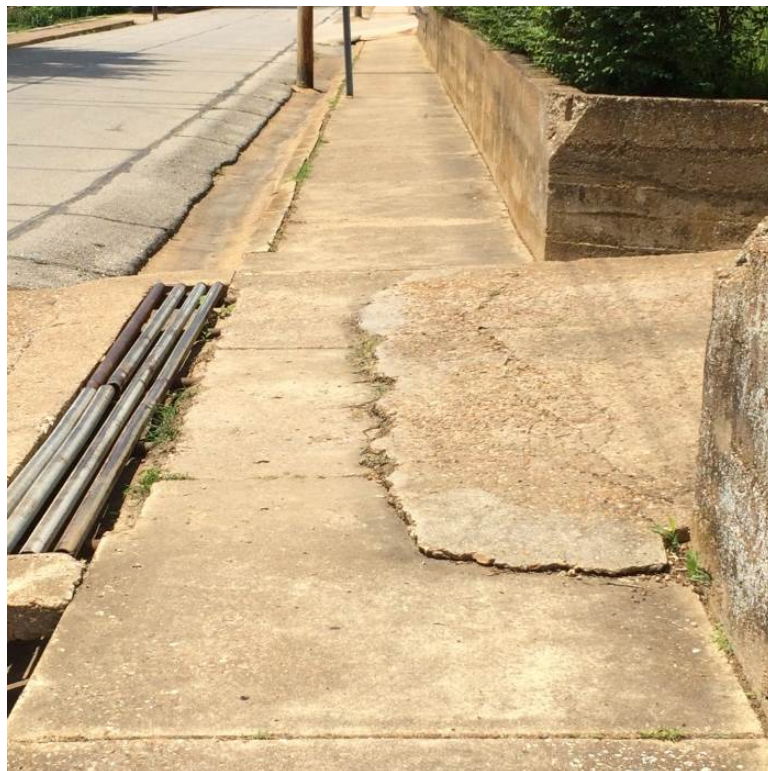
Poor Condition: East side of East Main close to downtown.
