Appendix E

PHASE I: SIDEWALK SURVEY

City of Sullivan

Sidewalk Inventory

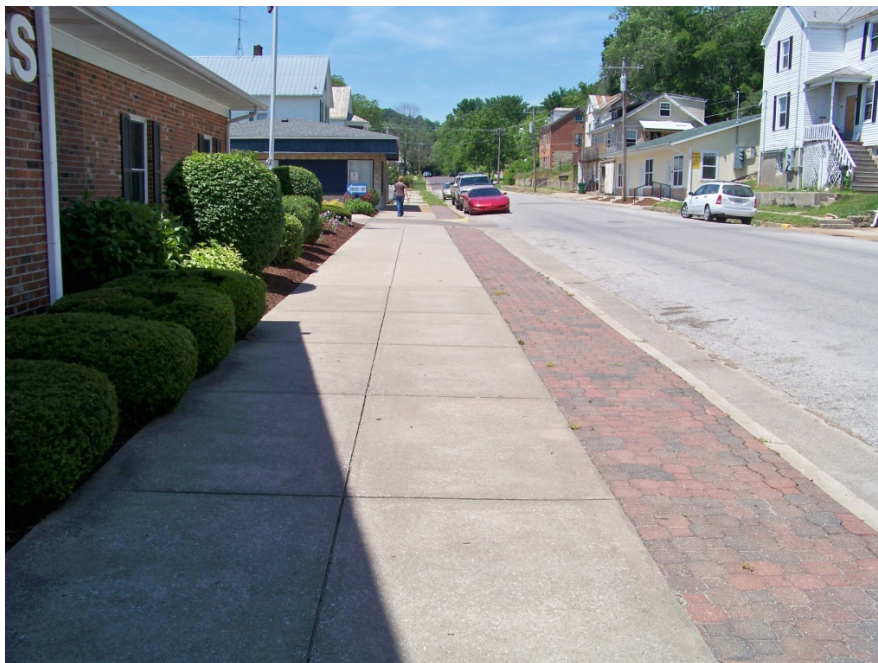
Good Condition: West Fifth Street, south side looking west

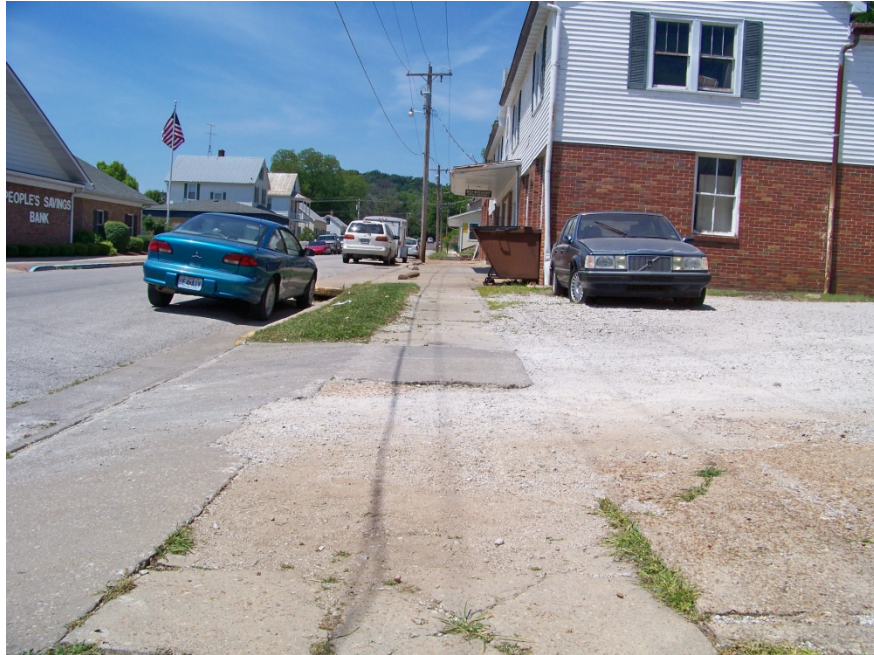
Fair Condition: West Fifth Street, north side looking west

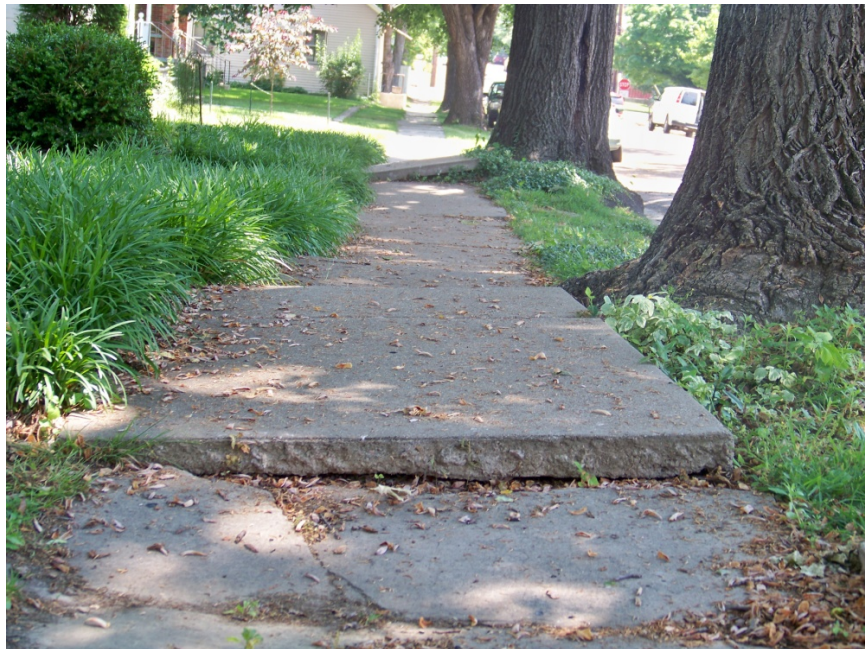
Poor Condition: West Third Street, north side looking east

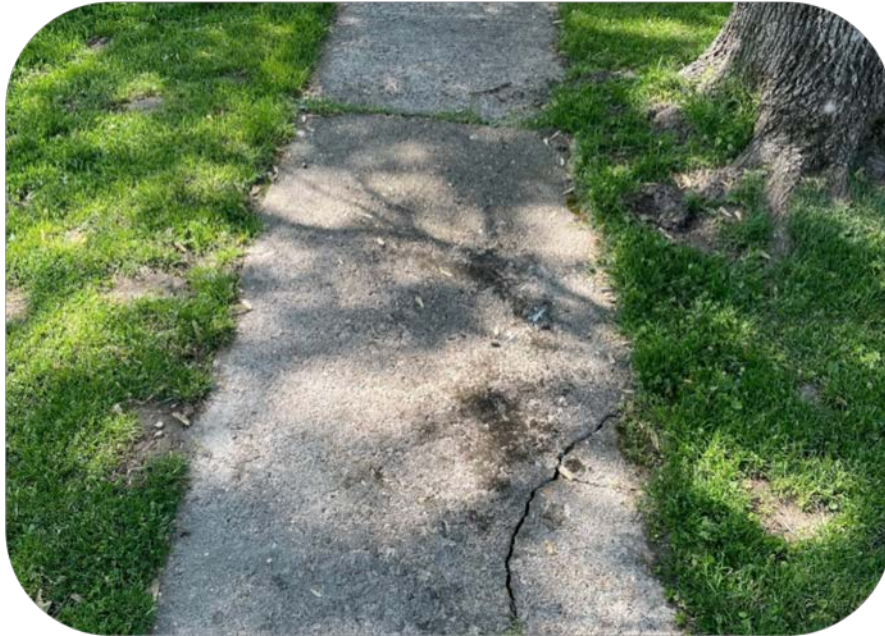
Fair Condition: Sidewalk along South side of Third St. looking west.

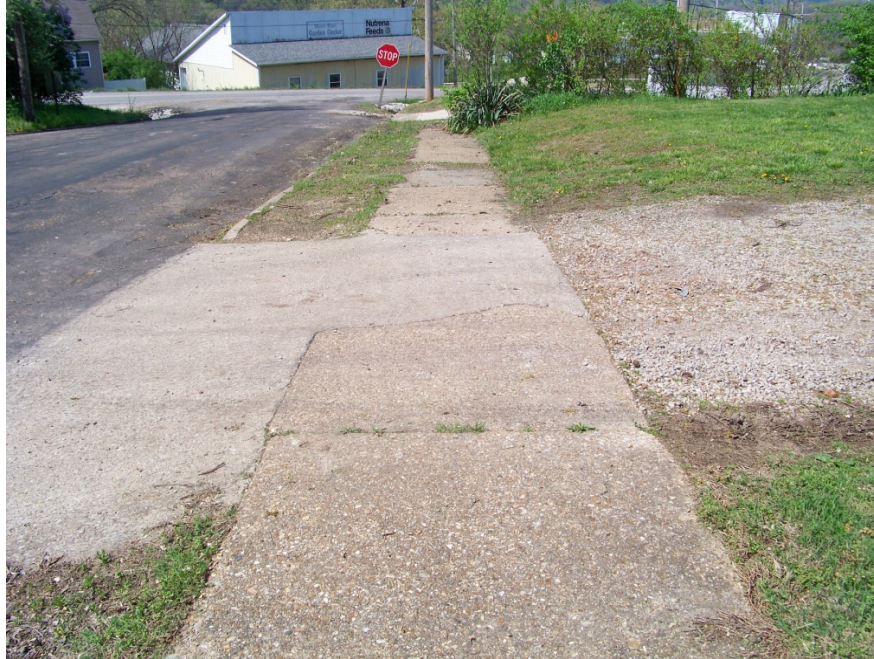
Fair Condition: Benton Street, north side looking west

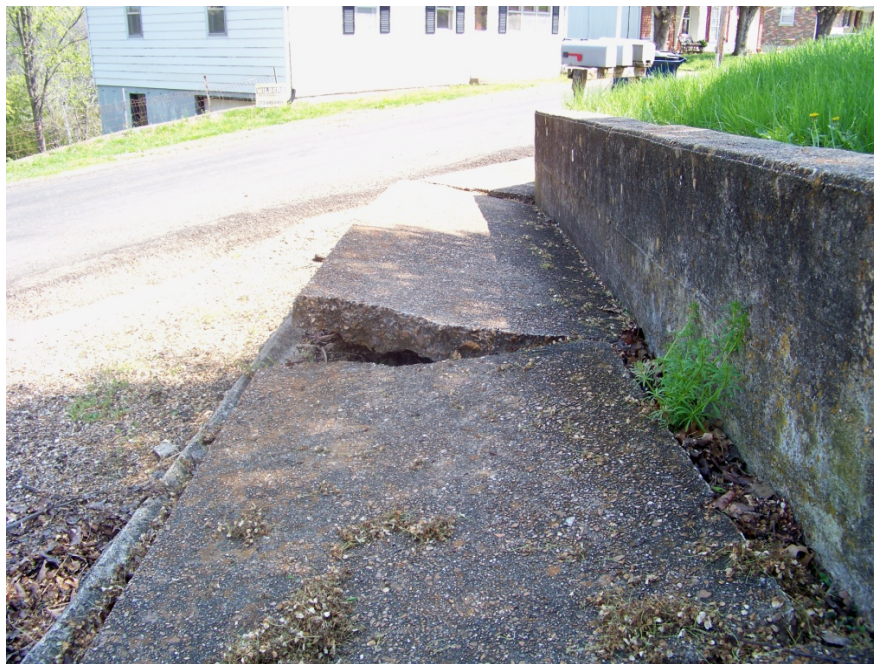
Poor Condition: Corner of Benton Street and Fifth Street, south side

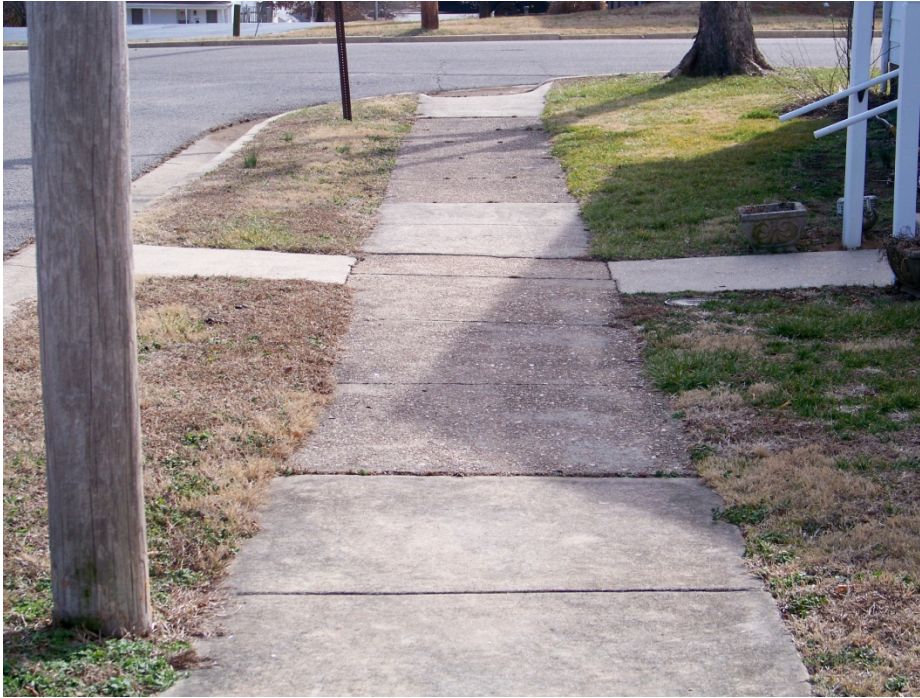
This sidewalk, in fair condition, is located on Cedar Street.

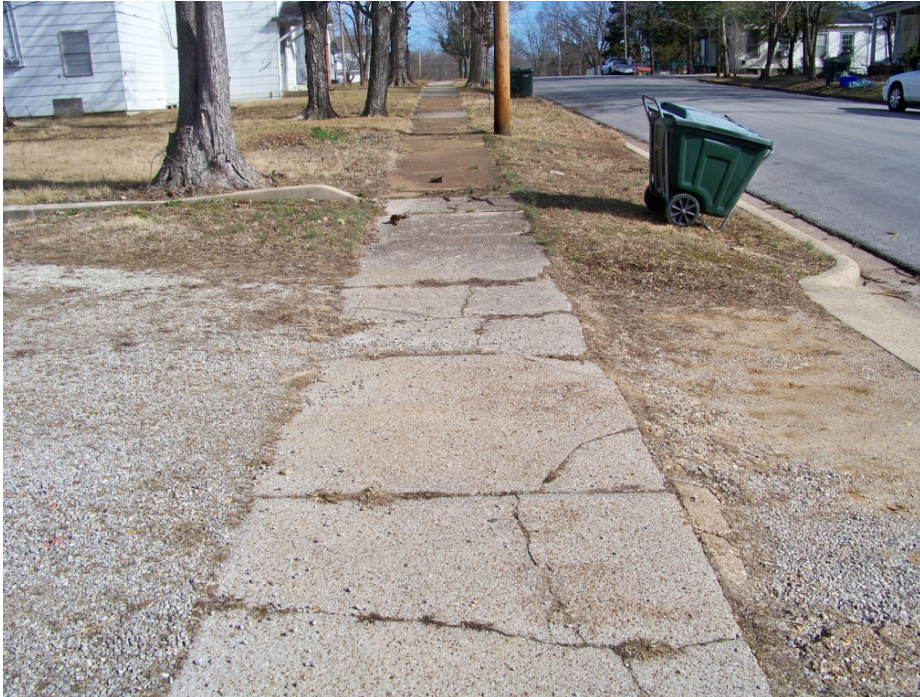
Sidewalks on portions of Olive Street are in poor condition.

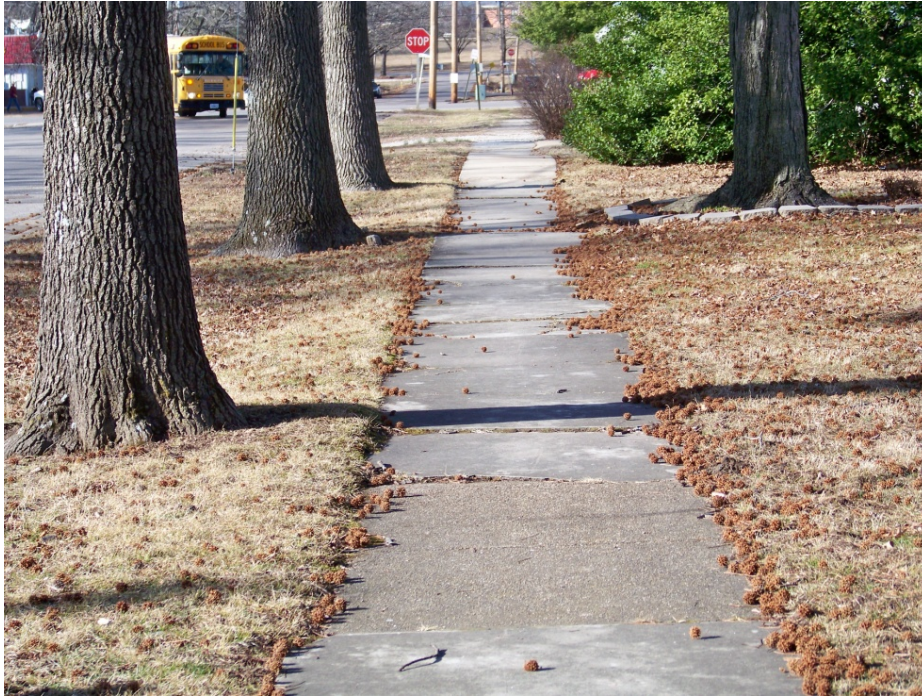
This sidewalk, in fair condition, is located on Seymour Street.

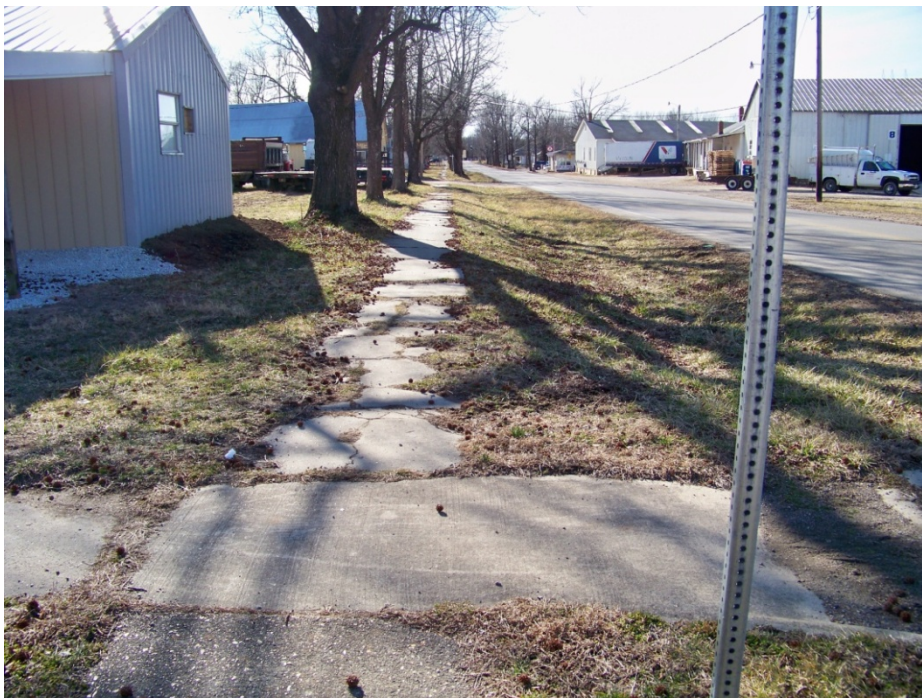
A large portion of the sidewalks in St. James are in poor condition, such as these along W. Washington Street.

The city is currently seeking to expand existing sidewalks into un-served areas as well as where gaps exist and repair poor condition sidewalks. Expansion/improvement is targeted for the following areas:

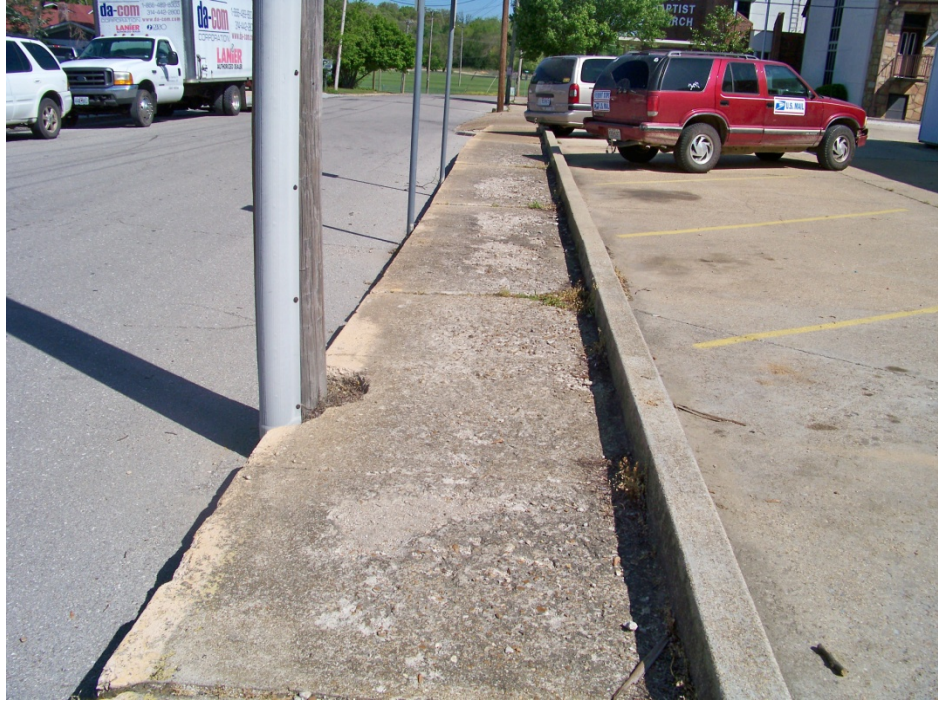
Fair Condition: North Benton Street, east side looking north

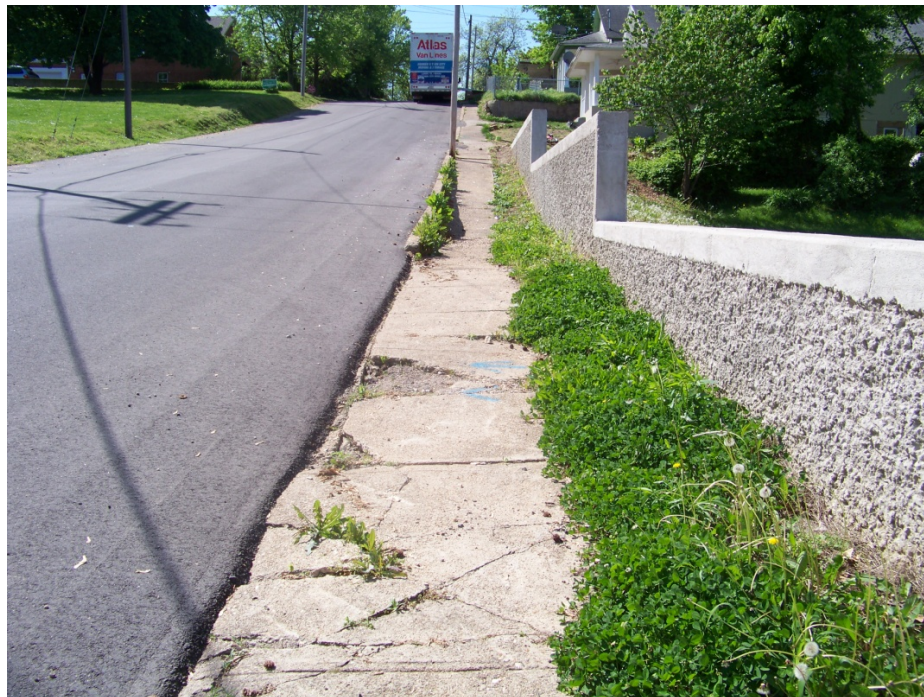
Poor Condition: South Benton Street, west side looking south

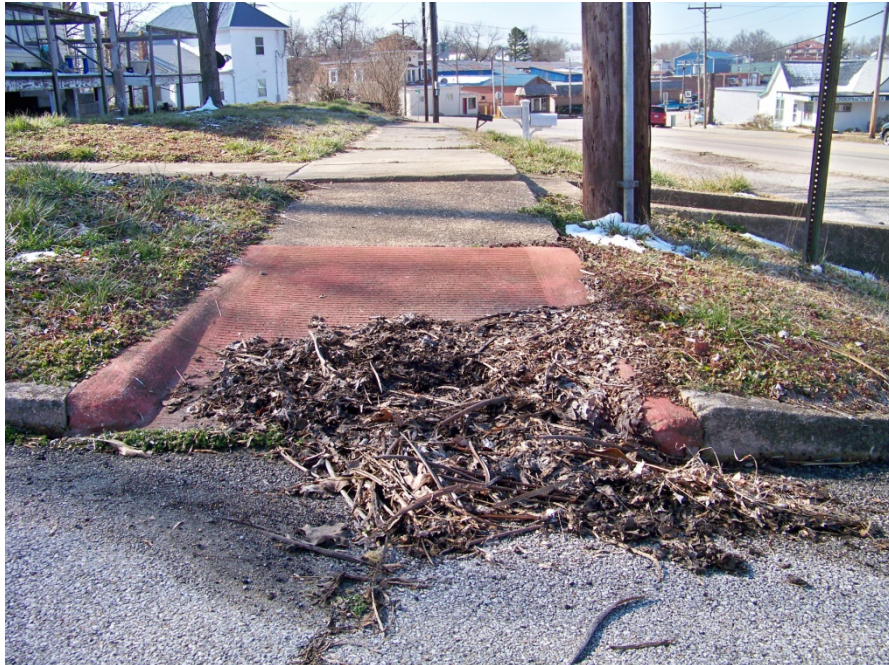
Fair Condition: Intersection E. Pine Street and Olive Street, southeast corner

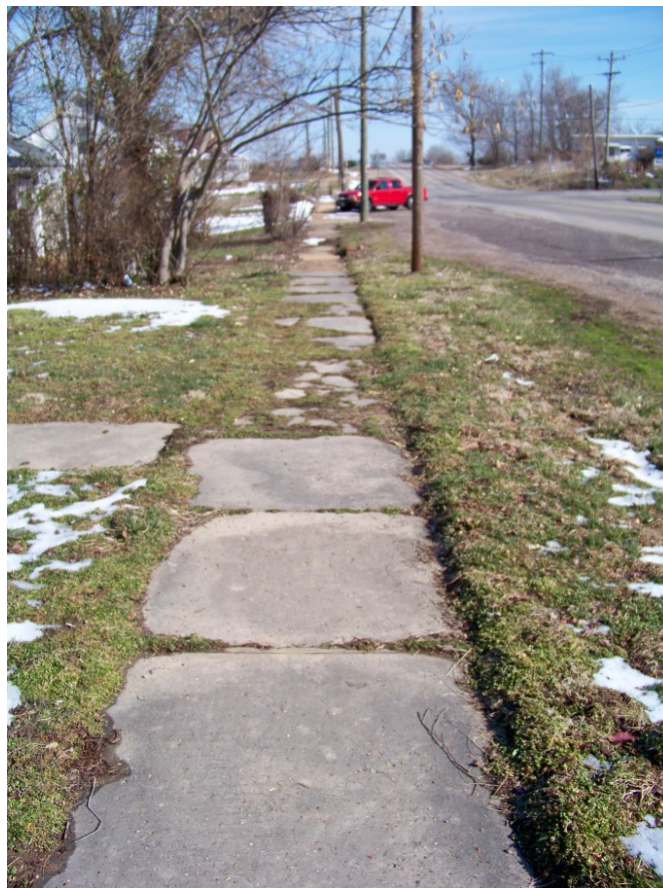
Poor Condition: E. Pine Street, west side looking north toward N. Old U.S. Highway 66

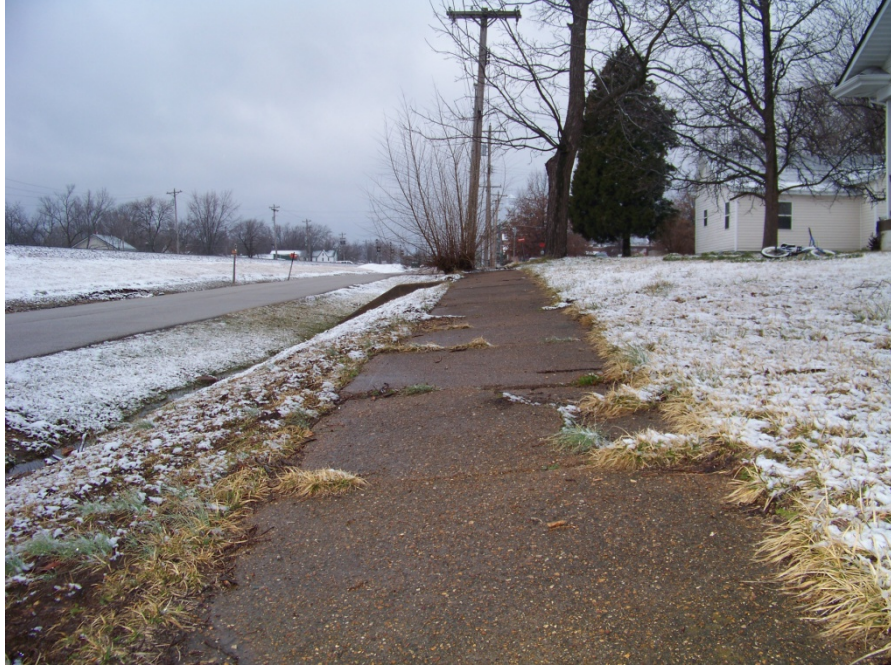
Fair Condition: West Main Ave, north side looking west

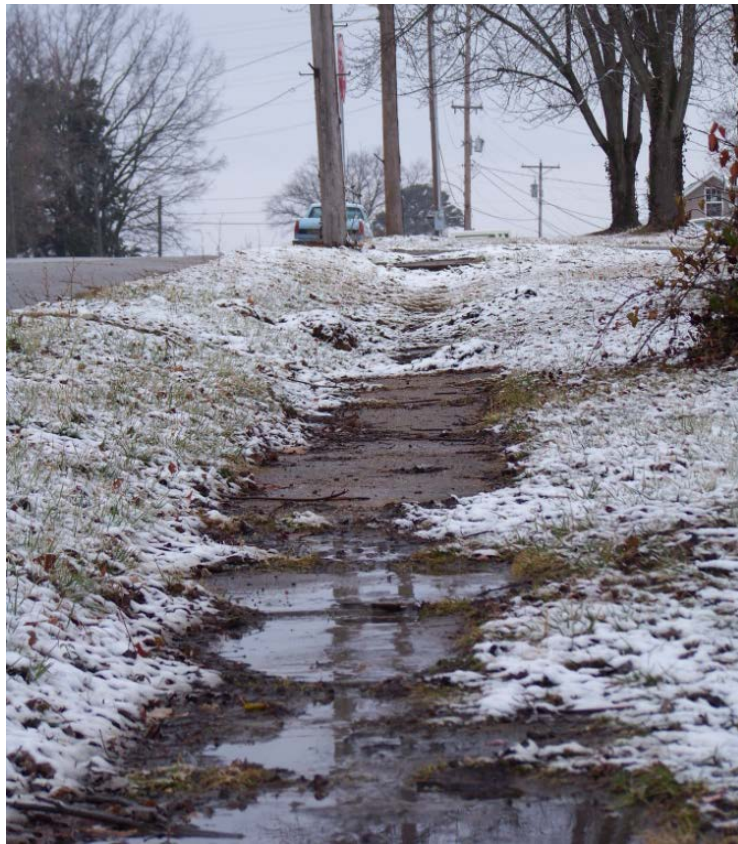
Poor Condition: Washington Blvd, north side looking west

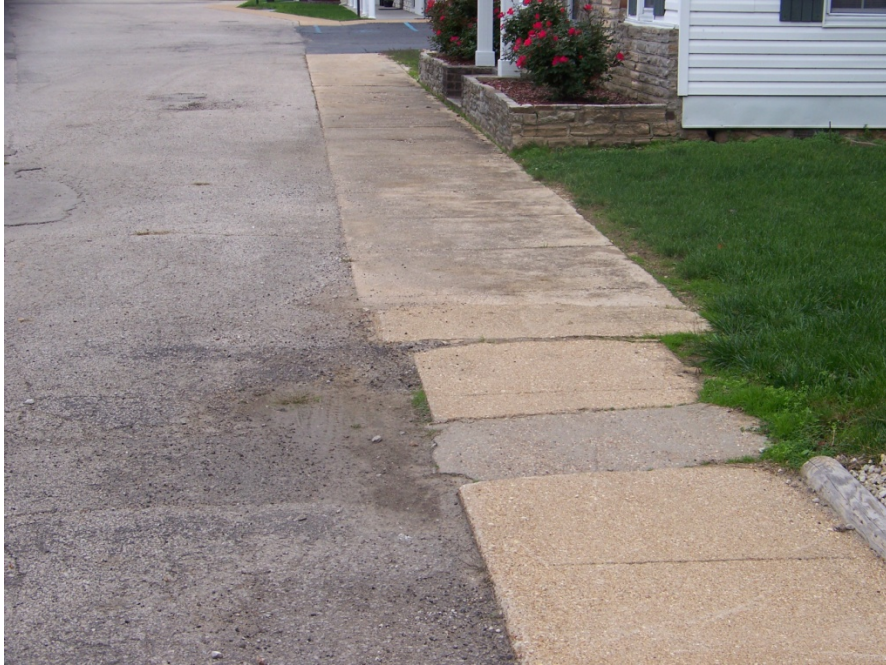
Fair Condition: Cedar Street, south side looking east from Hickory Street

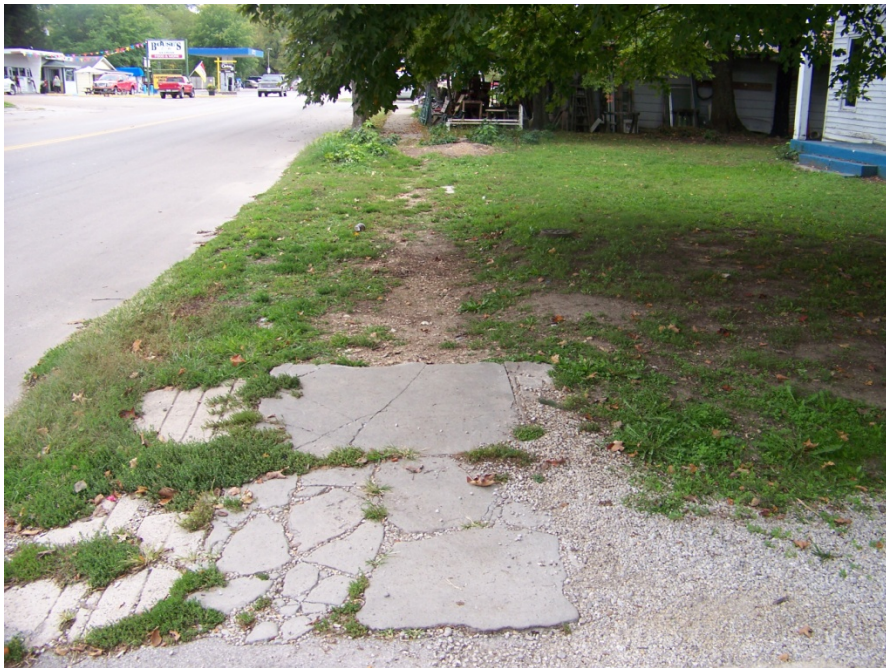
Poor Condition: Main Street, north side looking west toward S. Spring Street

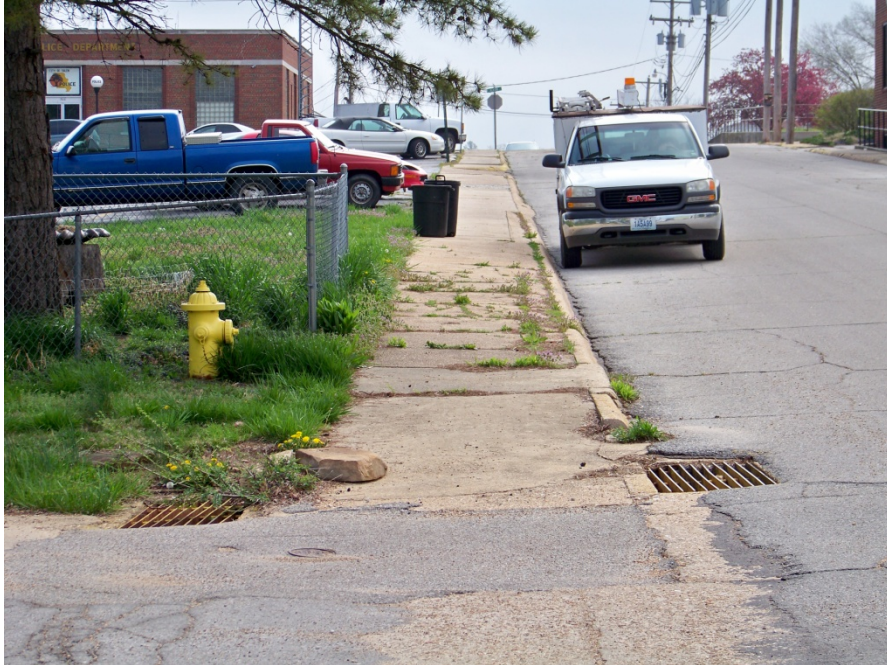
Fair Condition: Intersection of N. Henderson and 5th Street, north side looking west

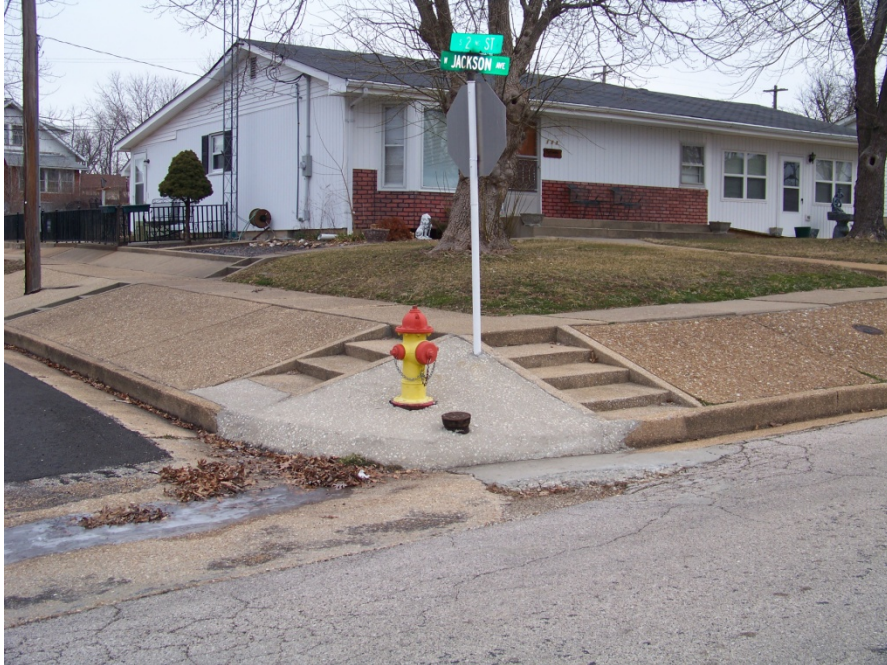
Fair Condition: Intersection of W. Jackson Avenue and S. 2nd Street, looking northeast

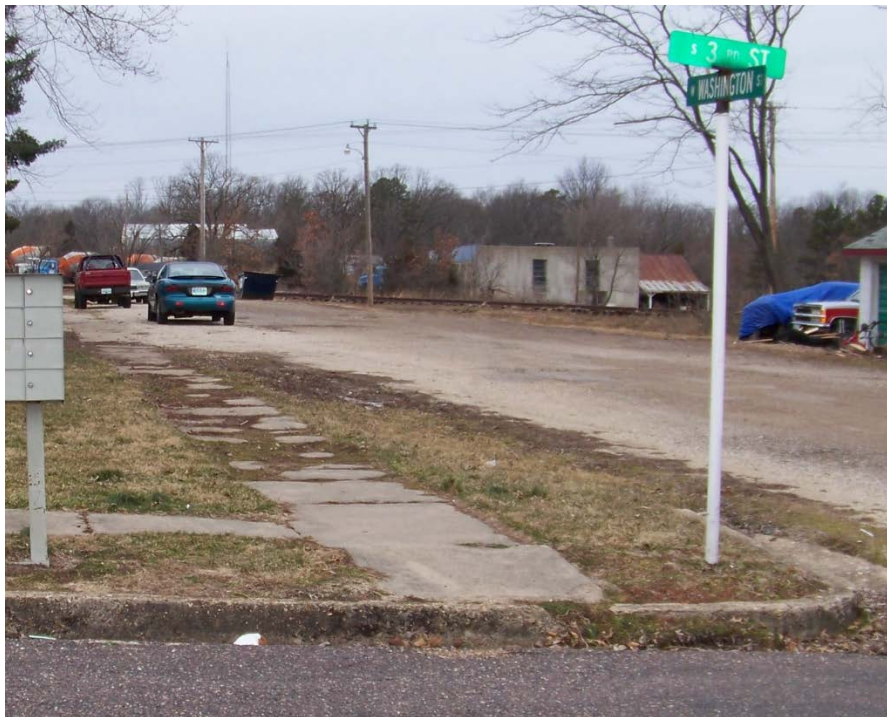
Poor Condition: W. Washington Avenue west of S. 3rd Street, south side looking west

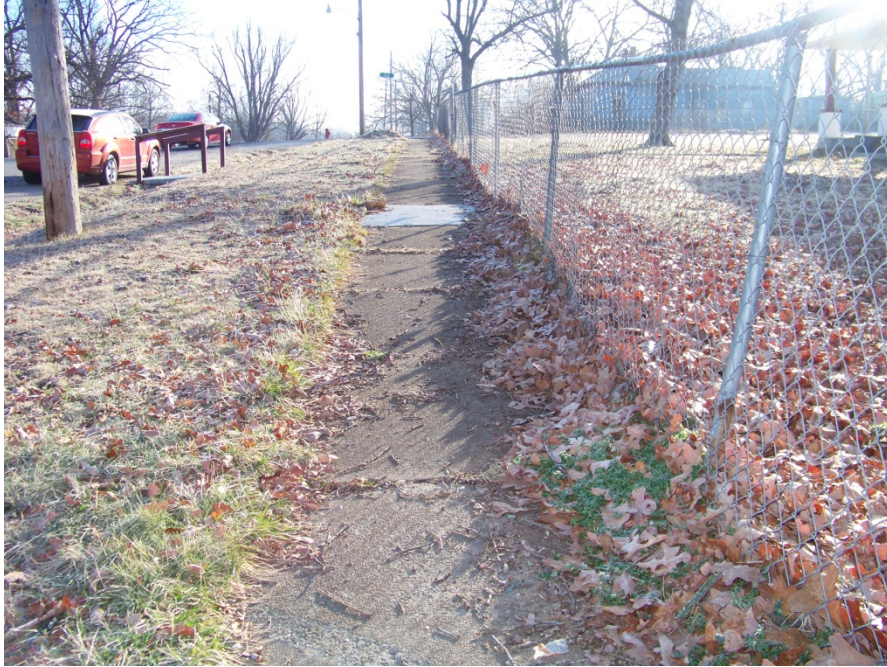
Fair Condition: E. 4th Street, south side looking east

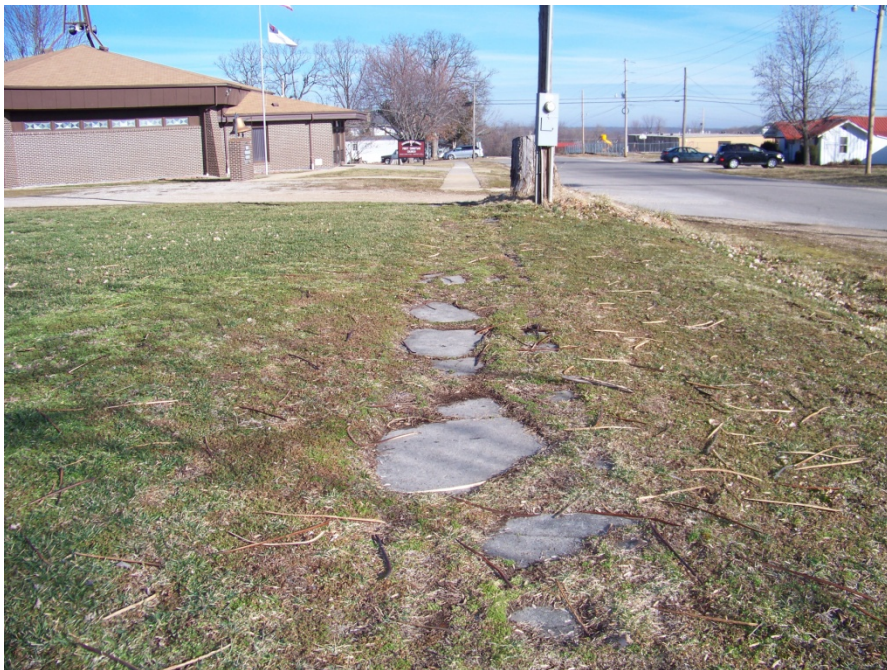
Poor Condition: S. Walnut Street, west side looking north

In the future, due to citizen interest, the city will seek to expand existing sidewalks by replacing sidewalks which are cracked, broken or narrow in the business district, parks and school areas. The jurisdiction does not have, but is considering the development of a comprehensive sidewalk plan. The motives for the city to have a comprehensive sidewalk plan are health/wellness and accessibility.

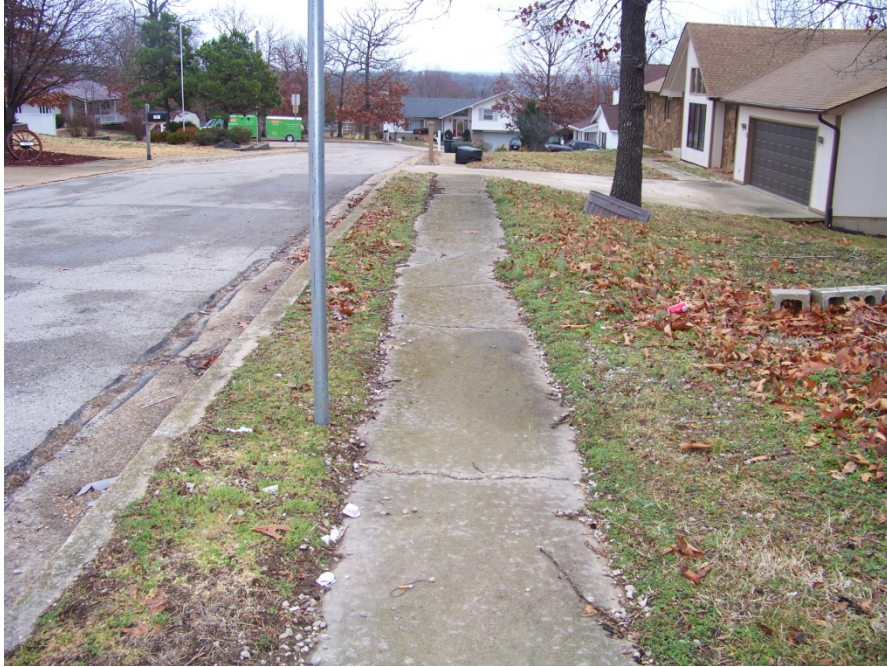
Fair Condition: Woodland Lane, south side looking east

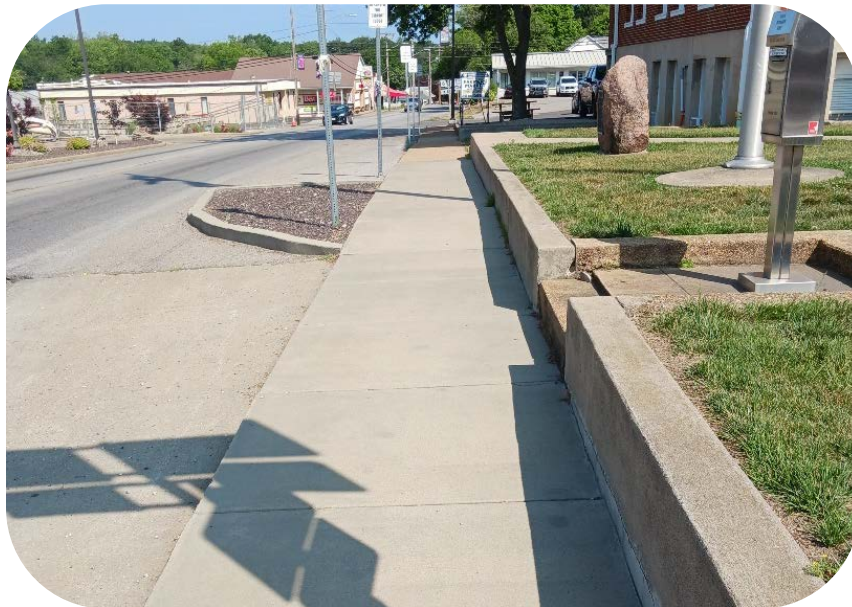
Good Condition: Sidewalk on north side of High Street looking northwest.

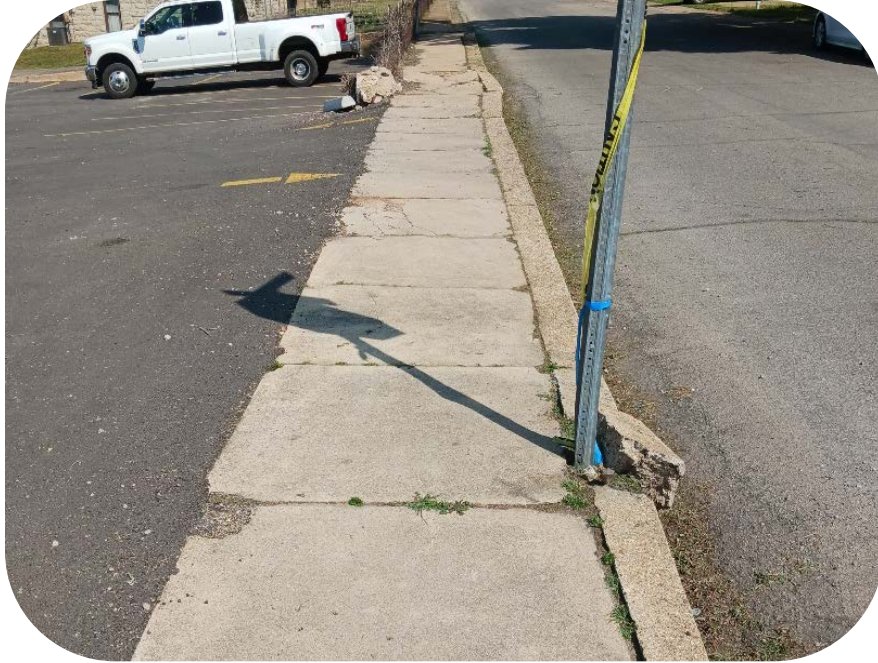
Fair Condition: Sidewalk along south side of Breton Street looking northwest.

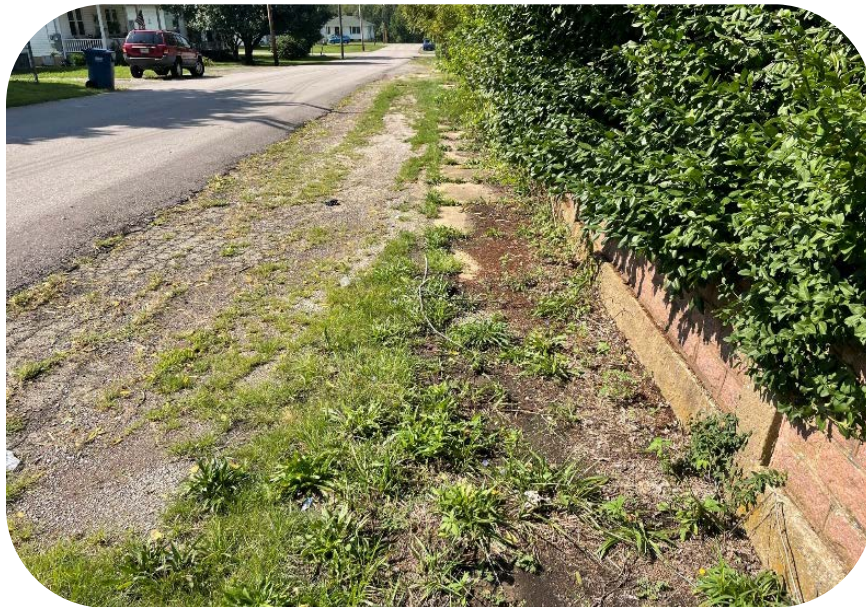
Poor Condition: Sidewalk along west side of Mineral Street looking south.

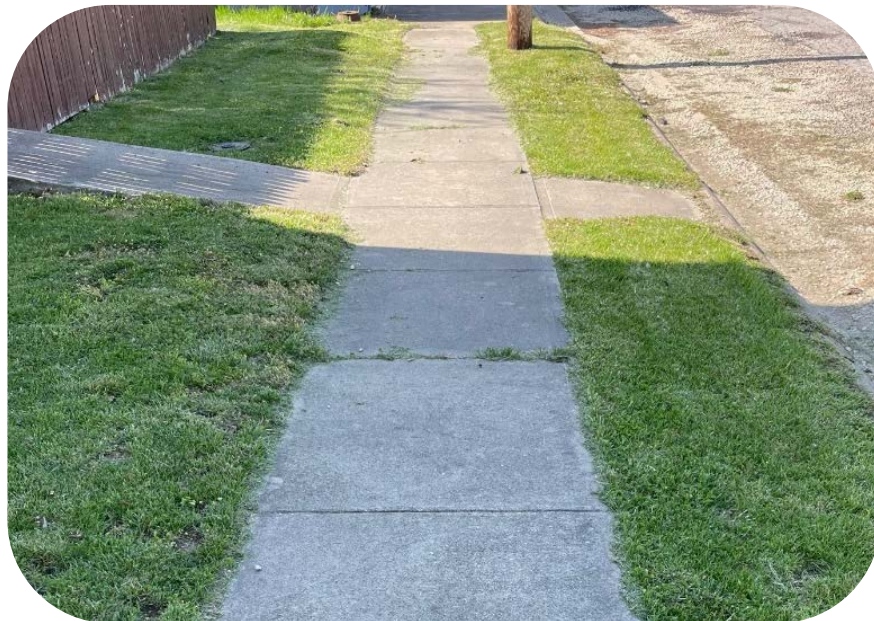
Good Condition: Sidewalk on west side of Main Street looking south.

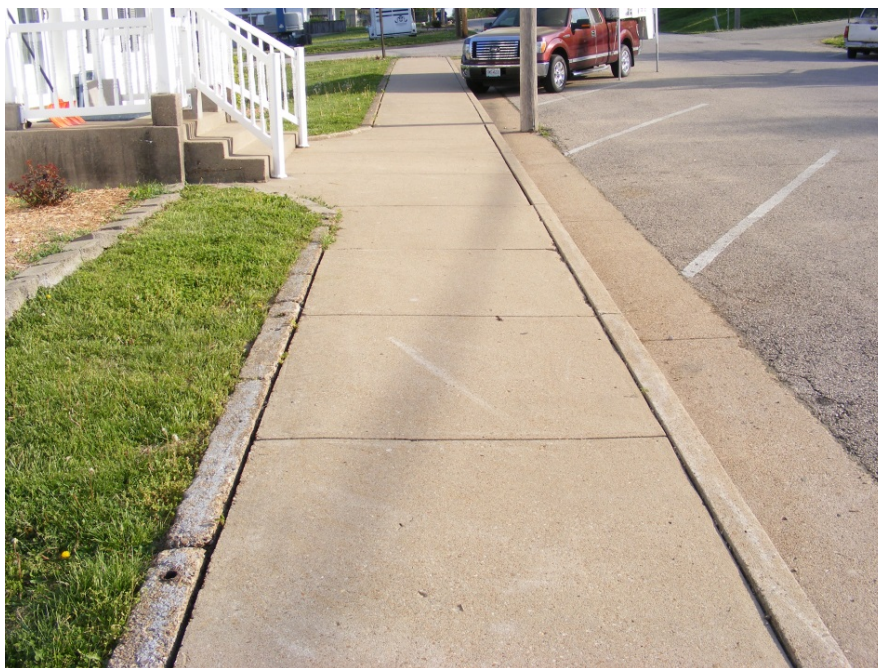
Good Condition: N. Main Street, west side looking north toward 6th Street

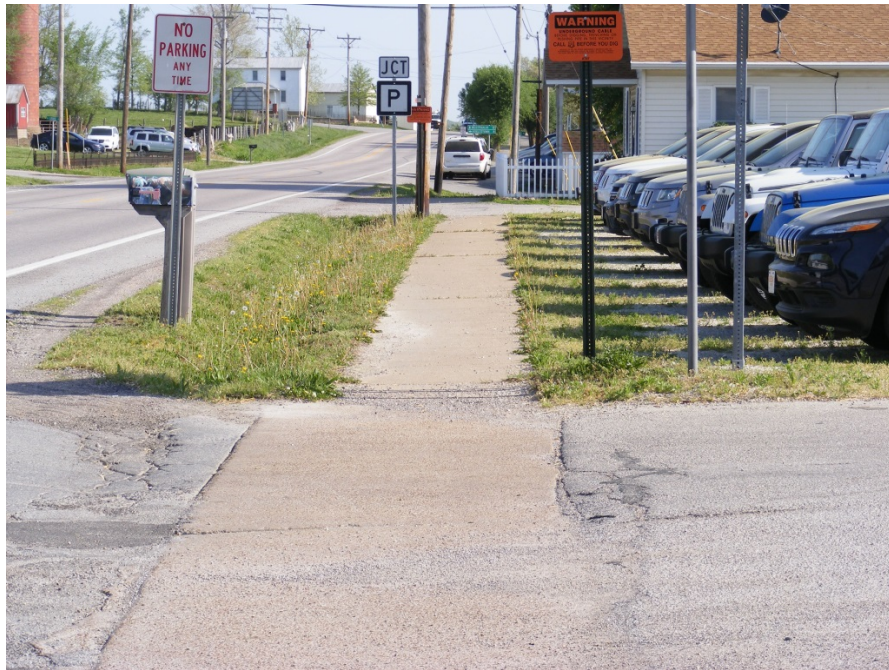
Fair Condition: Locust Street (Highway 63), west side looking north.

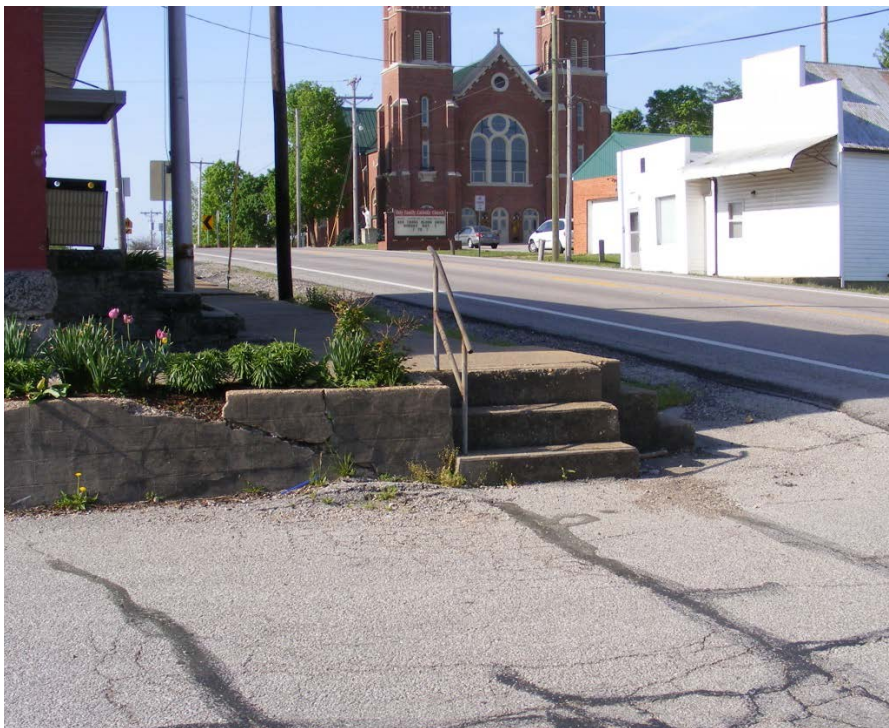
Poor Condition: Intersection of Locust Street (Highway 63) and Gilbert Avenue, southeast corner looking south.

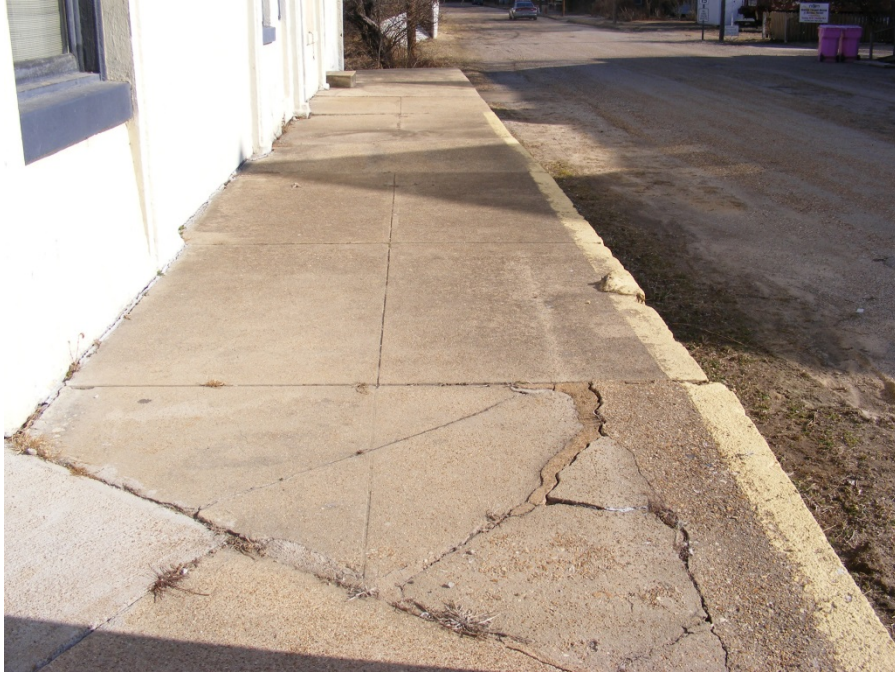
Fair Condition: N.W. corner of Front Street and Water Street, looking north

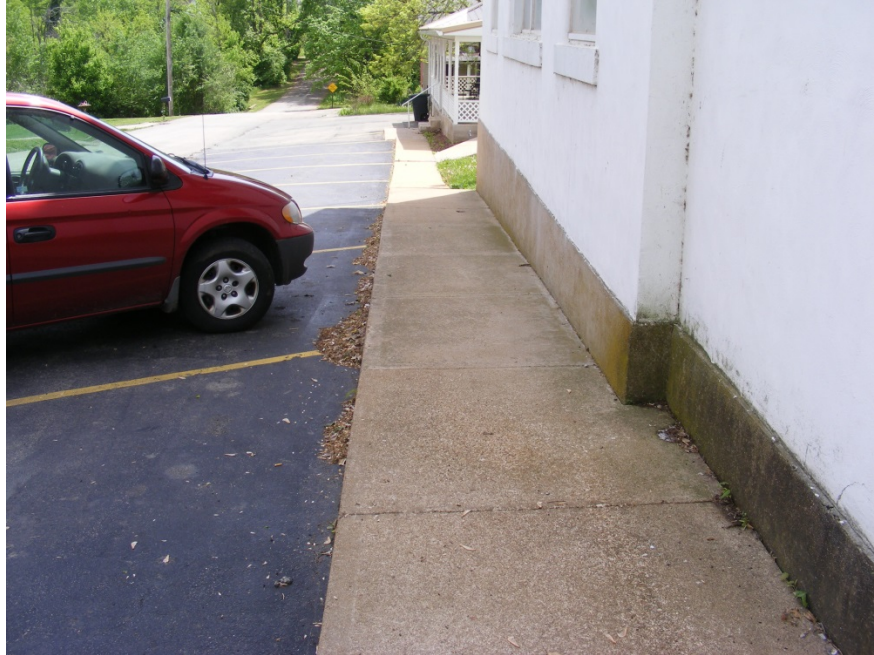
Fair Condition: Alexander Street, south side looking east toward College Street.

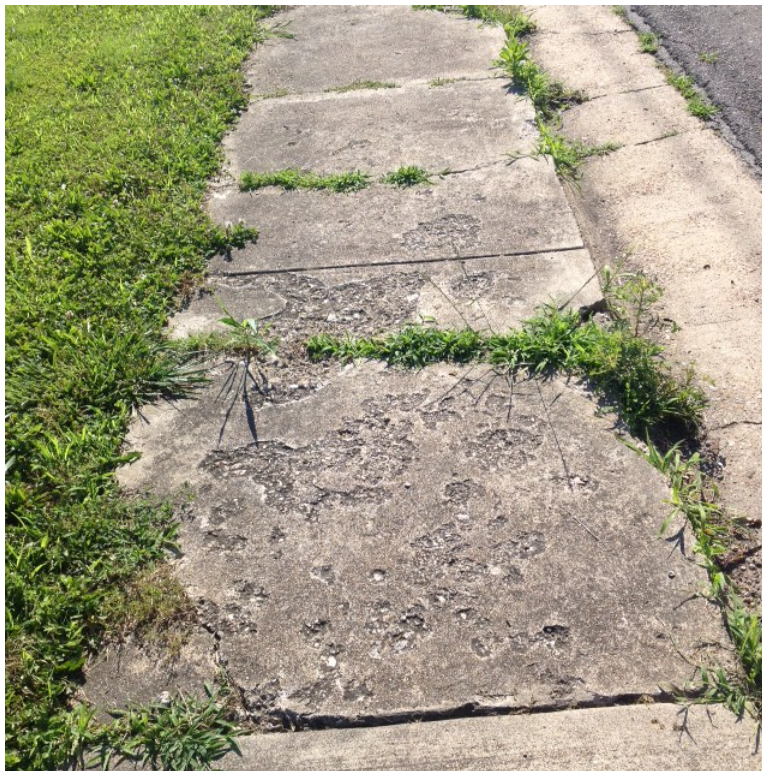
Poor Condition: South side of 2nd Street from Hwy. 532 to Pine Street.
