## Appendix E

### PHASE I: SIDEWALK SURVEY

# City of Sullivan Sidewalk Inventory

This inventory was completed in January 2012 by the city of Sullivan, with assistance from the Meramec Regional Planning Commission. Data for the map was gathered through a “windshield” survey and is only intended to be a general representation of sidewalk condition.

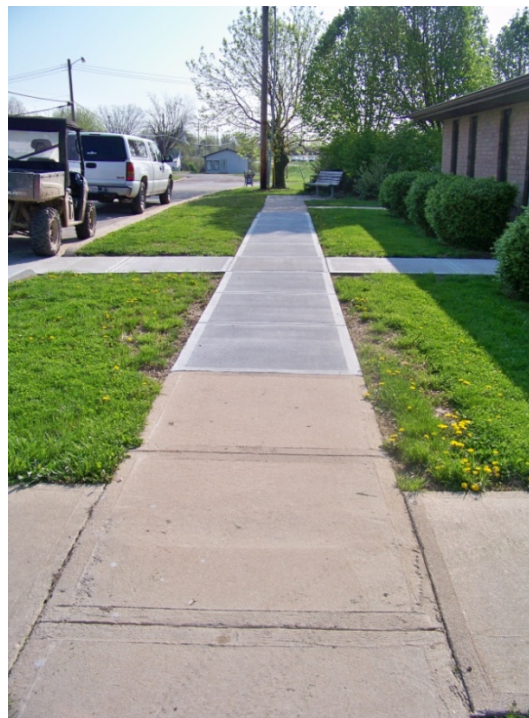
Good Condition:  
Third Street,  
south side  
looking east

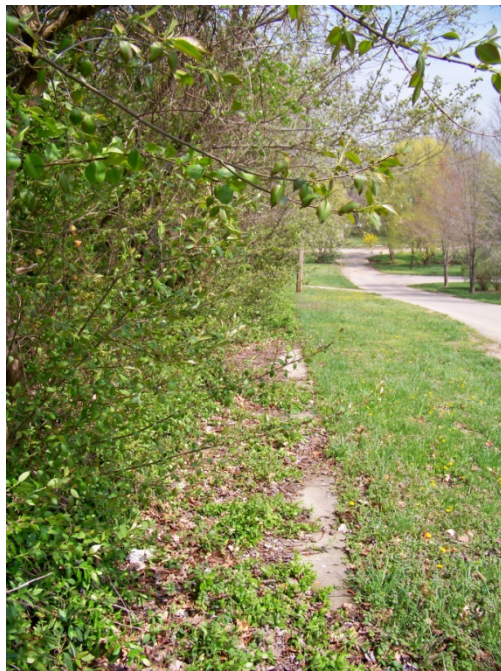
Poor Condition: N. Main Street, east side looking north (adjacent to historical marker)

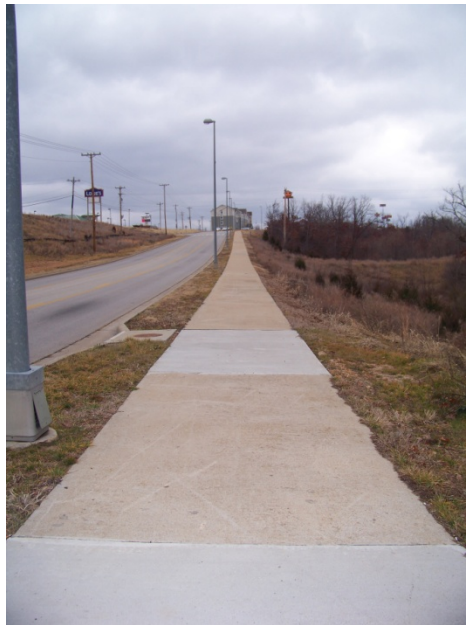
Good Condition: St. Robert Boulevard, south side looking east

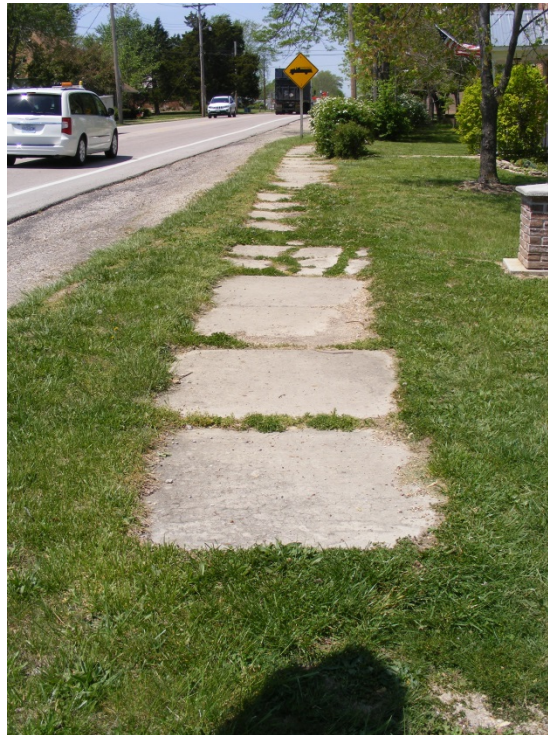
Poor Condition: Intersection of Highway 50 and 1<sup>st</sup> Street, northwest corner looking east.

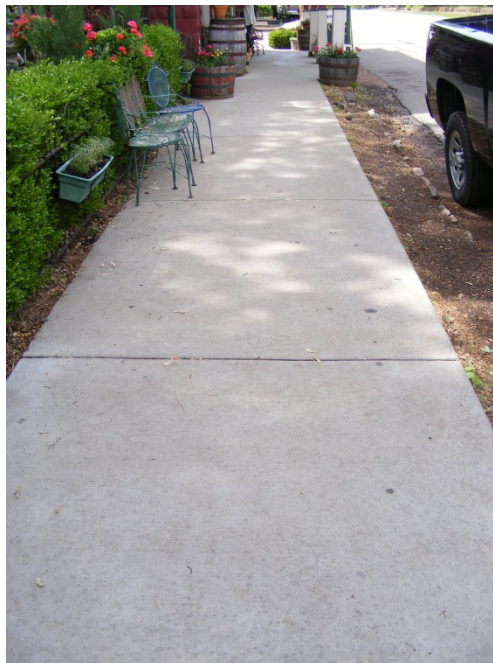
Good Condition: Main Avenue (Hwy 21), east side looking south toward Alexander Street.

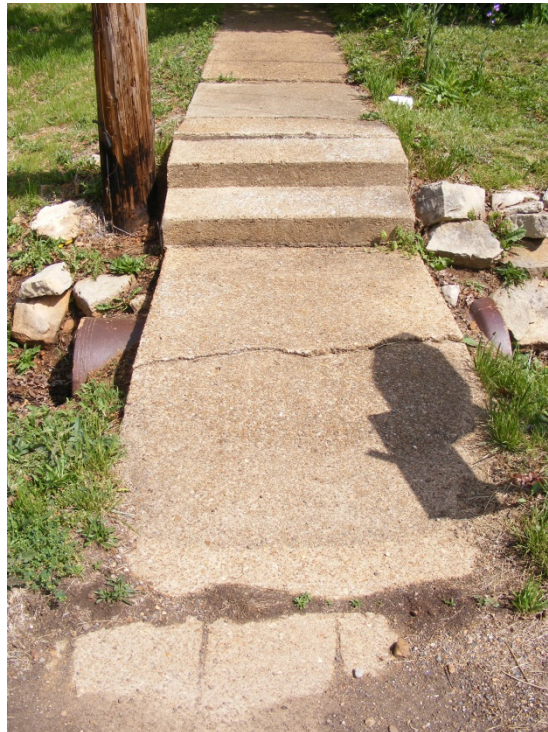
Poor Condition: Intersection of Ash Street and Linden Street, northeast corner looking north.
