## Appendix E

### PHASE I: SIDEWALK SURVEY

# City of Sullivan Sidewalk Inventory

This inventory was completed in January 2012 by the city of Sullivan, with assistance from the Meramec Regional Planning Commission. Data for the map was gathered through a “windshield” survey and is only intended to be a general representation of sidewalk condition.

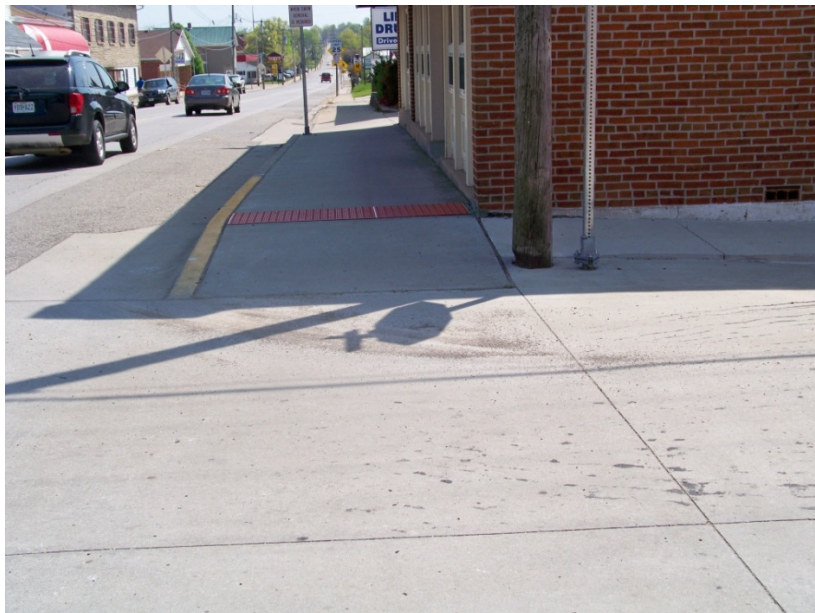
Good Condition: Corner of U.S. Hwy 50 (Main) and Third Street, south side looking east

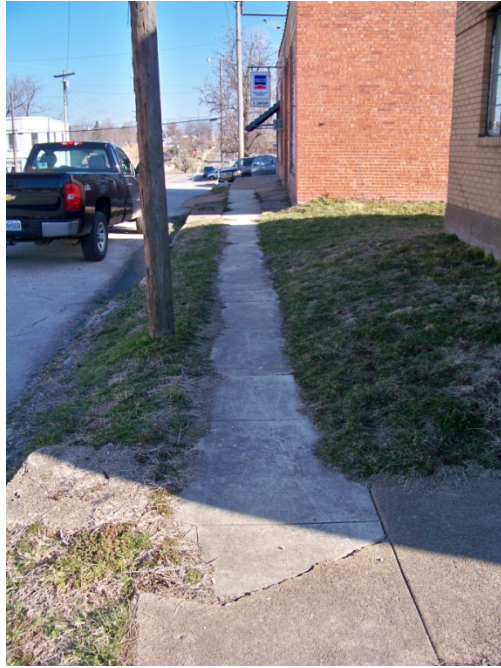
Fair Condition: North Commercial Street, east side looking north

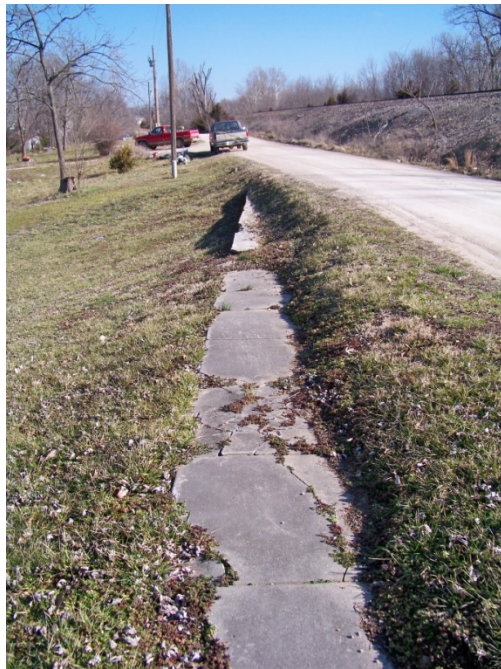
Poor Condition: Eastside Street, west side looking north

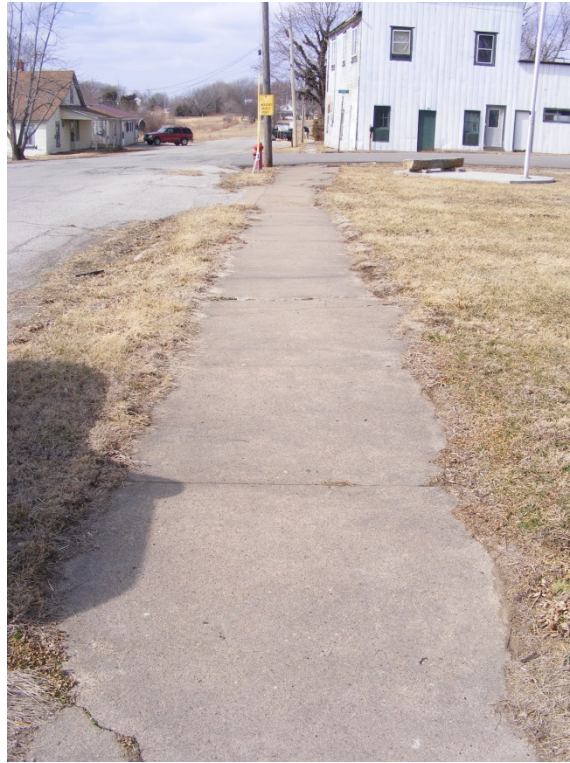
Fair Condition: North side of W. Colorado Ave., looking west to Frost Street

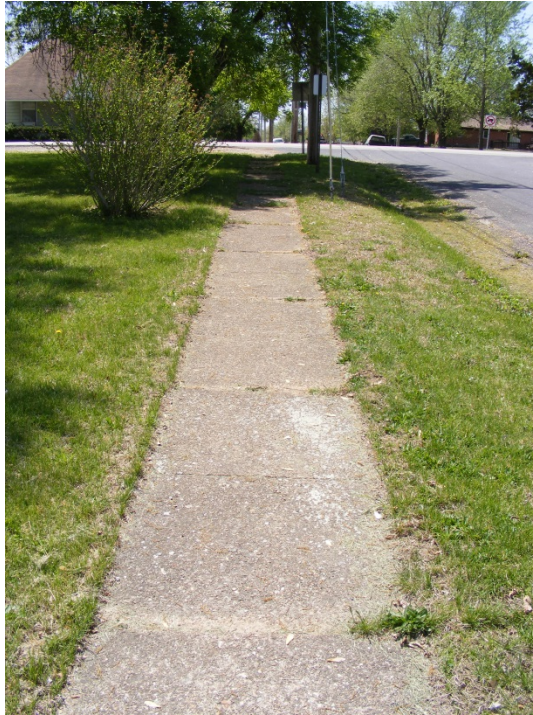
Fair Condition: Cedar Street, east side looking south toward Highway 50.

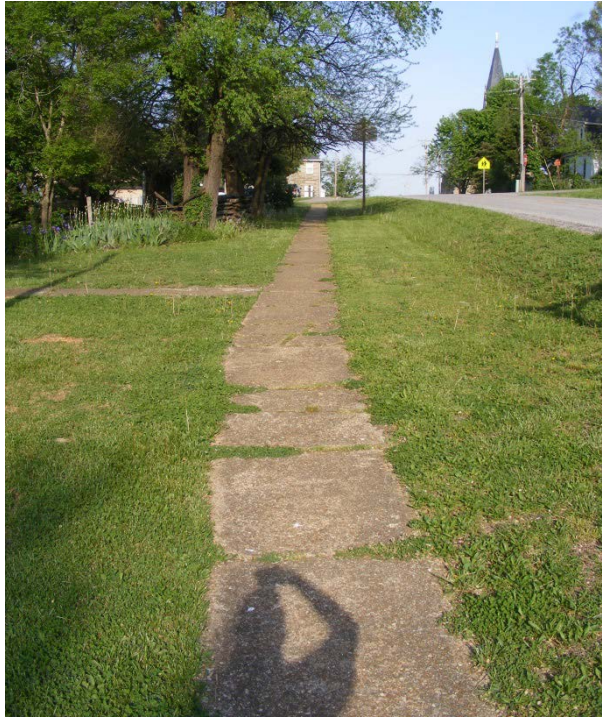
Fair Condition: 5<sup>th</sup> Street, south side looking west

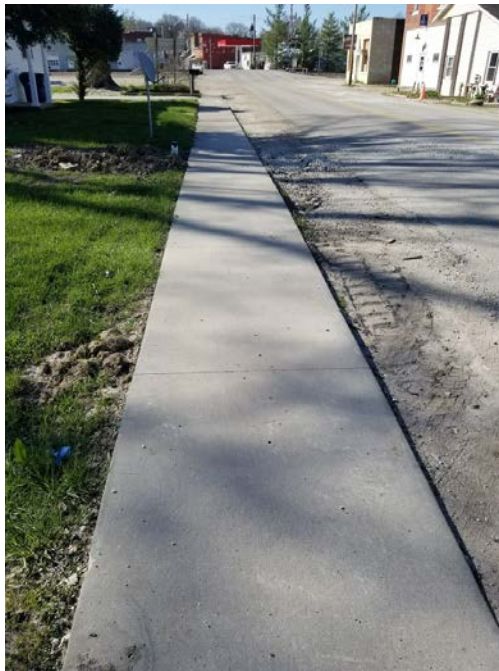
Good Condition: Main Street, east side looking south towards railroad tracks.

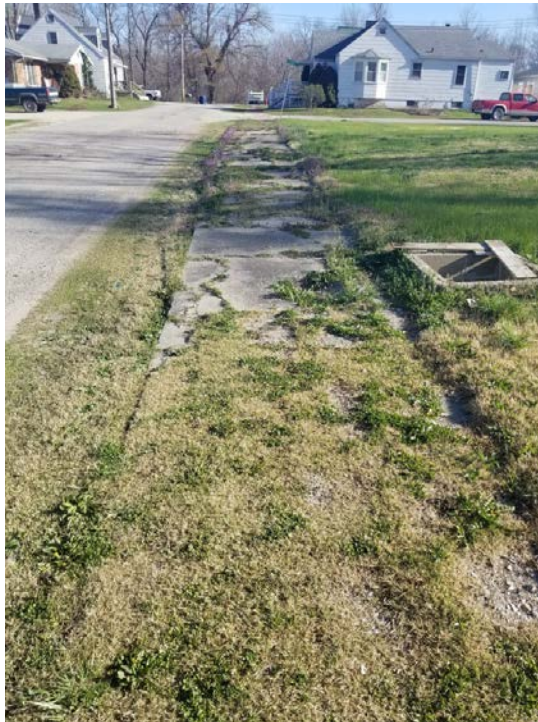
Poor Condition: Main Street, north of Missouri Avenue looking north.

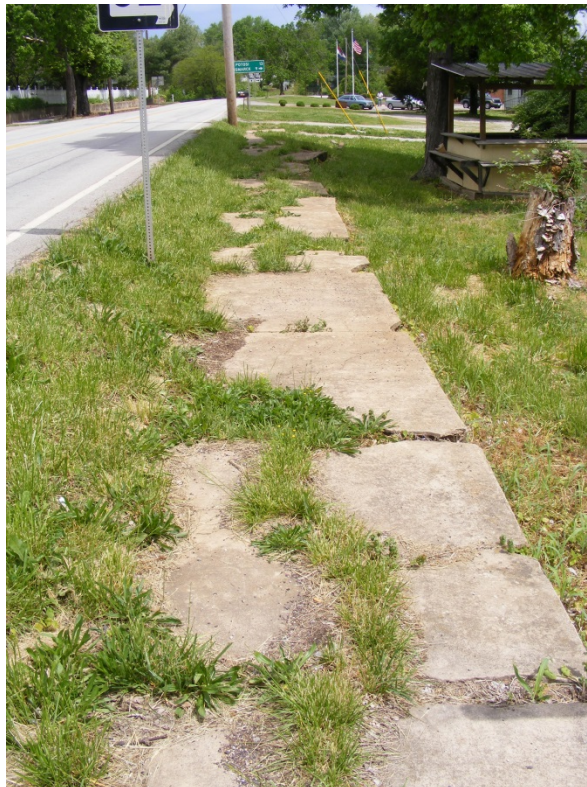
Poor Condition: Main Avenue (Hwy 21), west side looking north.

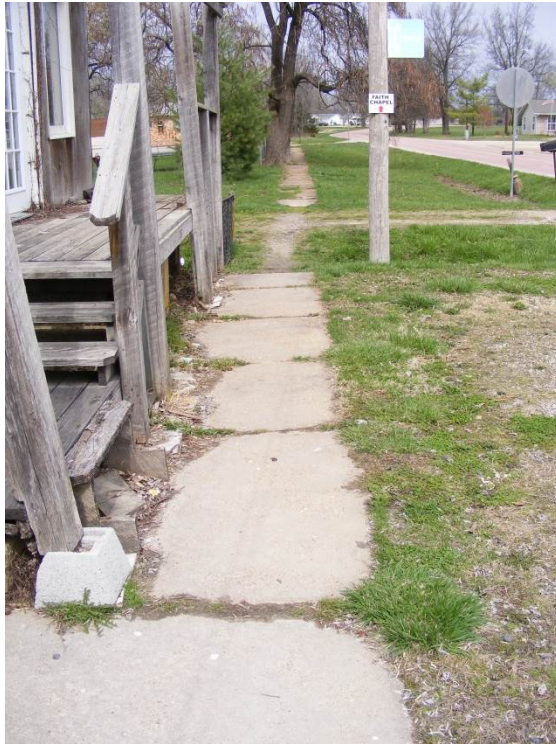
Fair Condition: Intersection of Springfield Avenue and Second Street looking northwest.

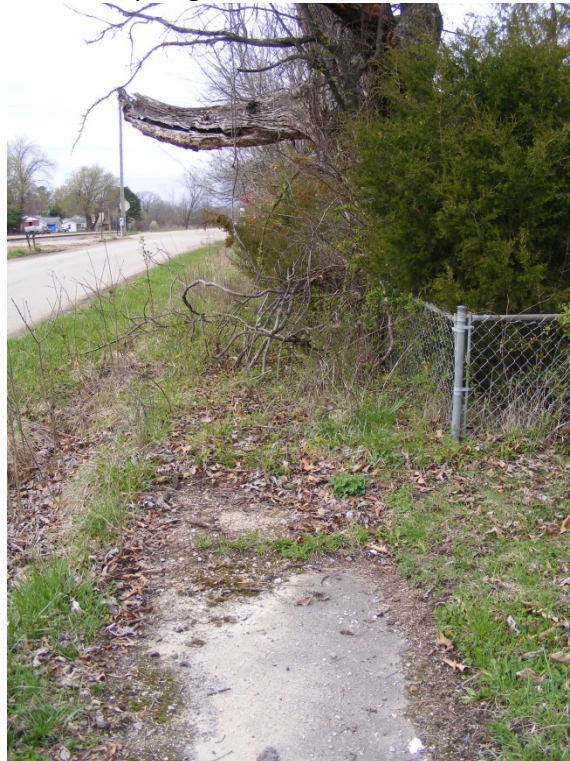
Poor Condition: North side of E. Springfield Avenue looking southwest.

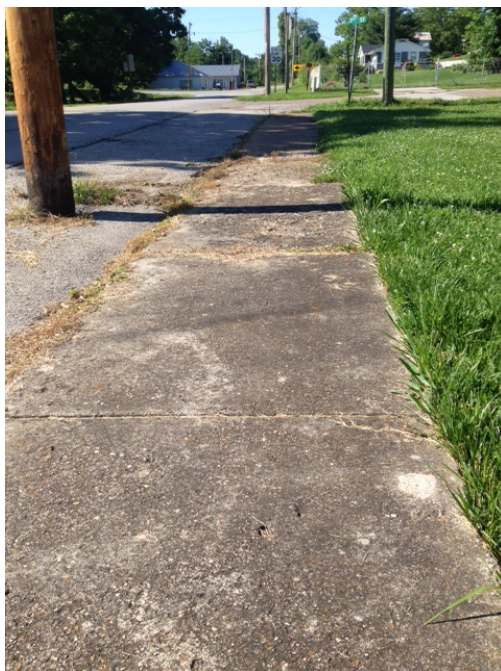
Fair Condition: East side of Hwy. 532 from 2<sup>nd</sup> to 3<sup>rd</sup> Streets.

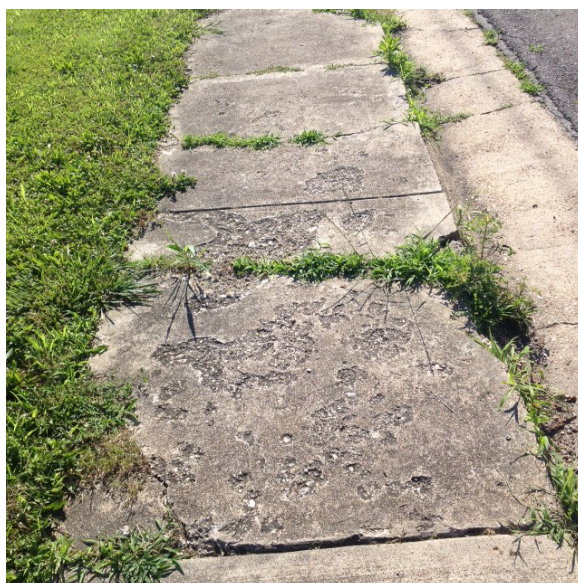
Poor Condition: South side of 2<sup>nd</sup> Street from Hwy. 532 to Pine Street.

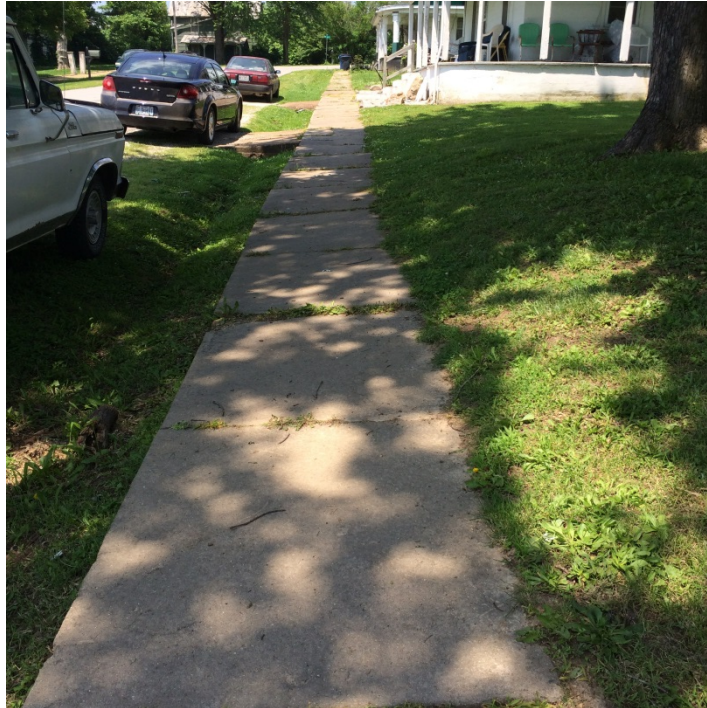
Fair Condition: West end of 5<sup>th</sup> Street

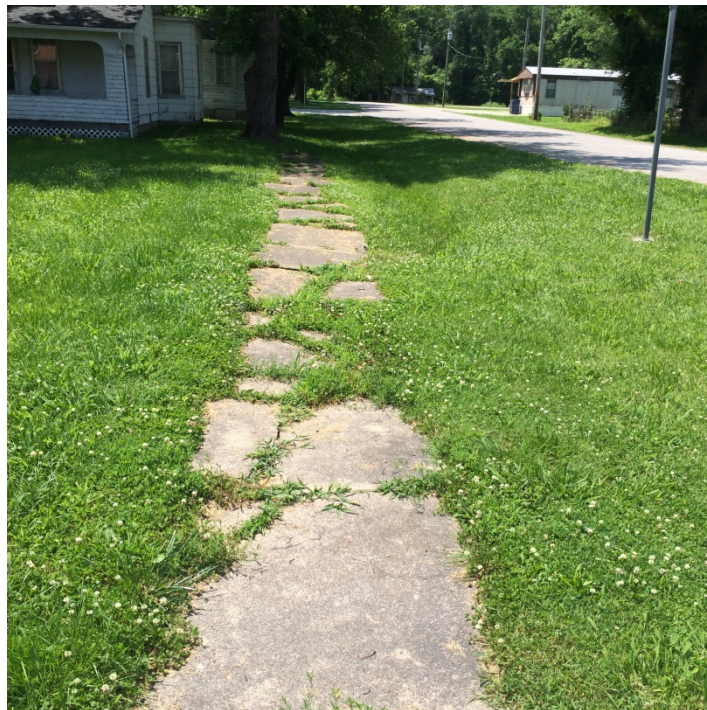
Poor Condition: Located at 2<sup>nd</sup> and Bertha streets.

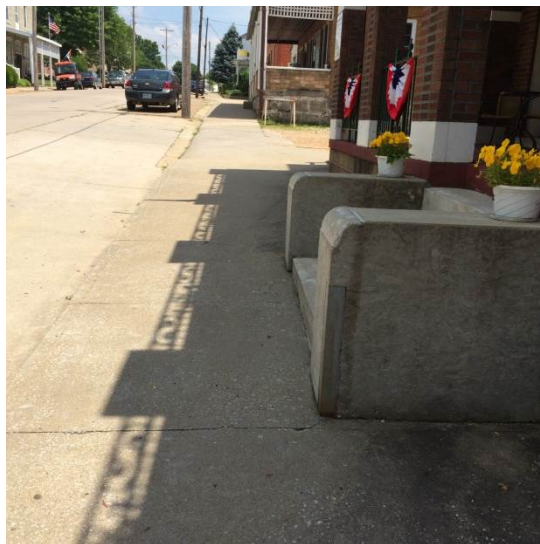
Good Condition: West side of East Main between Maries and Mill streets.

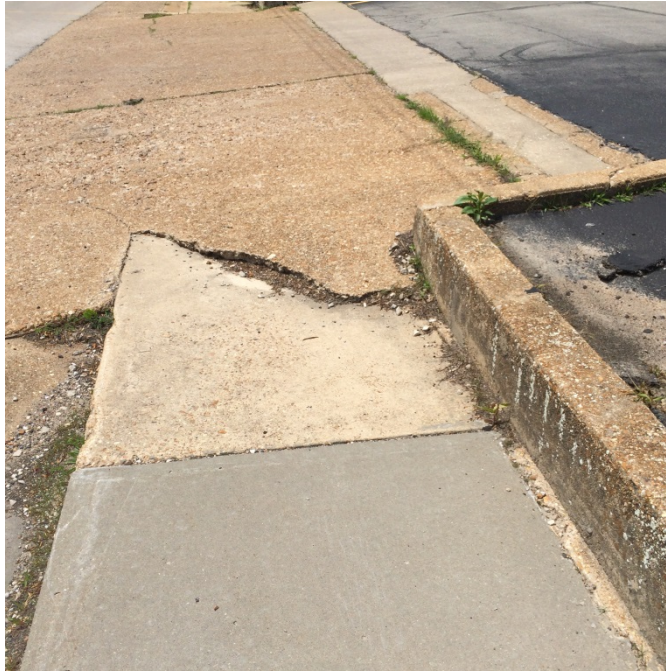
Fair Condition: East side of East Main close to downtown.

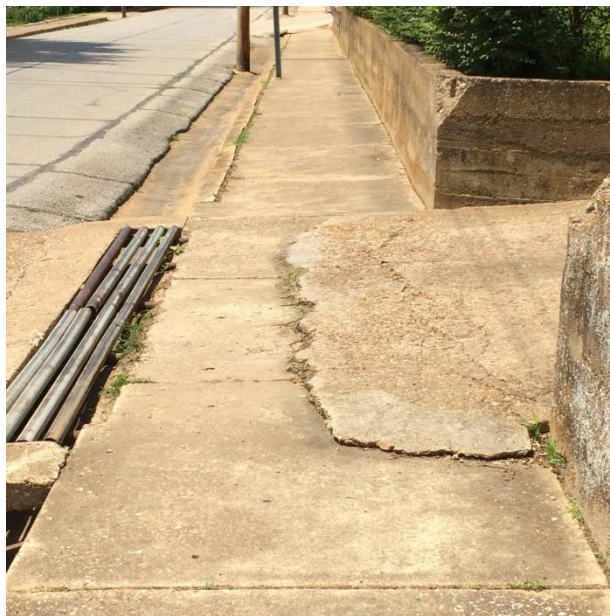
Poor Condition: East side of East Main close to downtown.
