## Appendix E

### PHASE I: SIDEWALK SURVEY

# City of Sullivan Sidewalk Inventory

This inventory was completed in January 2012 by the city of Sullivan, with assistance from the Meramec Regional Planning Commission. Data for the map was gathered through a “windshield” survey and is only intended to be a general representation of sidewalk condition.

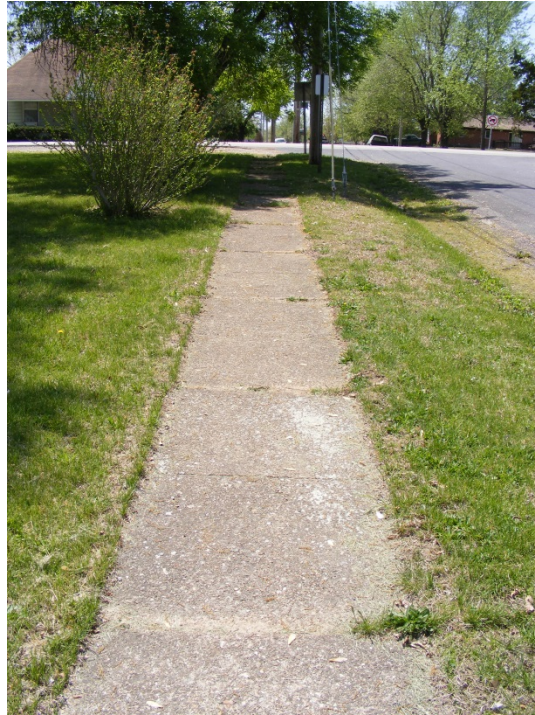
Fair Condition: Cedar Street, east side looking south toward Highway 50.

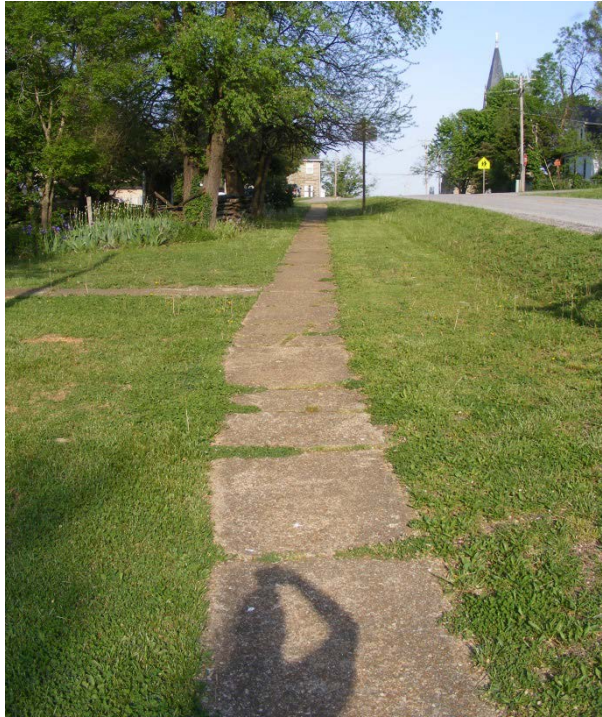
Fair Condition: 5<sup>th</sup> Street, south side looking west
