## Appendix E

### PHASE I: SIDEWALK SURVEY

# City of Sullivan Sidewalk Inventory

This inventory was completed in January 2012 by the city of Sullivan, with assistance from the Meramec Regional Planning Commission. Data for the map was gathered through a “windshield” survey and is only intended to be a general representation of sidewalk condition.

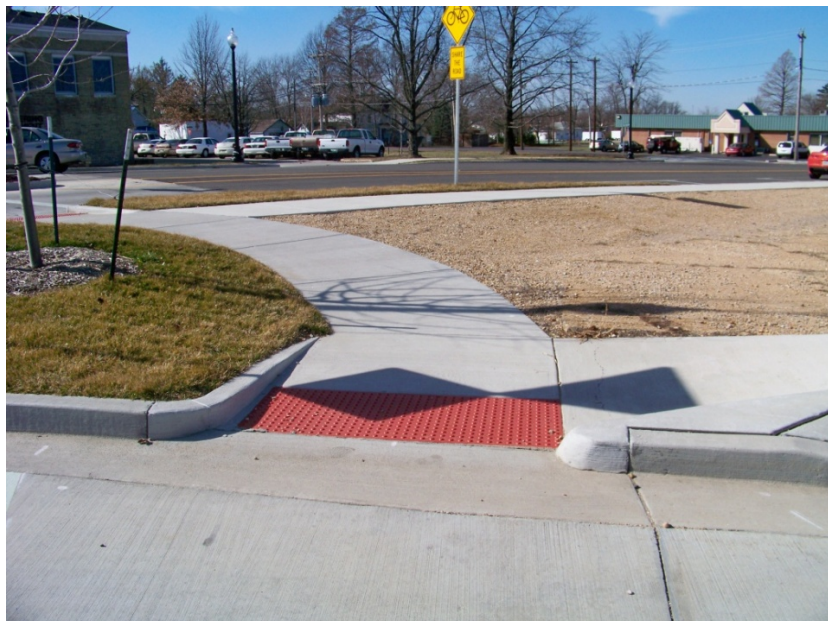
Good Condition: Roundabout at intersection of Taylor and Washington

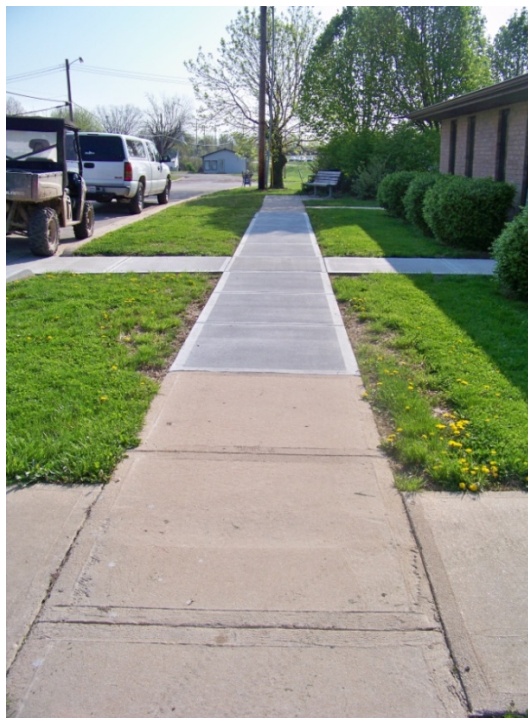
Good Condition:  
Third Street,  
south side  
looking east

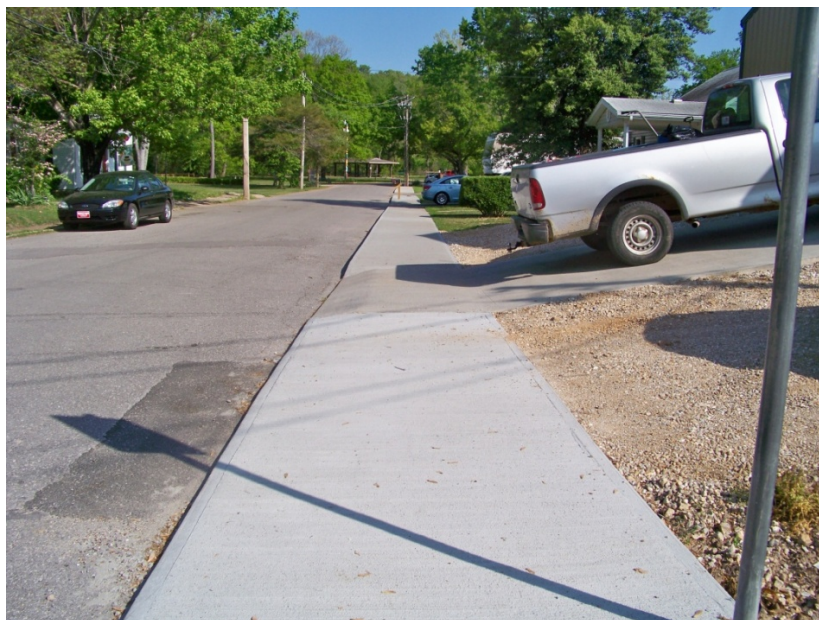
Good Condition: Olive Street, east side looking north

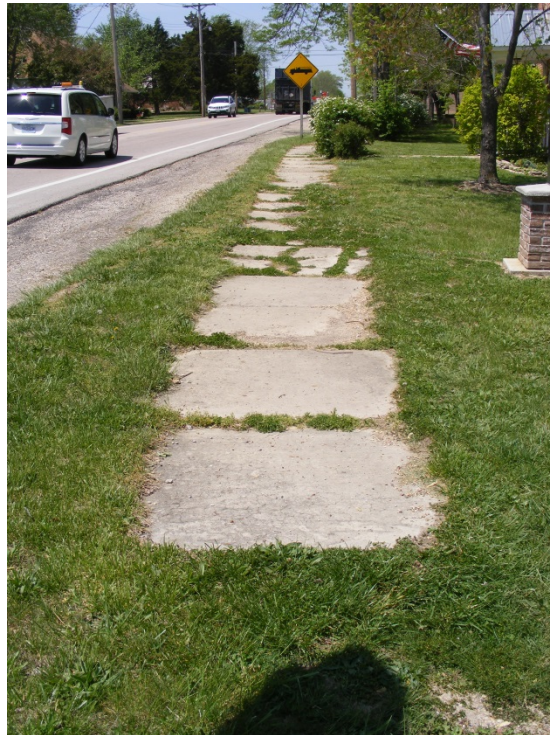
Poor Condition: Intersection of Highway 50 and 1<sup>st</sup> Street, northwest corner looking east.

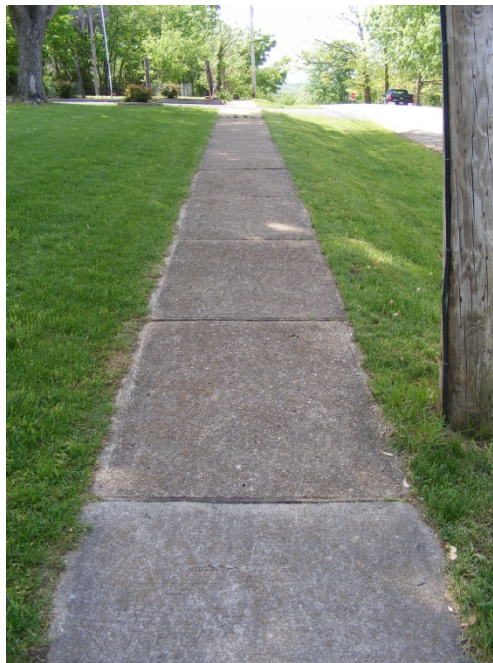
Good Condition: Linden Street, east side looking south toward Cherry Street

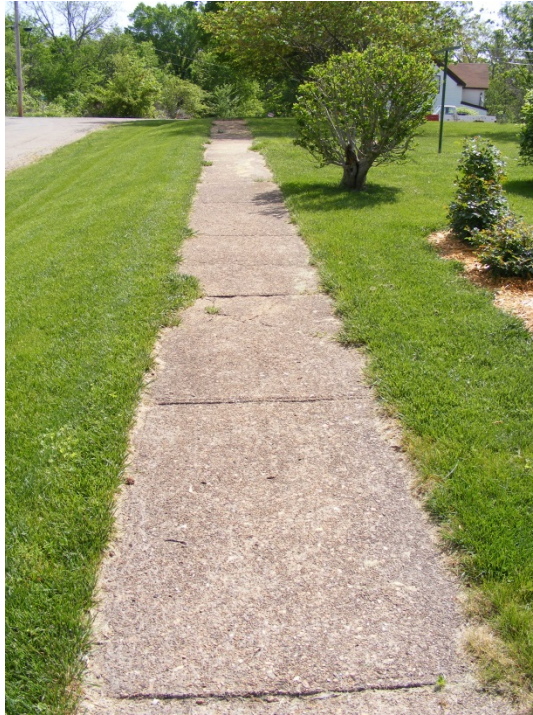
Fair Condition: Cedar Street, south side looking east toward Summit Street

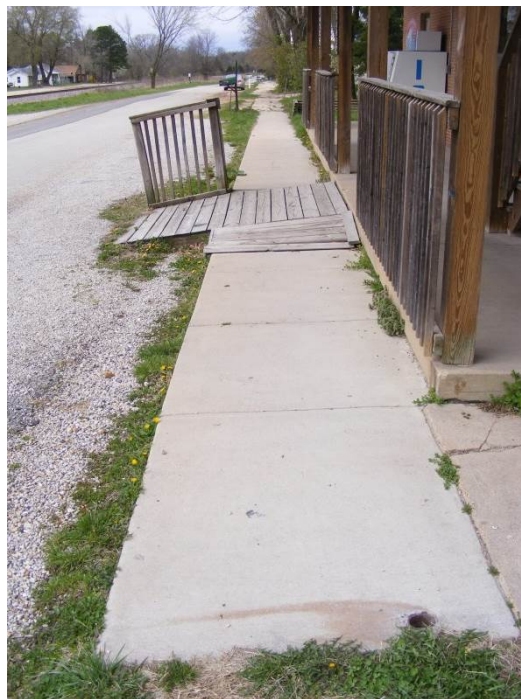
Good Condition: Intersection of Springfield Avenue and Second Street looking southwest.

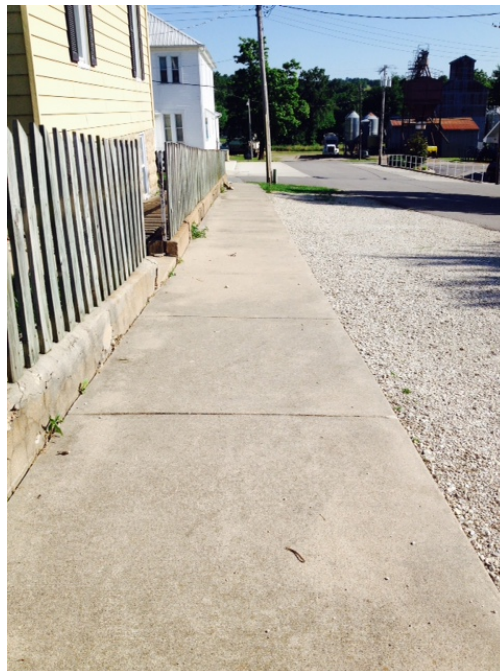
Good Condition: East side of Pine Street from 2<sup>nd</sup> to 3<sup>rd</sup> Street.

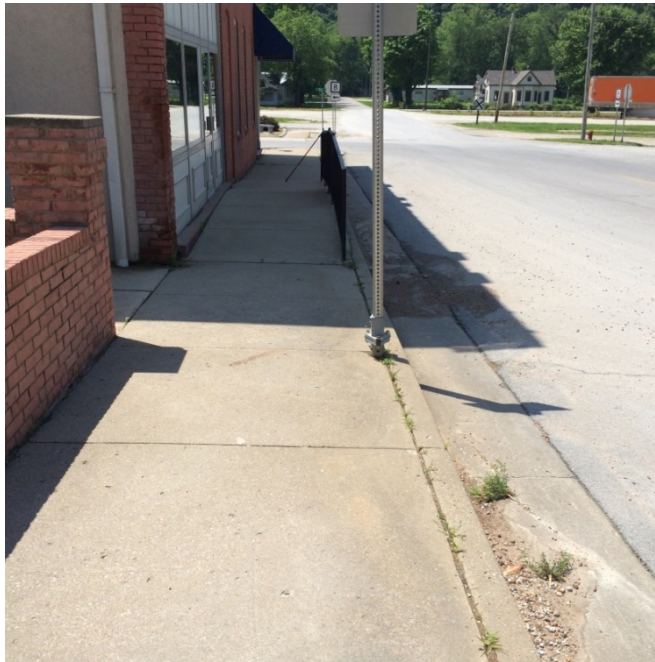
Good Condition: Located at 4<sup>th</sup> Street and Bertha Street
