## **Appendix E**

### **PHASE I: SIDEWALK SURVEY**

# City of Sullivan

## Sidewalk Inventory

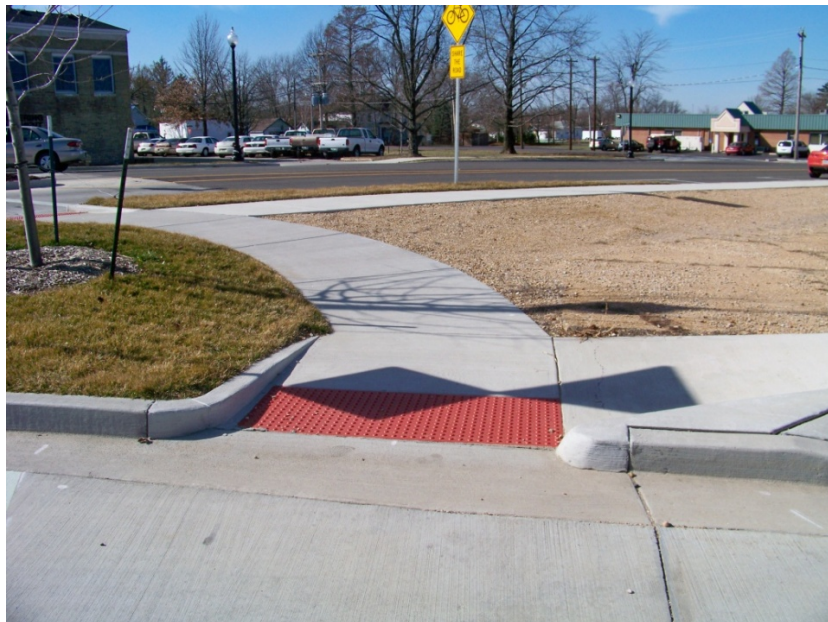
Good Condition: Roundabout at intersection of Taylor and Washington

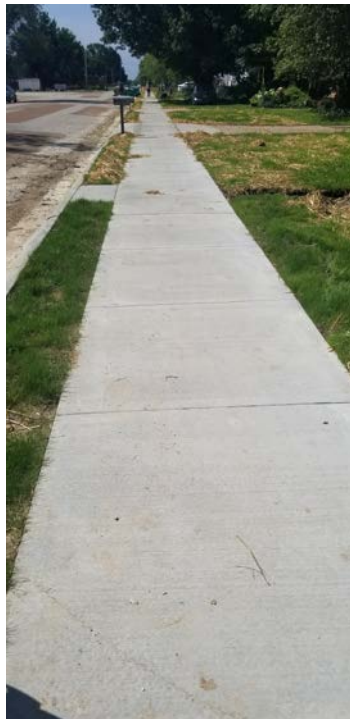
Good Condition:  
Johnson Avenue  
looking south.  
New section of  
sidewalk built as  
a part of the  
FY17 TAP grant  
through MoDOT.

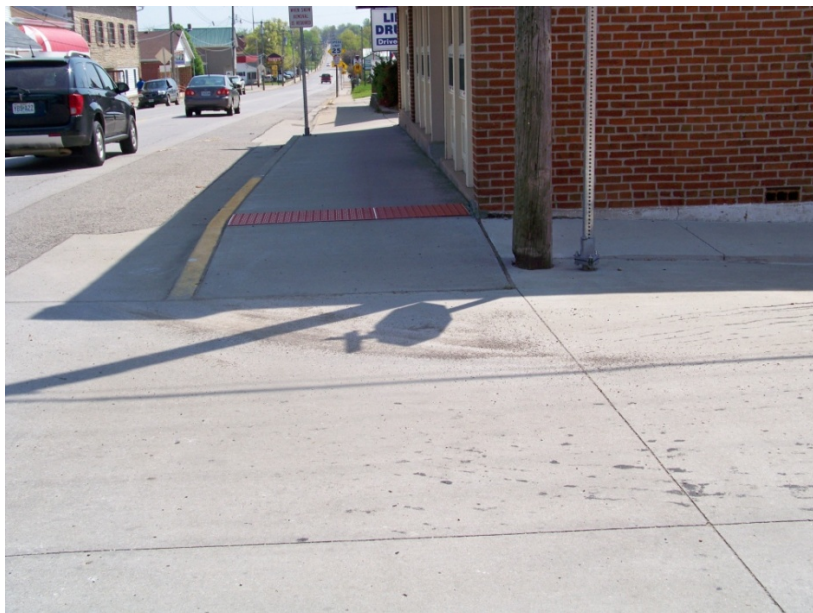
Good Condition: Corner of U.S. Hwy 50 (Main) and Third Street, south side looking east

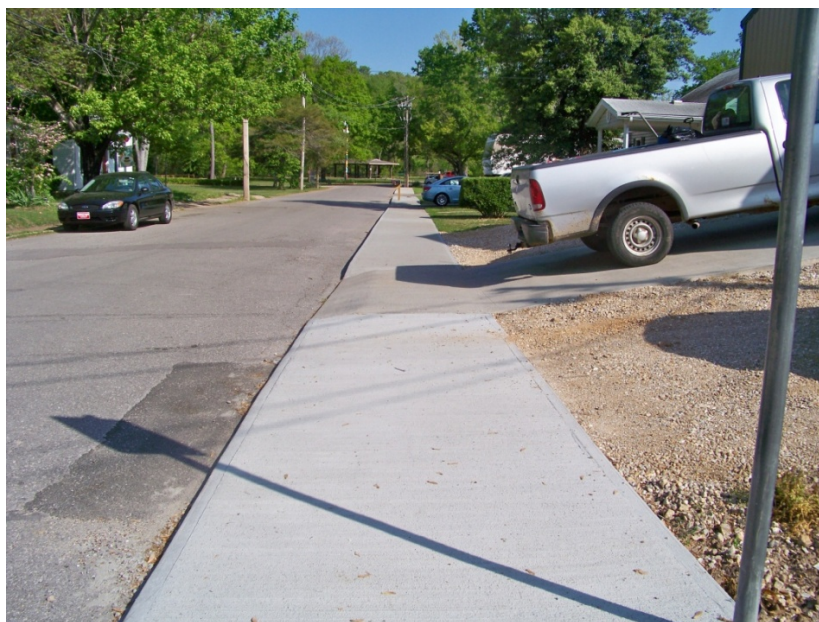
Good Condition: Olive Street, east side looking north

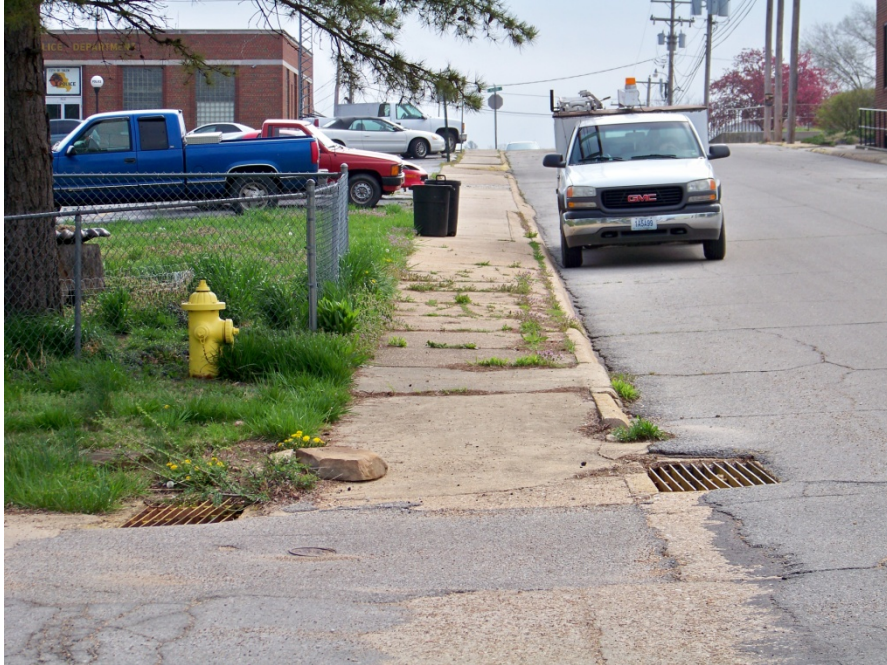
Fair Condition: Intersection of N. Henderson and 5<sup>th</sup> Street, north side looking west

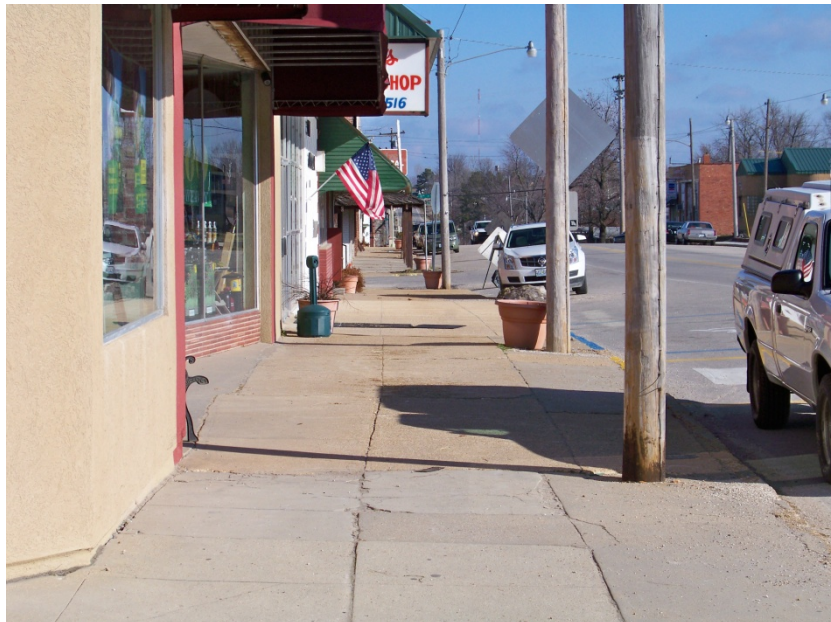
Good Condition: North Commercial Street, west side looking north

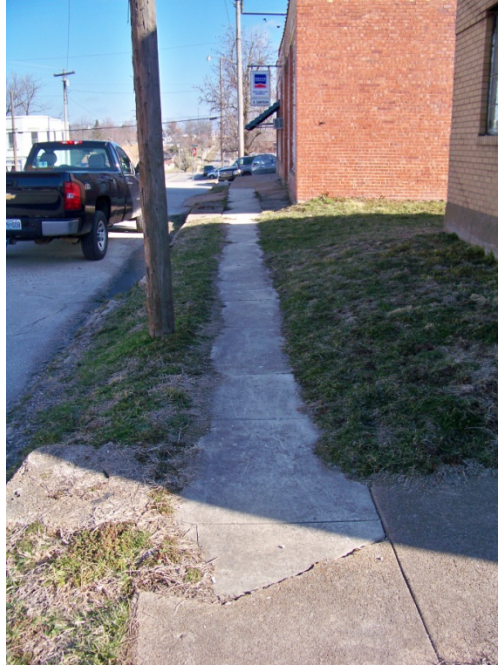
Fair Condition: North Commercial Street, east side looking north

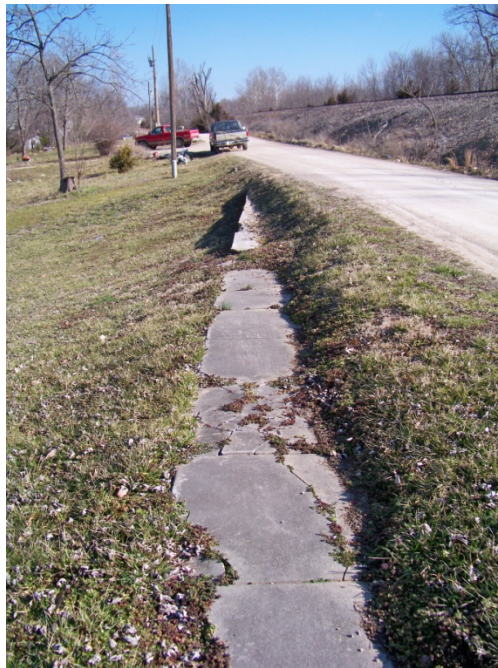
Poor Condition: Eastside Street, west side looking north

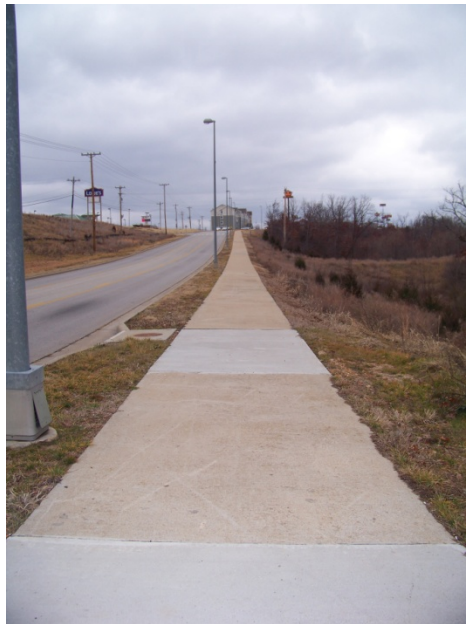
Good Condition: St. Robert Boulevard, south side looking east

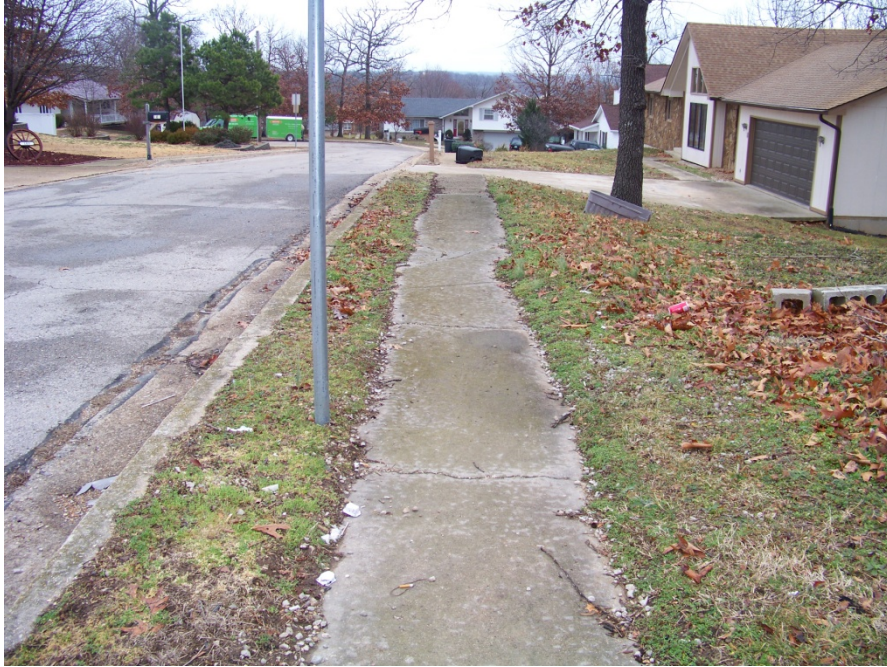
Fair Condition: Woodland Lane, south side looking east

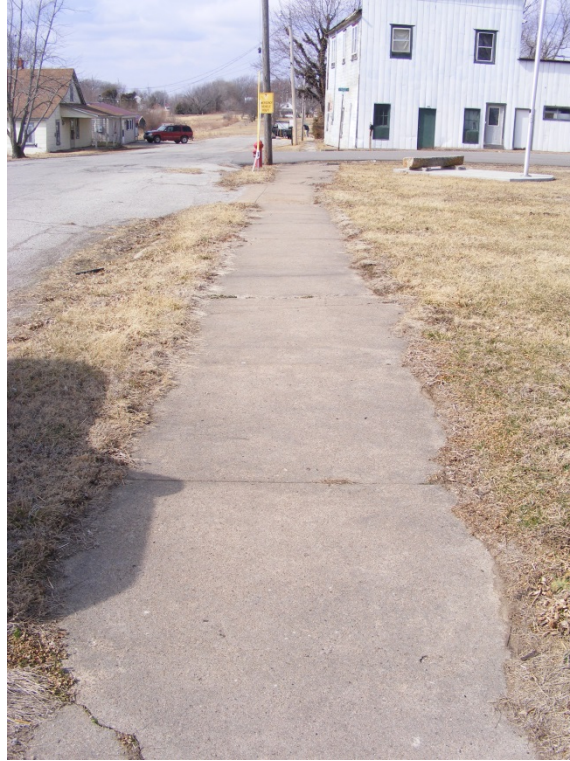
Fair Condition: North side of W. Colorado Ave., looking west to Frost Street

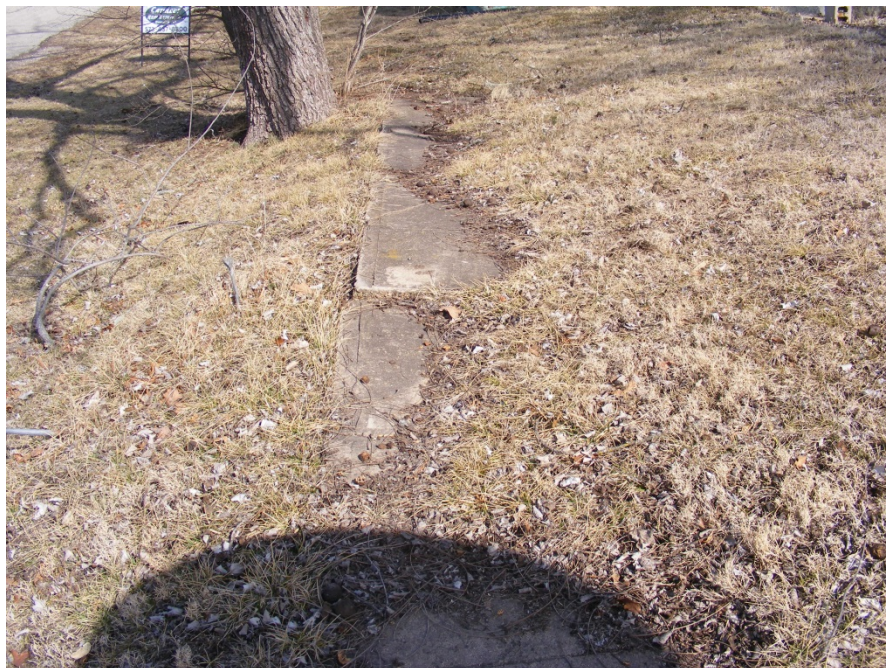
Poor Condition: N.W. corner of Taylor and East Missouri, looking north

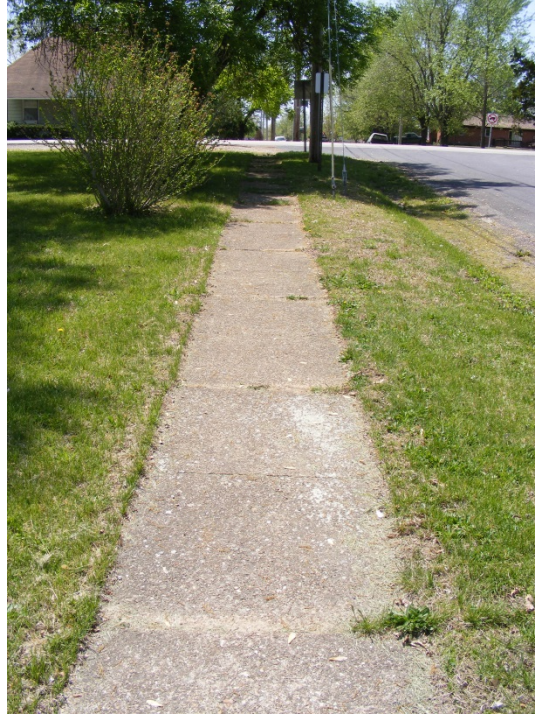
Fair Condition: Cedar Street, east side looking south toward Highway 50.

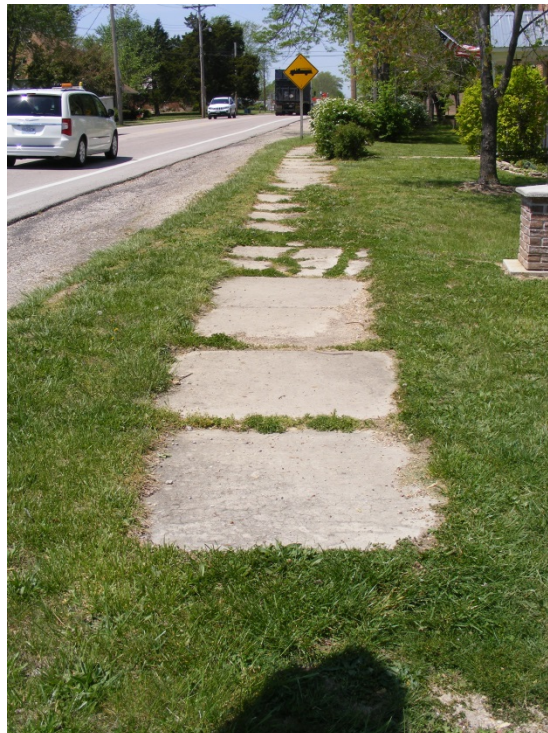
Poor Condition: Intersection of Highway 50 and 1<sup>st</sup> Street, northwest corner looking east.

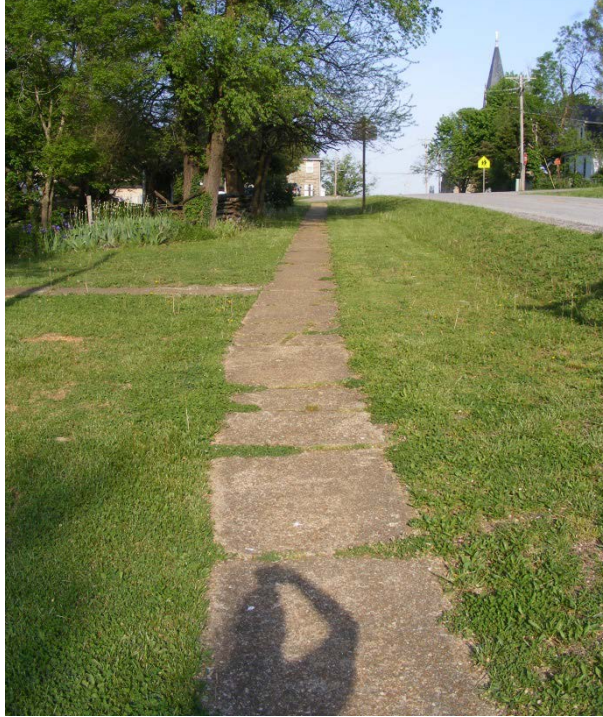
Fair Condition: 5<sup>th</sup> Street, south side looking west

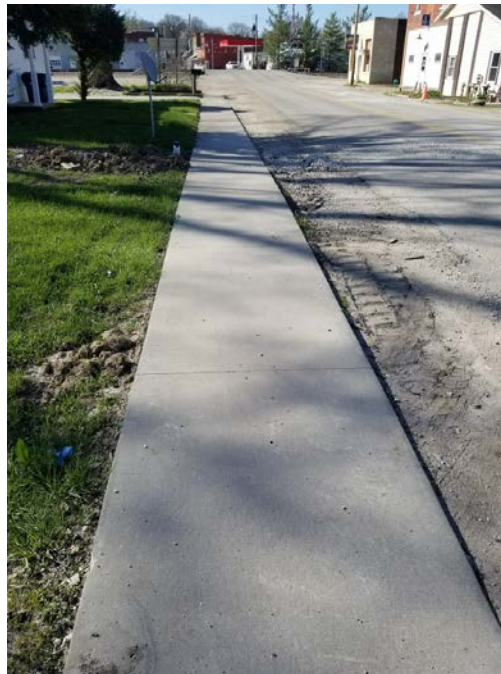
Good Condition: Main Street, east side looking south towards railroad tracks.

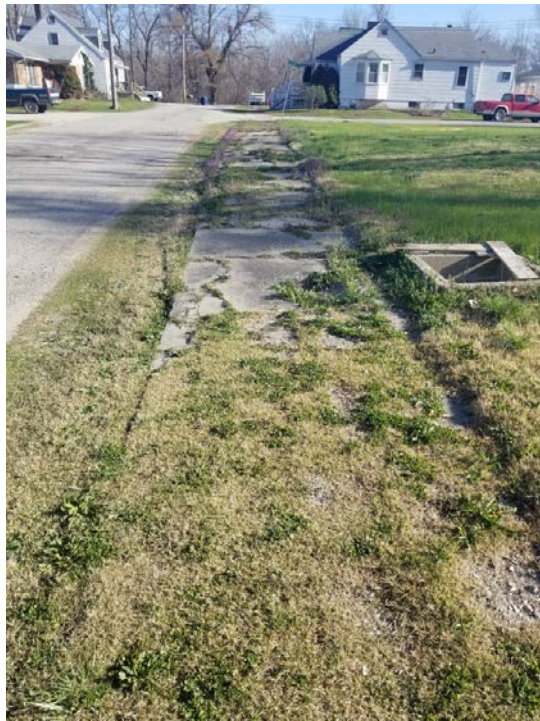
Poor Condition: Main Street, north of Missouri Avenue looking north.

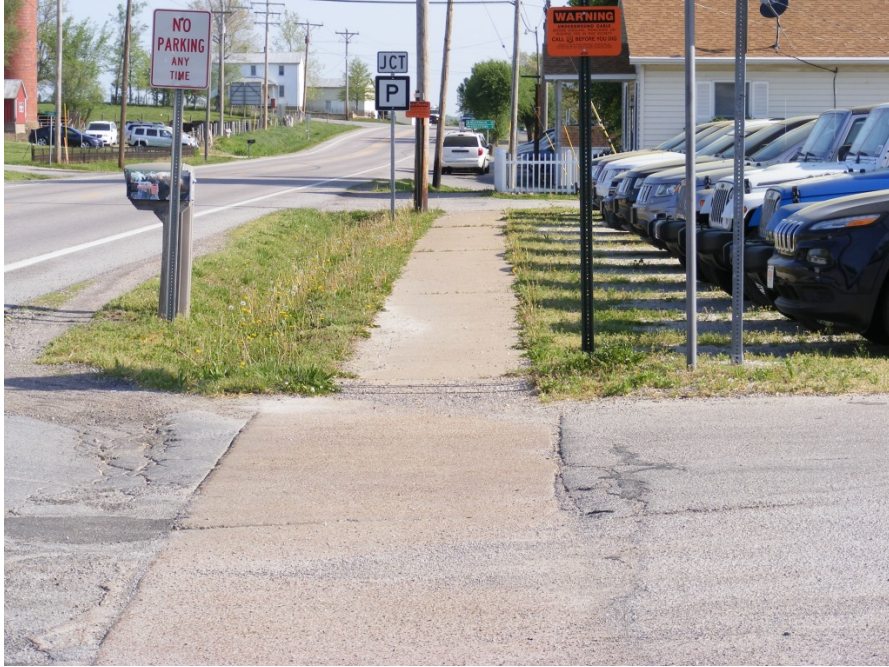
Fair Condition: Locust Street (Highway 63), west side looking north.

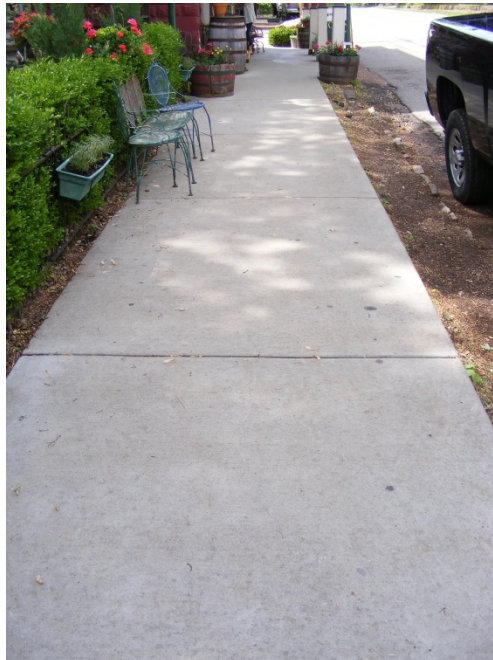
Good Condition: Main Avenue (Hwy 21), east side looking south toward Alexander Street.

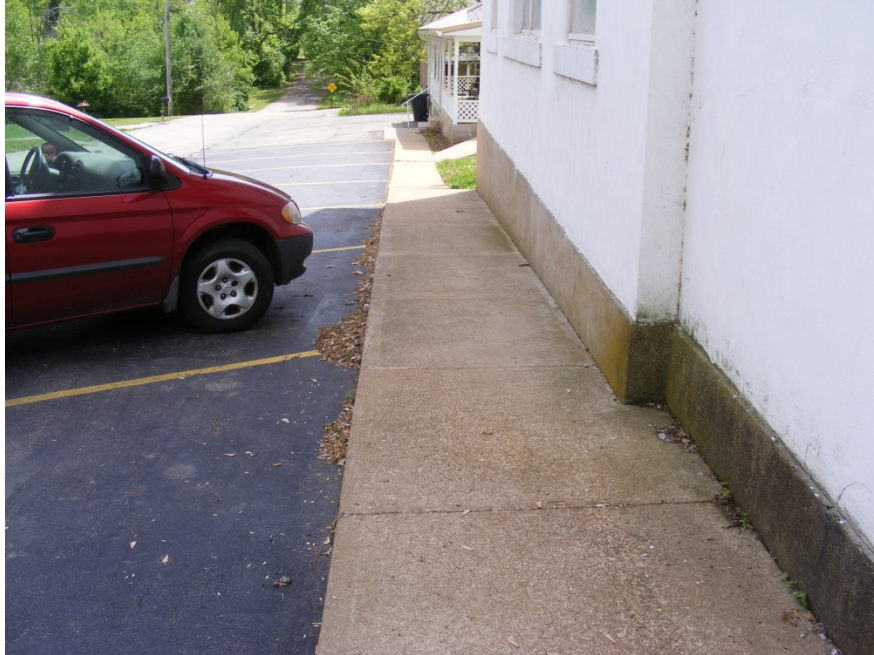
Fair Condition: Alexander Street, south side looking east toward College Street.

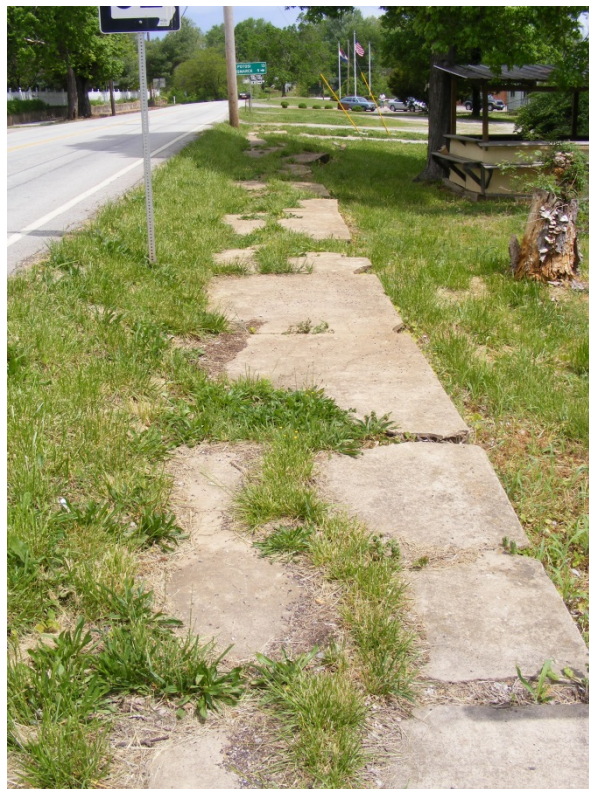
Poor Condition: Main Avenue (Hwy 21), west side looking north.

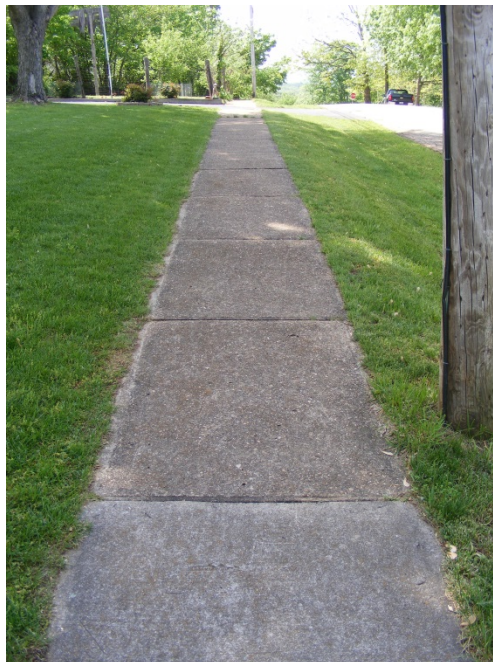
Good Condition: Linden Street, east side looking south toward Cherry Street

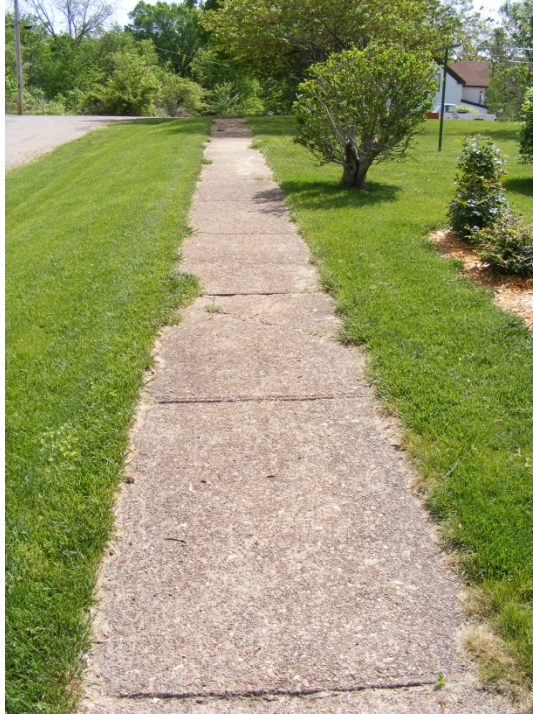
Fair Condition: Cedar Street, south side looking east toward Summit Street

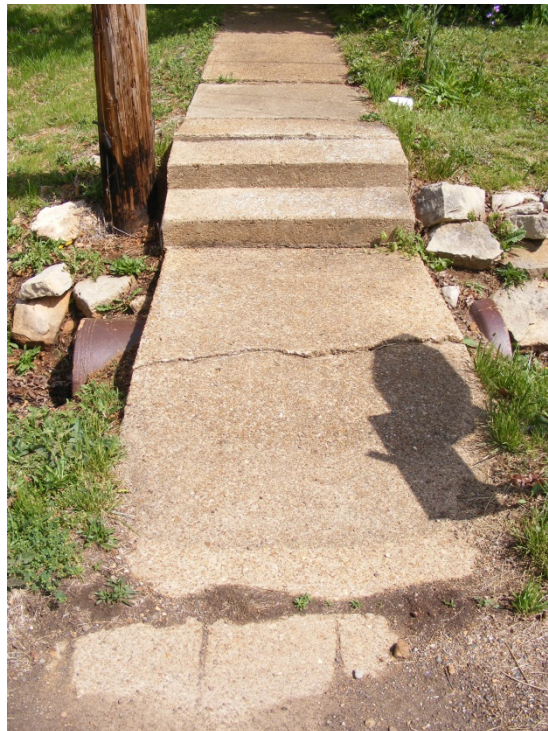
Poor Condition: Intersection of Ash Street and Linden Street, northeast corner looking north.

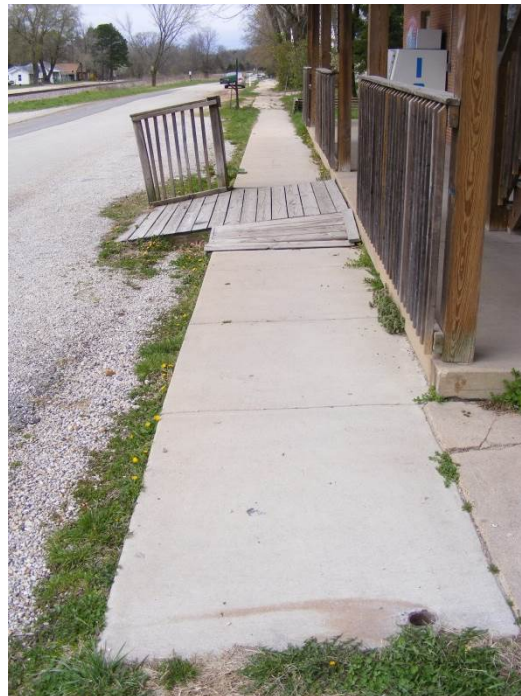
Good Condition: Intersection of Springfield Avenue and Second Street looking southwest.

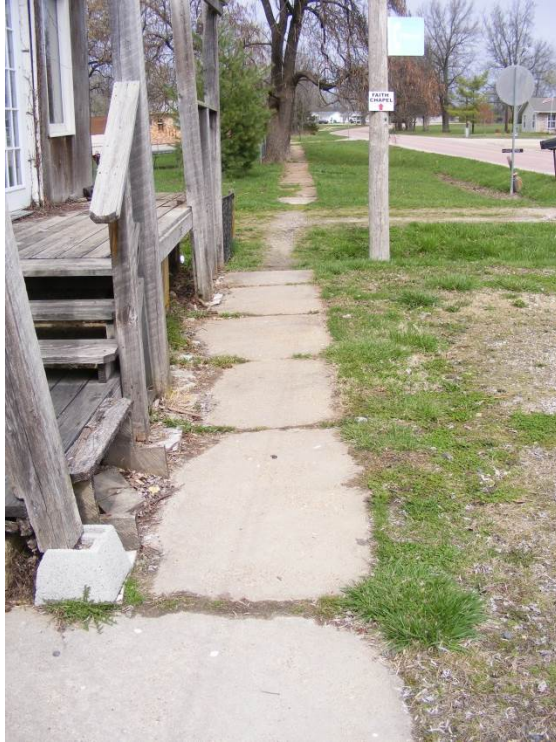
Fair Condition: Intersection of Springfield Avenue and Second Street looking northwest.

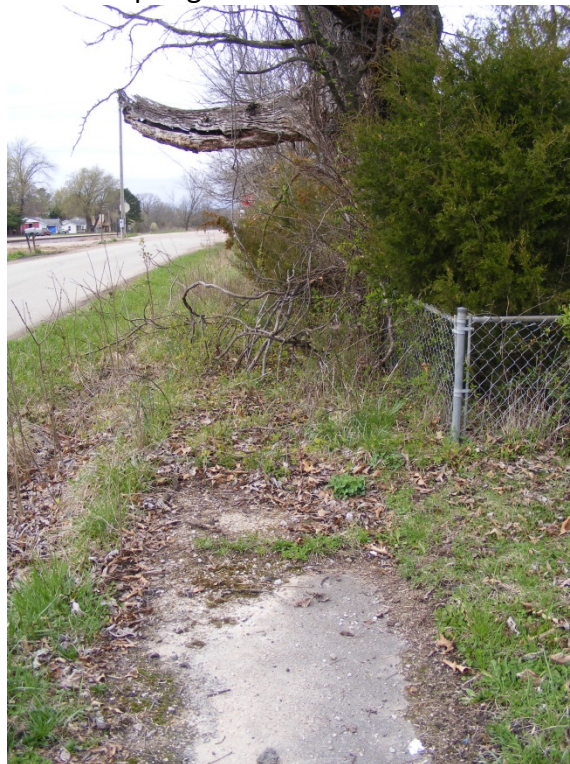
Poor Condition: North side of E. Springfield Avenue looking southwest.

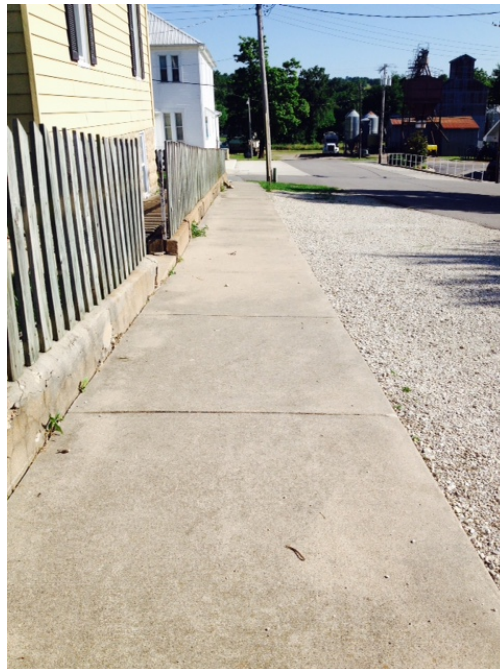
Good Condition: East side of Pine Street from 2<sup>nd</sup> to 3<sup>rd</sup> Street.

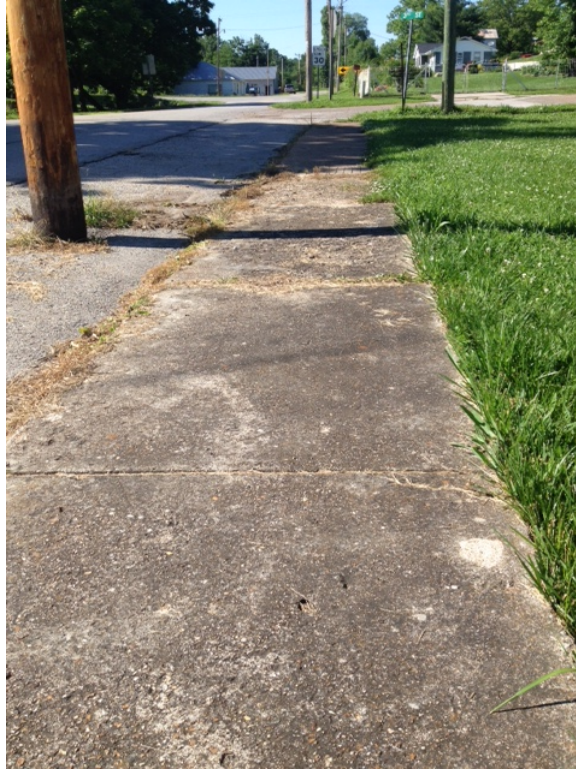
Fair Condition: East side of Hwy. 532 from 2<sup>nd</sup> to 3<sup>rd</sup> Streets.

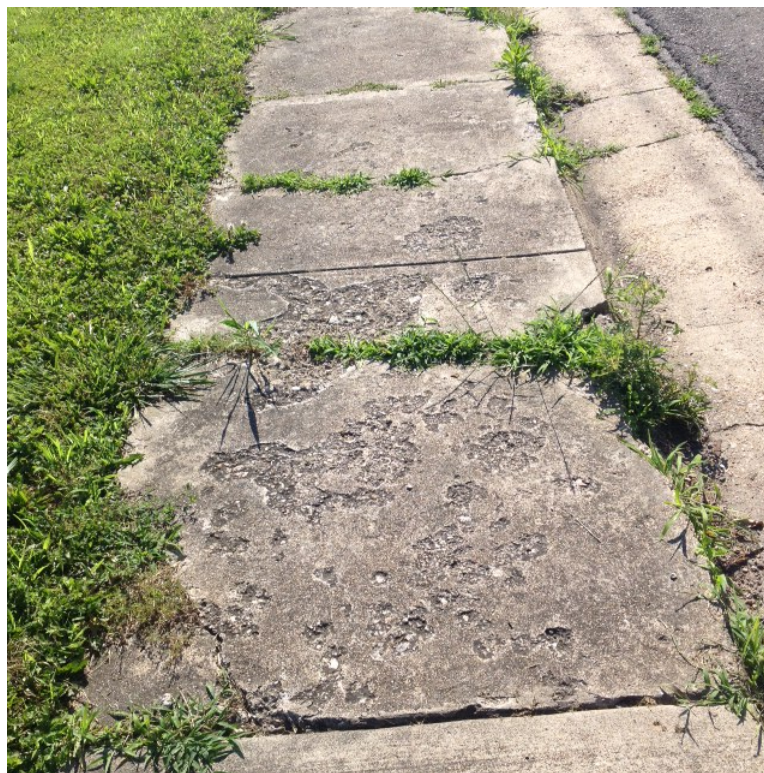
Poor Condition: South side of 2<sup>nd</sup> Street from Hwy. 532 to Pine Street.

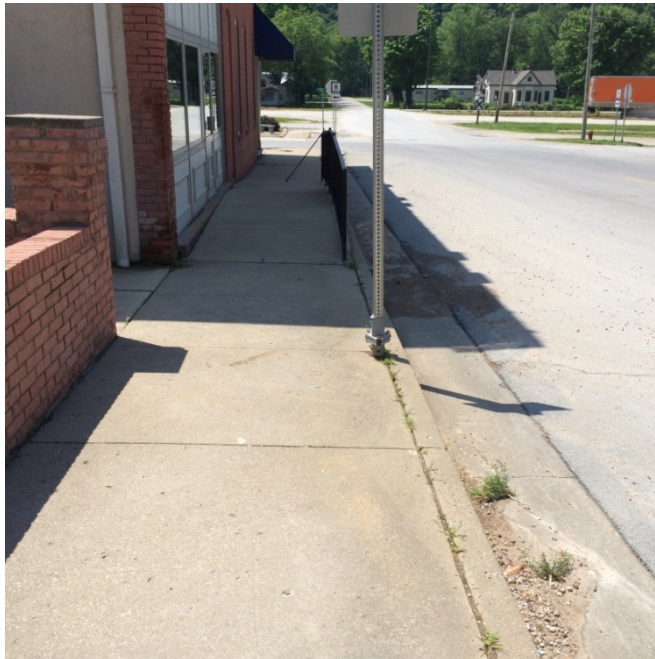
Good Condition: Located at 4<sup>th</sup> Street and Bertha Street

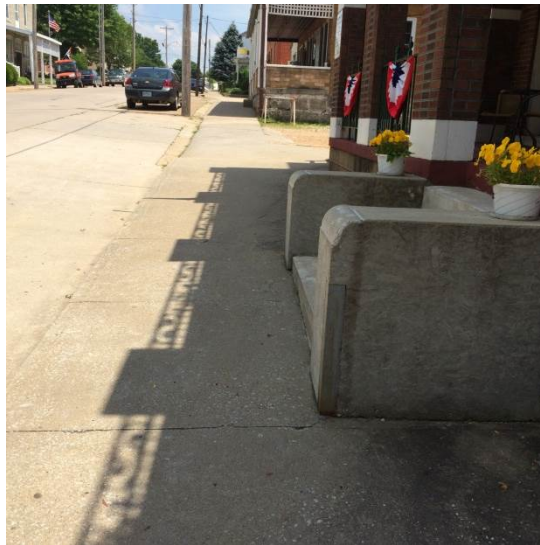
Good Condition: West side of East Main between Maries and Mill streets.
