Appendix E

PHASE I: SIDEWALK SURVEY

City of Sullivan

Sidewalk Inventory

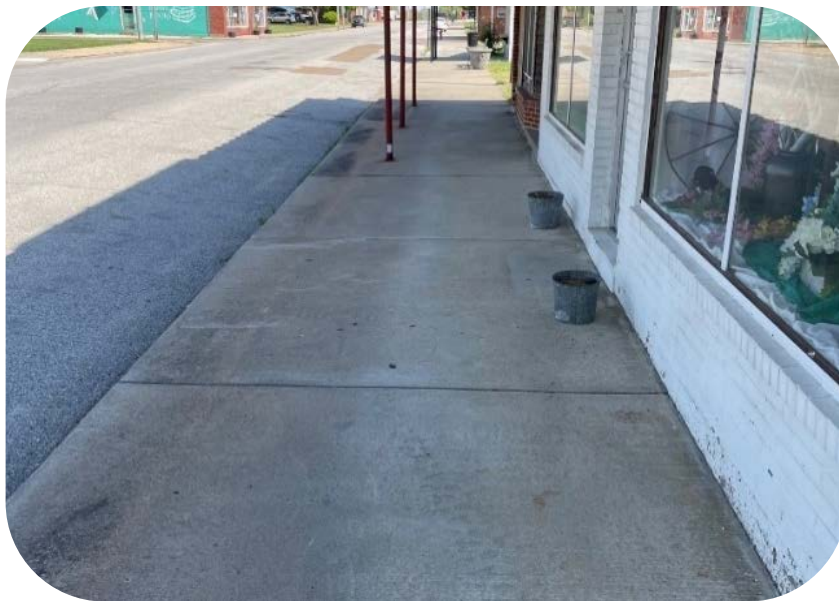
Good Condition: Sidewalk on east side of Alvarado Ave. looking north.

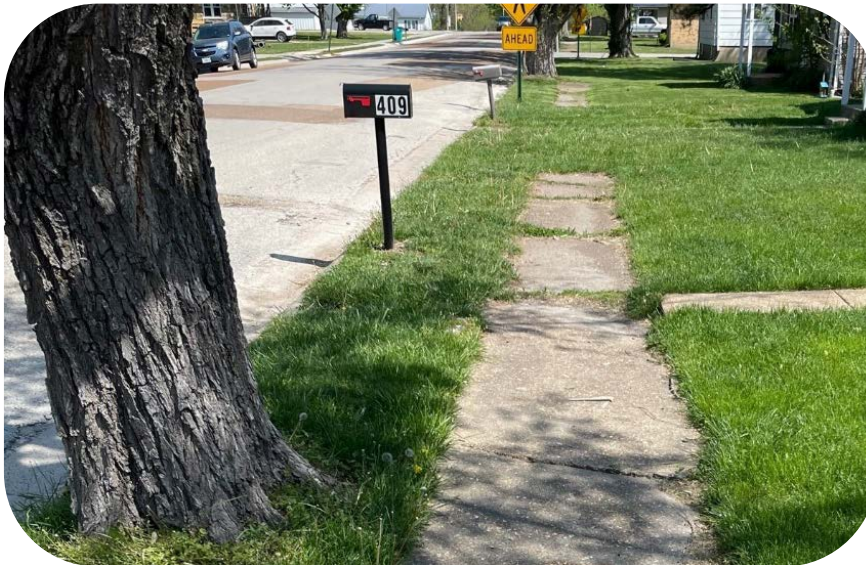
Poor Condition: Sidewalk along east side of Johnson Ave. looking north.

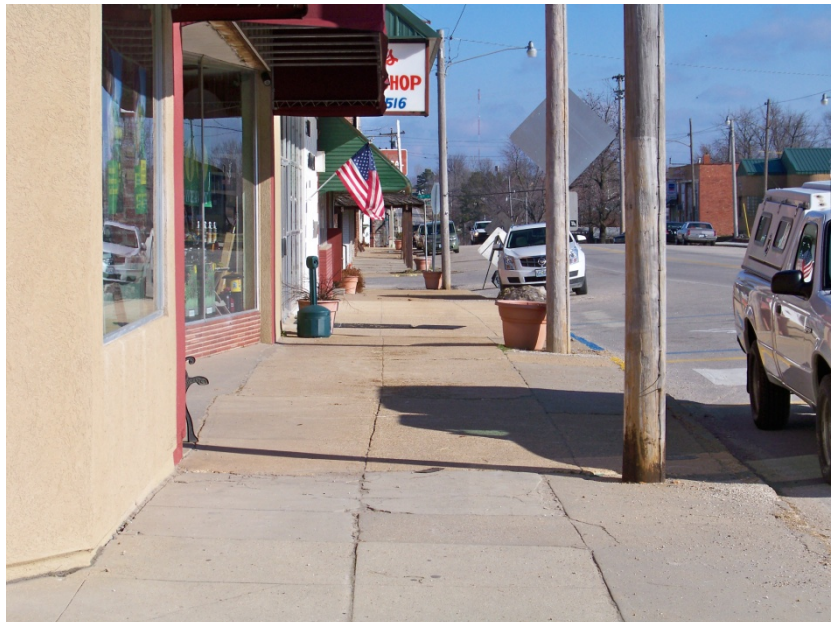
Good Condition: North Commercial Street, west side looking north

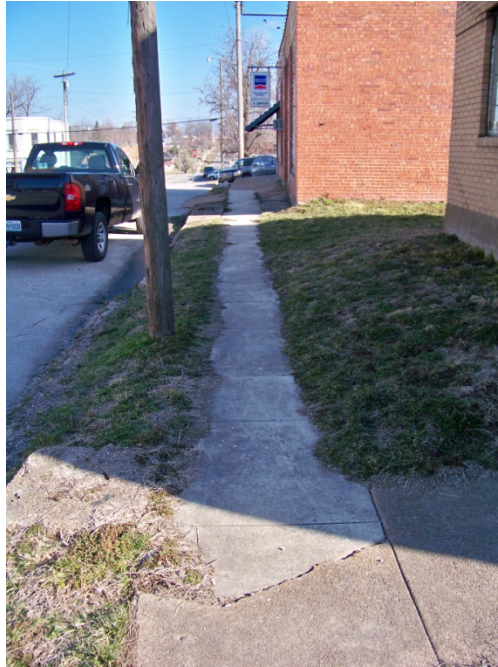
Fair Condition: North Commercial Street, east side looking north

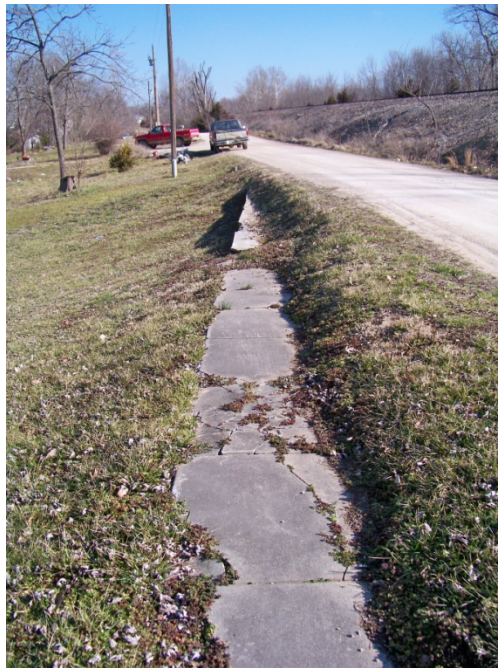
Poor Condition: Eastside Street, west side looking north

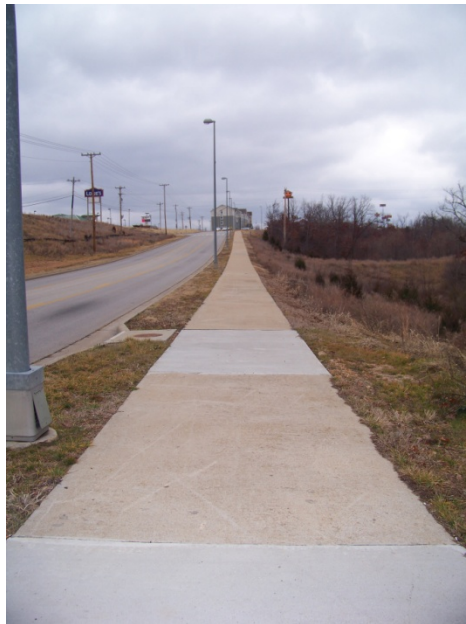
Good Condition: St. Robert Boulevard, south side looking east

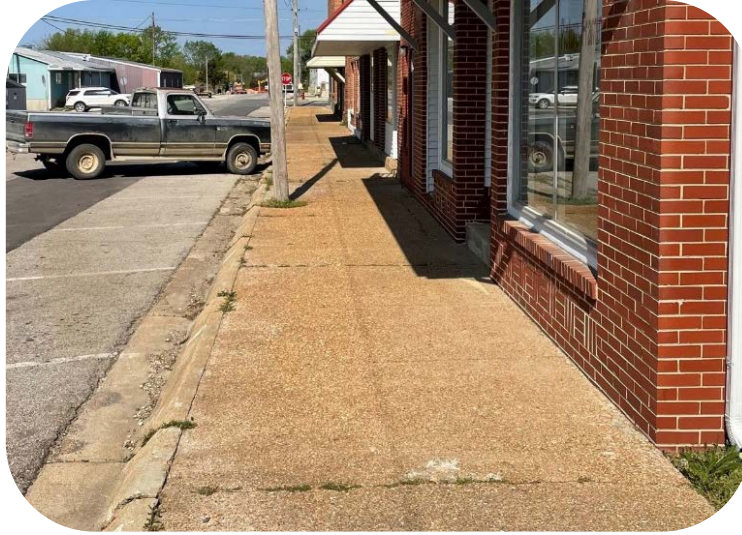
Fair Condition: Sidewalk along north side of Colorado Avenue looking west.

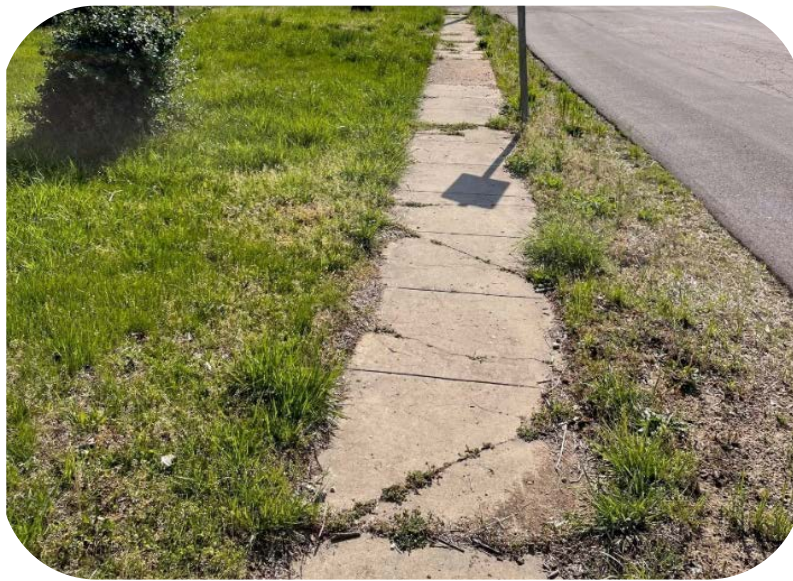
Poor Condition: Sidewalk along north side of Colorado Avenue.

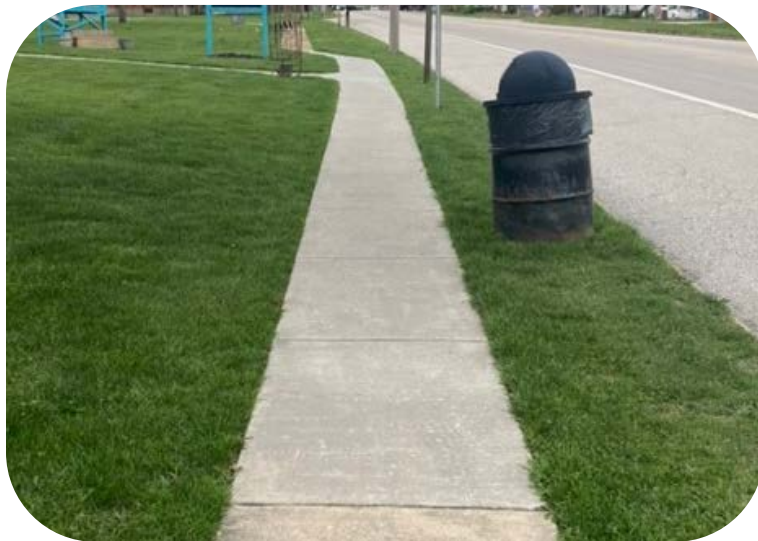
Good Condition: Sidewalk on south side of State Route 50 looking west.

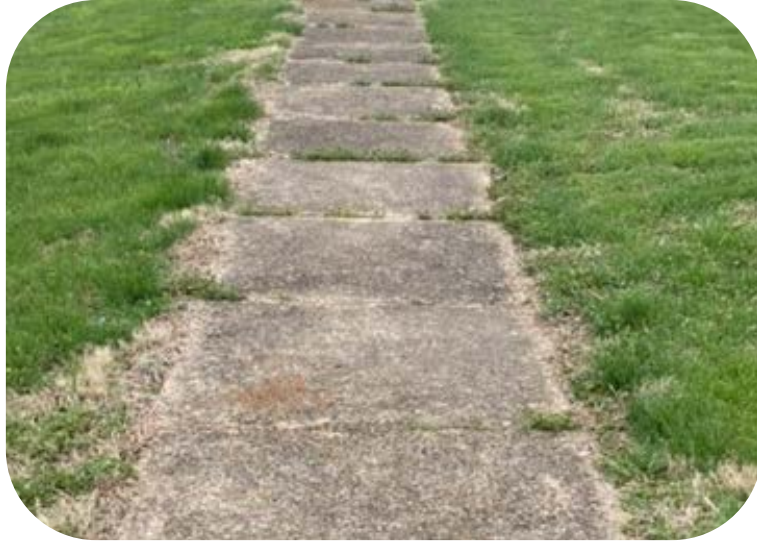
Fair Condition: Cedar Street, east side looking south toward Highway 50.

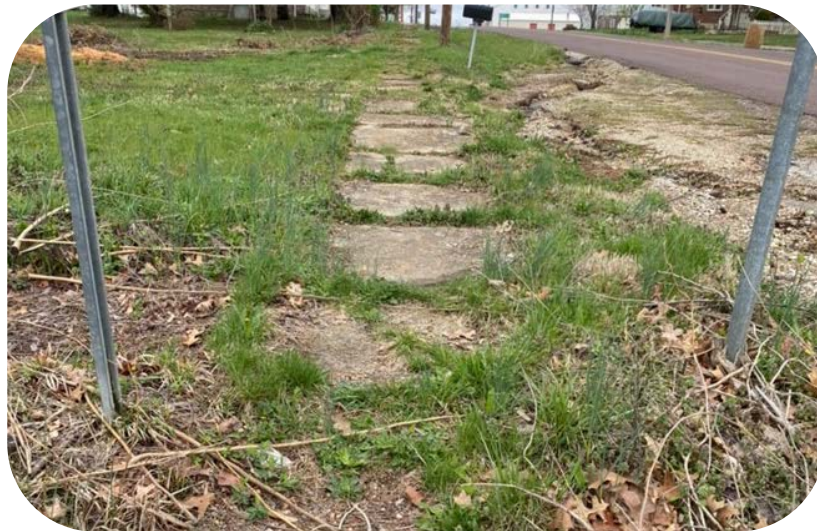
Poor Condition: Intersection of Highway 50 and 1st Street, northwest corner looking east.

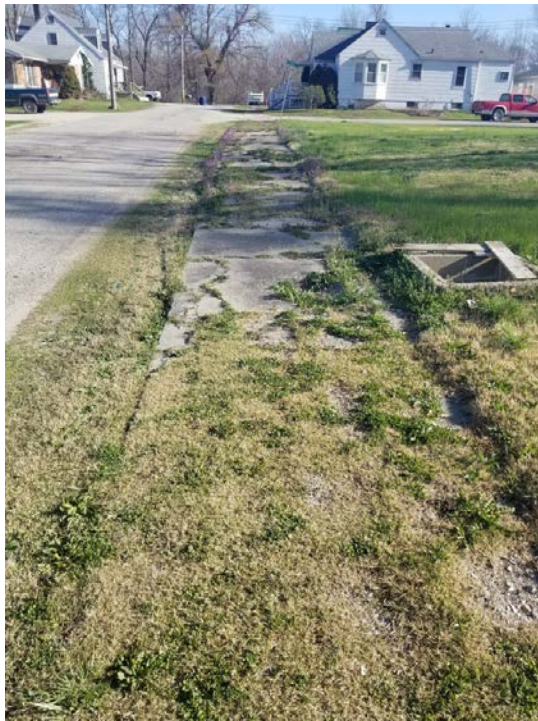
Poor Condition: Main Street, north of Missouri Avenue looking north.

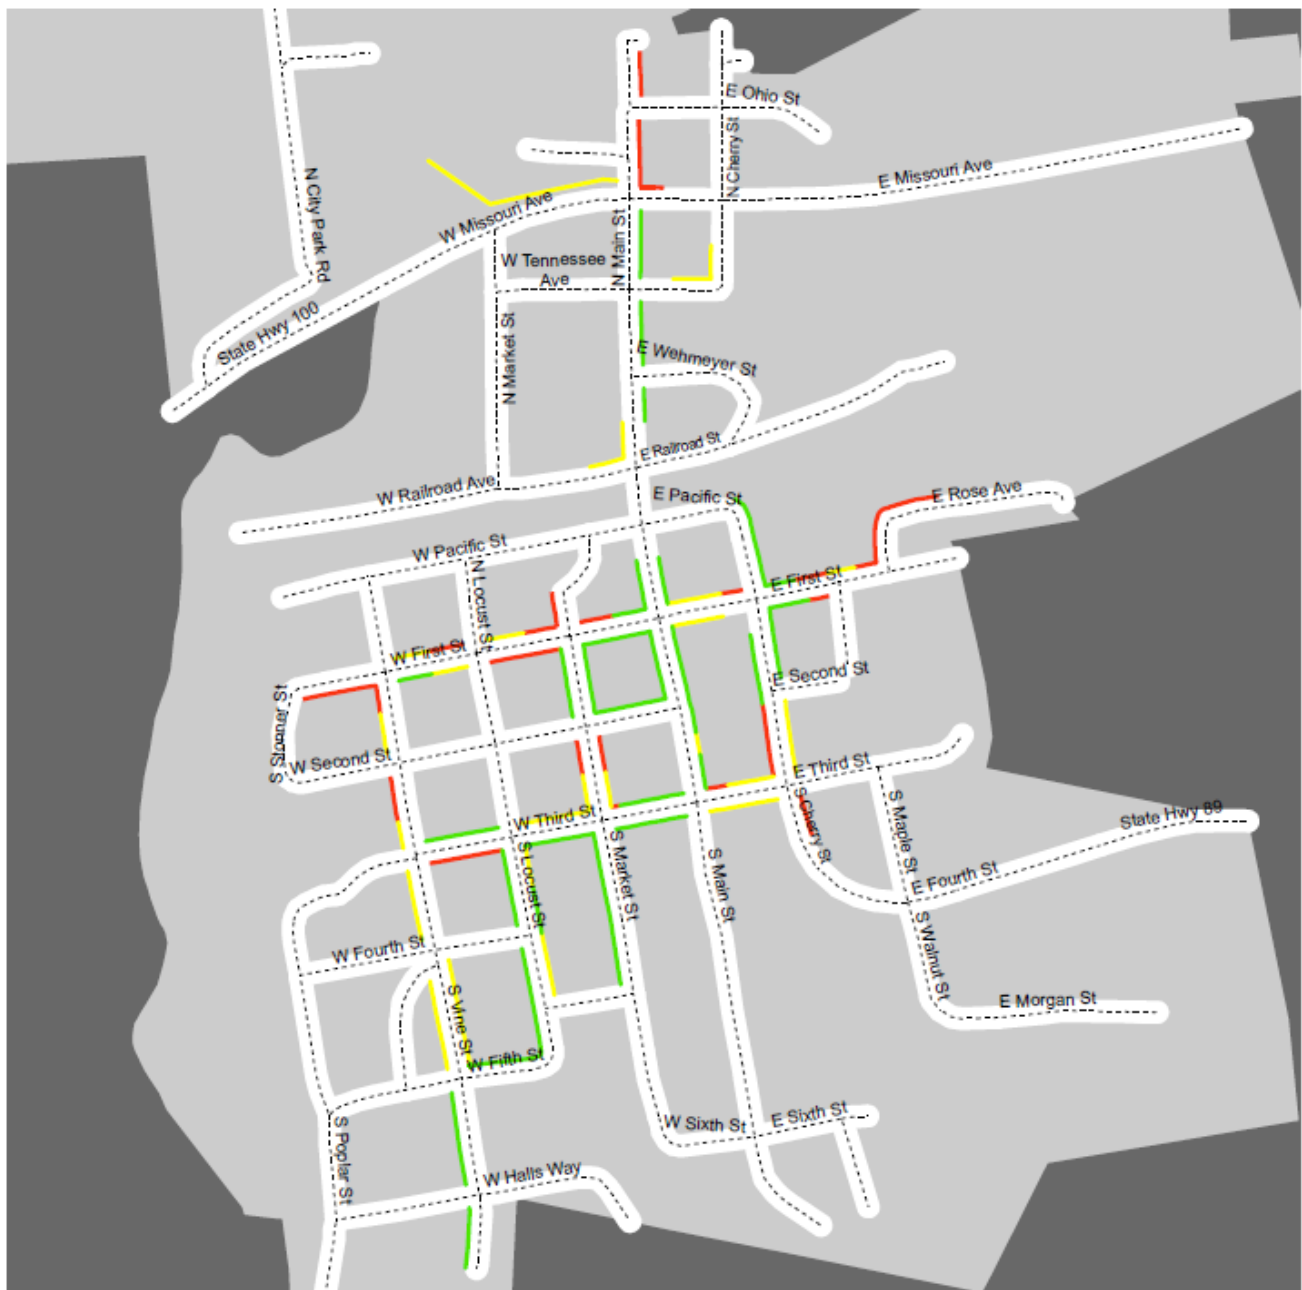
City of Chamois, MO Sidewalks

This map depicts sidewalk conditions in the City of Chamois, MO. Sidewalks were ranked as good, fair, and poor. The total length of line segments were calculated for each rank. Created by MRPC in partnership with the Missouri Department of Transportation. April 2018

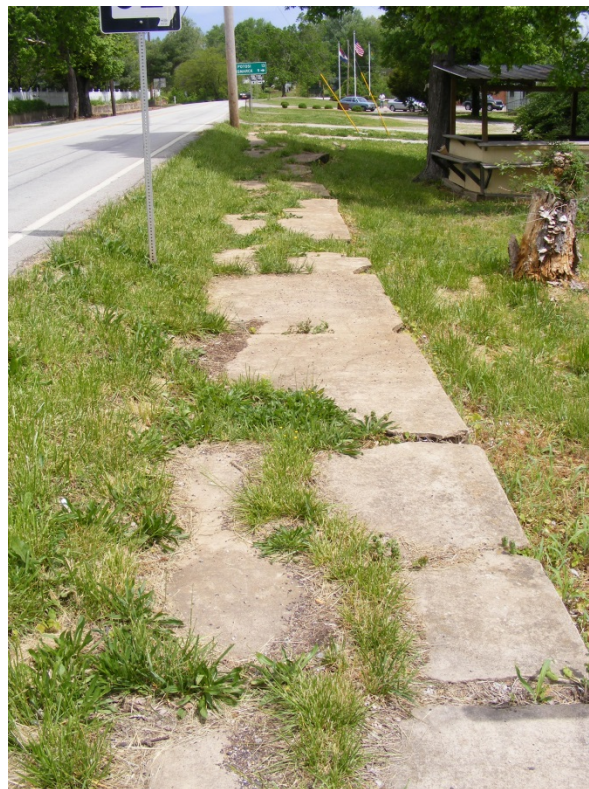
Poor Condition: Main Avenue (Hwy 21), west side looking north.

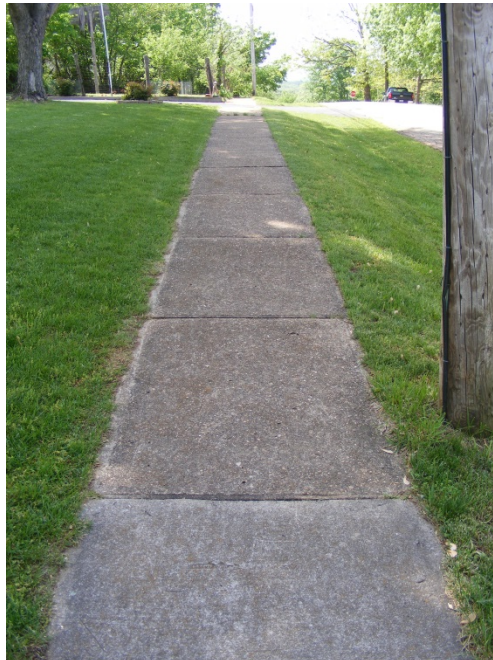
Good Condition: Linden Street, east side looking south toward Cherry Street

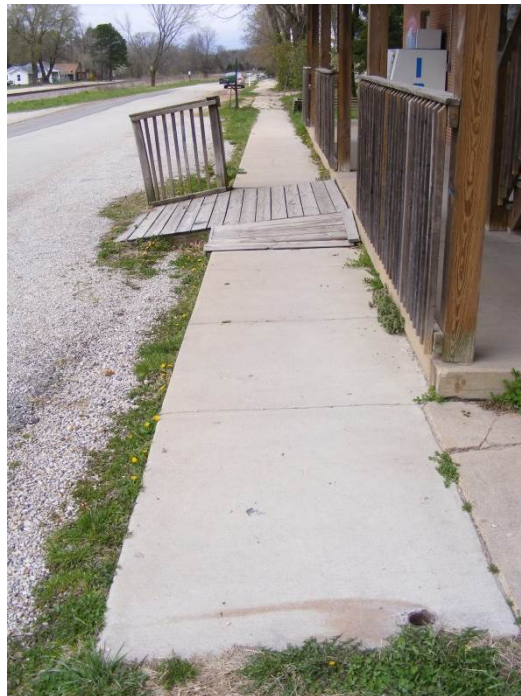
Good Condition: Intersection of Springfield Avenue and Second Street looking southwest.

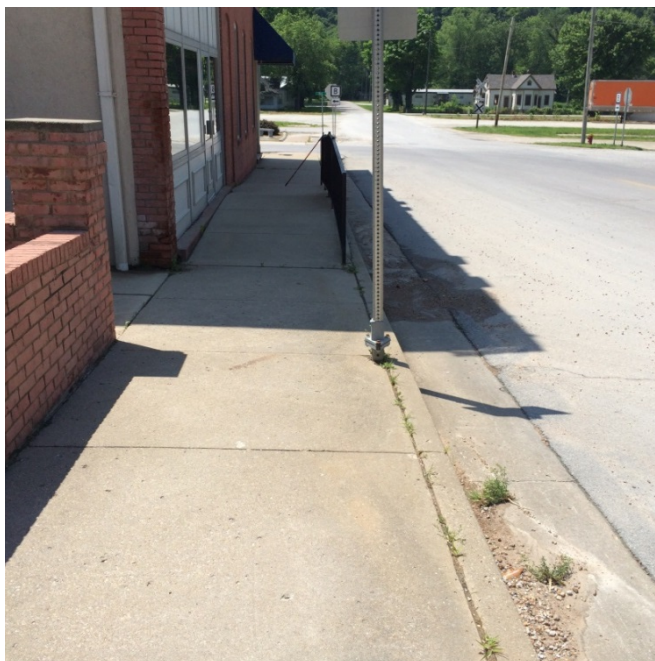
Good Condition: Located at 4th Street and Bertha Street
